AIRPROX REPORT No 2025209

Date: 05 Sep 2025 Time: 1317Z Position: 5450N 00136W Location: Chester-Le-Street

PART A: SUMMARY OF INFORMATION REPORTED TO UKAB

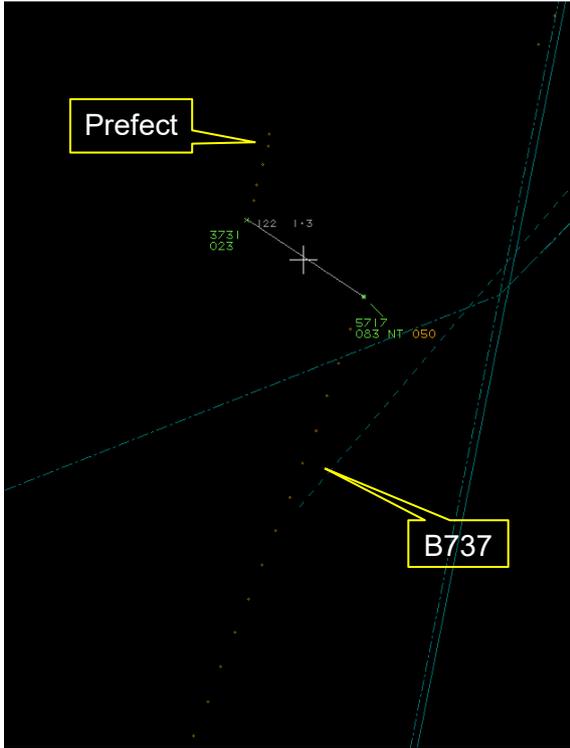
Figure 1: CPA: 1317:23. 6000ft/1.3NM
Slant range 9919ft.

Both aircraft were tracked via radar and identified through Mode S data. Figures 1 and 2 show the individual closest points of approach both vertically and horizontally with the combined closest point of approach calculated as having occurred at 1317:23.

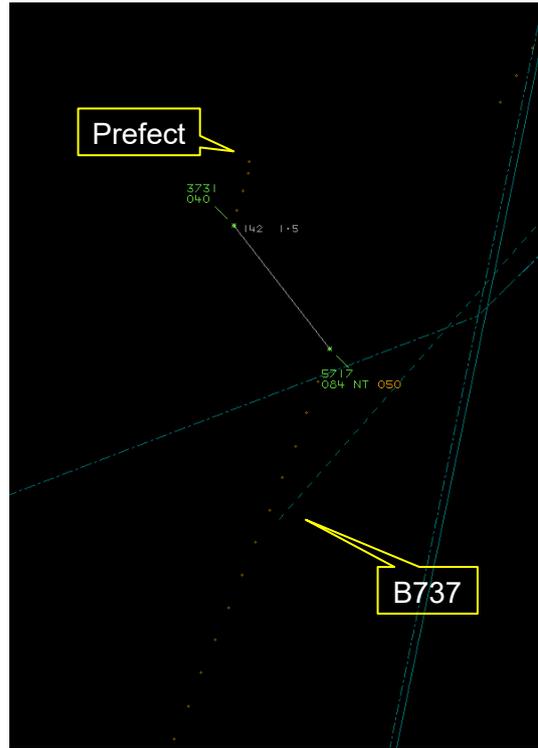
Figure 2: CPA-4 sec (1317:19). 4400ft/1.5NM
Slant range 10,120ft

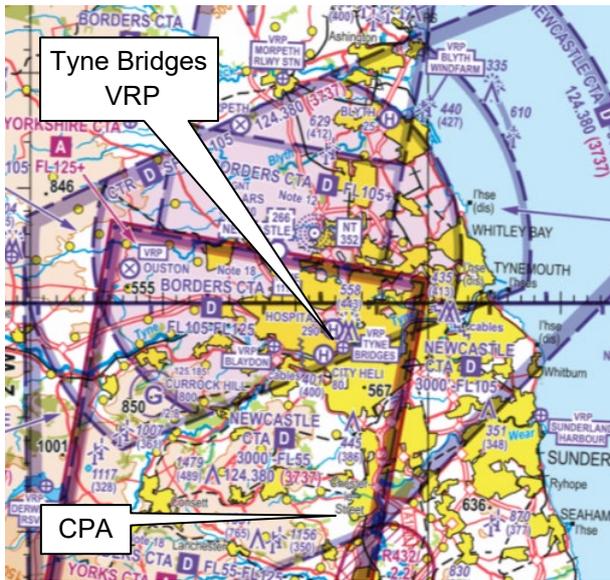
Figure 3: Civil charting of the event area.

Figures 3 and 4 show the relevant parts of the charts available to civil and military operators. The Prefect pilot had carried that shown at Figure 4.

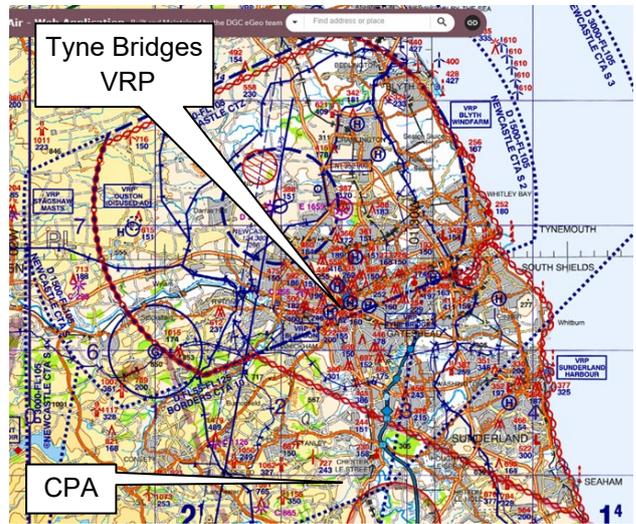
Figure 4: Military charting of the event area.
