AIRPROX REPORT No 2025213

Date: 26 Sep 2025 Time: 1438Z Position: 5230N 00214W Location: Wolverhampton

PART A: SUMMARY OF INFORMATION REPORTED TO UKAB

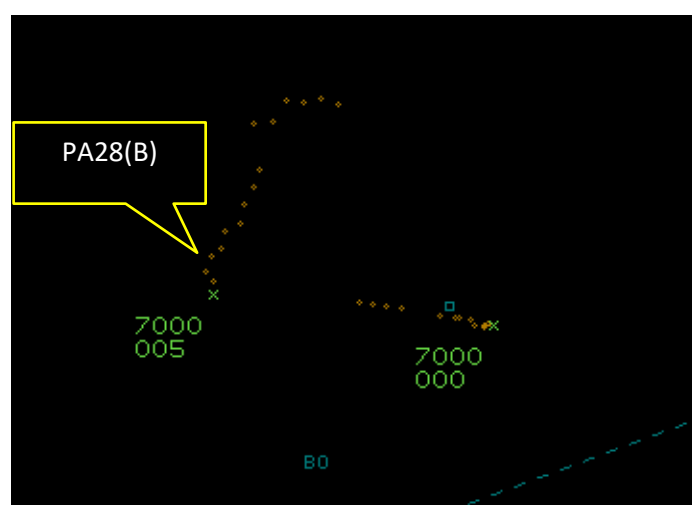
Figure 1: 1435:33

An analysis of the NATS radar replay was undertaken, and PA28(B) could be seen and identified using Mode S Data and indicating 500ft (radar QNH 1021hPa), although the track was subject to some radar jitter, probably due to the altitude of the aircraft (Figure 1). Other data sources were also analysed, but only showed both aircraft after the event in MLAT and not via ADS-B.

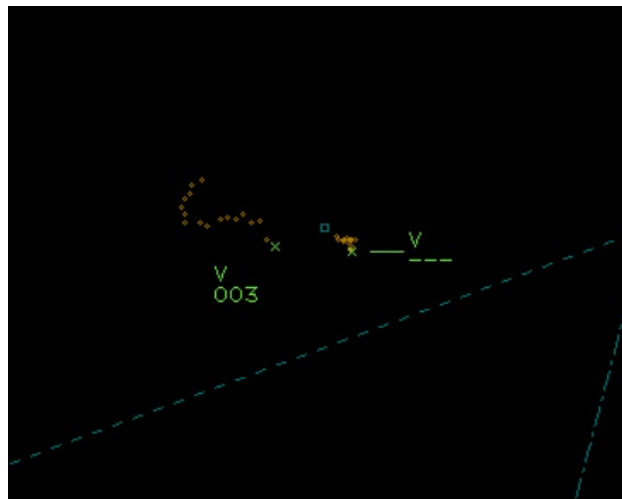
Figure 2: 1436:11

The PA28(B) pilot appeared to set up for finals on an approach and conducted the go-around at around 1436:11 (Figure 2).

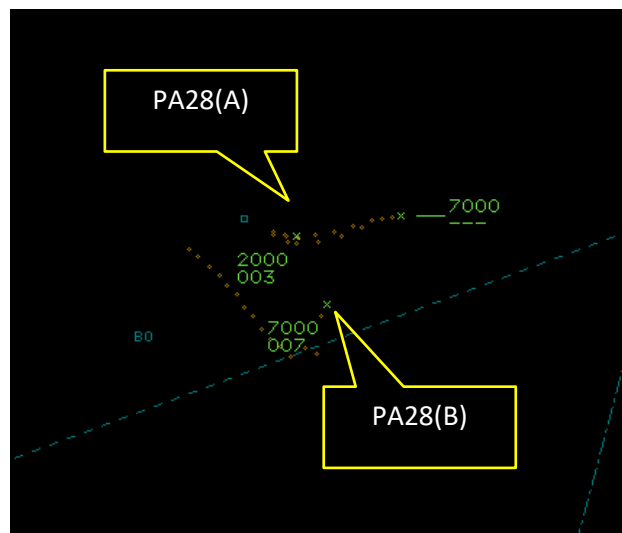
Figure 3 – 1437:17

PA28(A) appeared on the radar replay at 1437:09 and could be seen climbing out of the airfield, as described by the pilot (Figure 3). At this stage, the PA28(B) pilot appeared to have turned left onto a northerly heading.

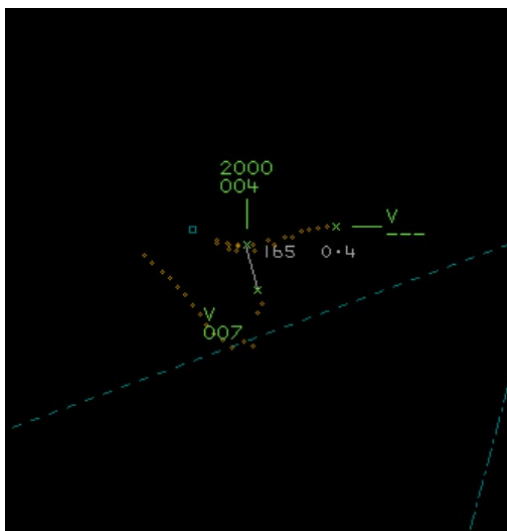
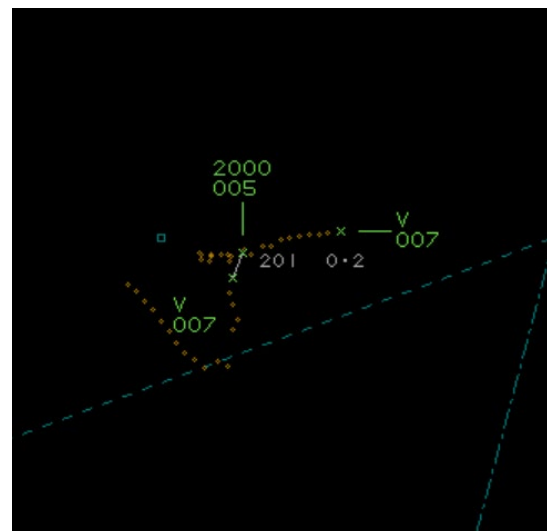
PA28(B) continued to head towards PA28(A), as PA28(A) climbed out (Figure 4 and 5).

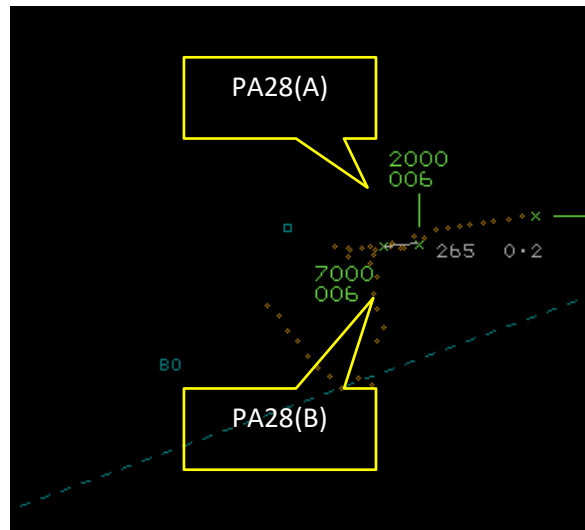
Figure 6 – CPA 1437:34

CPA occurred at 1437:35 with PA28(B) crossing 0.2NM behind PA28(A) at the same level.
