AIRPROX REPORT No 2025214

Date: 27 Sep 2025 Time: 0933Z Position: 5140N 00055W Location: ivo of Stokenchurch

PART A: SUMMARY OF INFORMATION REPORTED TO UKAB

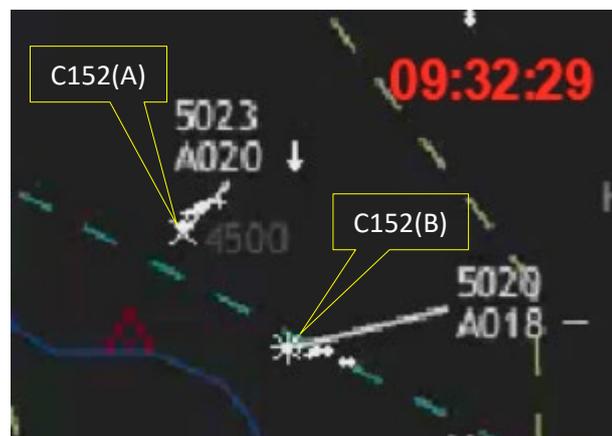
Figure 1

C152(B) was operating VFR, squawking 5020 with the pilot established on the LARS North frequency and in receipt of a Basic Service. The pilot of C152(A) was operating VFR and reported onto the Farnborough LARS North frequency at 0924:58 (all times UTC) and requested a Basic Service. The LARS North and East controller issued the pilot with squawk 5023, QNH1020 and a Basic Service. At 0932:29 (Figure 1) the controller issued the pilot of [C152(B)] with Traffic Information regarding [C152(A)] *"traffic 2 o'clock, range of a mile, right-to-left, slightly above"*, the pilot replied, *"visual with traffic, [C152(B) C/S], they are above us, we're descending a bit"*.

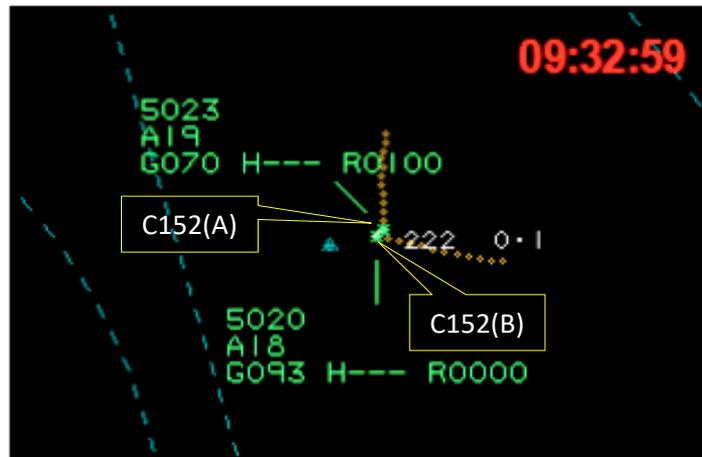
Figure 2

The controller passed reciprocal Traffic Information to the pilot of [C152(A)] at 0932:43 *"traffic left 10 o'clock half a mile left-to-right has you in sight shortly going to under fly you left-to-right"*, the pilot did not respond. The controller called the pilot a second time, no response. The Closest Point of Approach between [C152(A)] (Mode-A 5023) and [C152(B)] (Mode-A 5020) occurred at 0932:59 and was recorded on the NODE Multi-Track radar as 0.1NM and 100ft (Figure 2).

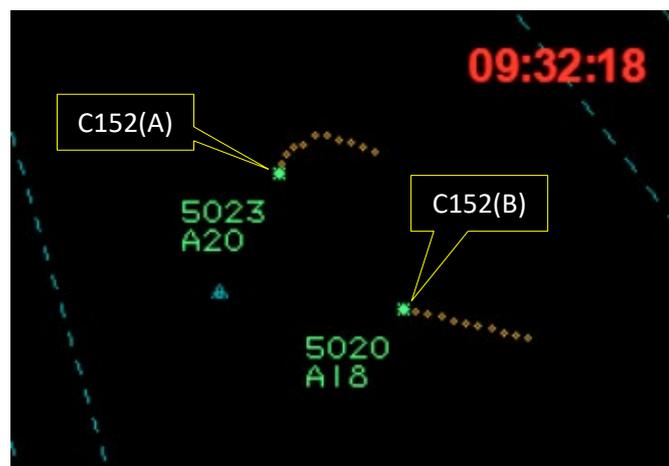
Figure 3

The NATS4118 described that *‘just before the event, both aircraft are tracking west towards Stokenchurch, when at 0932z, [C152(A)] commences a left turn to the south towards the track of [C152(B)]’* (Figure 3).

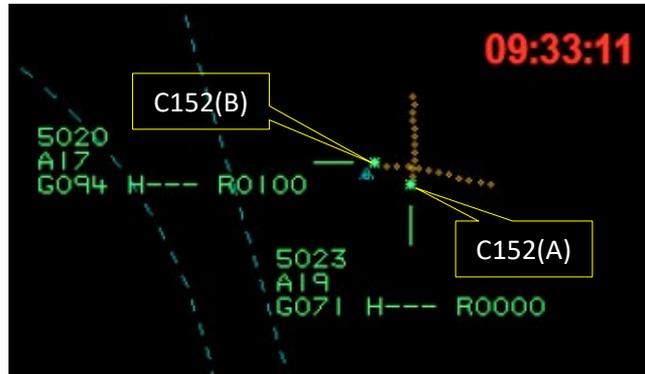
Figure 4

Both pilots were operating in receipt of a Basic Service, however, the LARS controller had observed the turn by [C152(A)] and passed Traffic Information to the pilot of [C152(B)] at 0932:29, followed by reciprocal Traffic Information to the pilot of [C152(A)] at 0932:43 prior to the Closest Point of Approach. Review of NODE radar indicated no evidence of either aircraft enacting any avoidance manoeuvre (Figure 4). This correlated with the pilot report from [C152(A)] above.

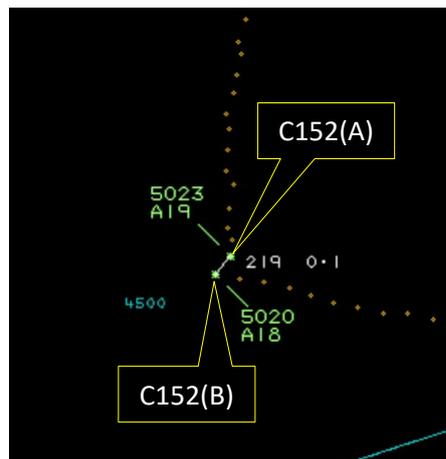
Figure 5 – CPA Time 0933:02

An analysis of the NATS radar replay was undertaken and both aircraft were identified using Mode S data. CPA was assessed to have occurred at 0933:02 with 0.1NM lateral and 100ft vertical separation (Figure 5). Neither aircraft was observed with reference to ADS-B data sources.
