AIRPROX REPORT No 2025223

Date: 07 Oct 2025 Time: 1504Z Position: 5358N 00038W Location: 3NM SW Wetwang

PART A: SUMMARY OF INFORMATION REPORTED TO UKAB

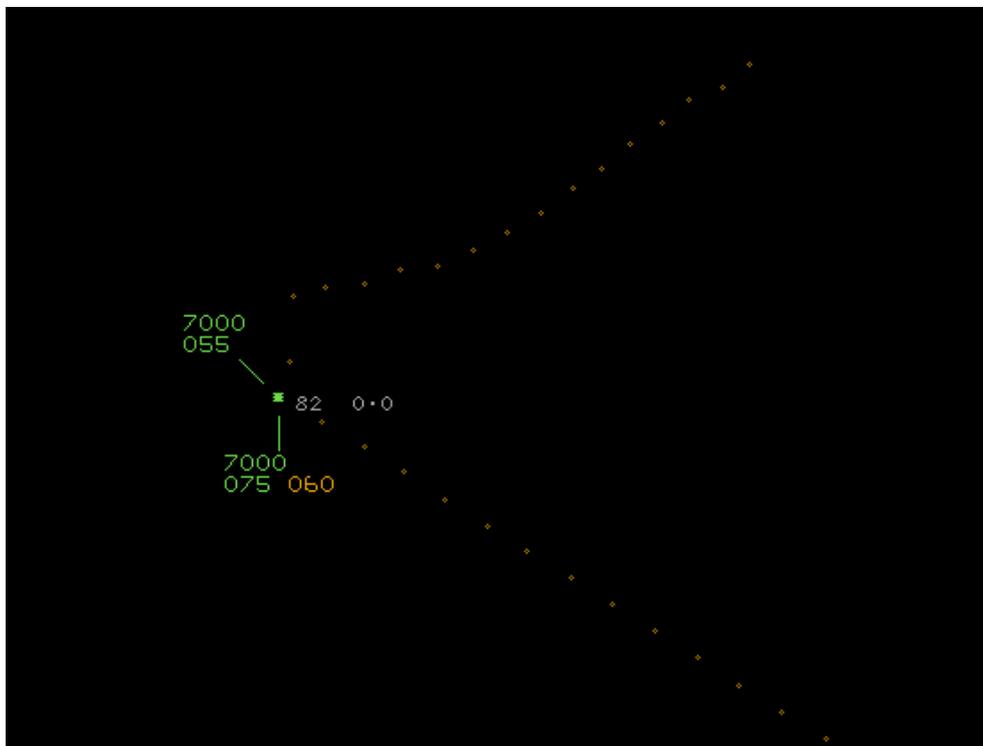
An analysis of the NATS radar replay was undertaken and both aircraft could be positively identified from Mode S data (Figure 1). Neither aircraft was observed by reference to ADS-B data sources.

Figure 1 – CPA at 1503:30 (radar data)

The diagram was constructed and the separation determined from the radar data.

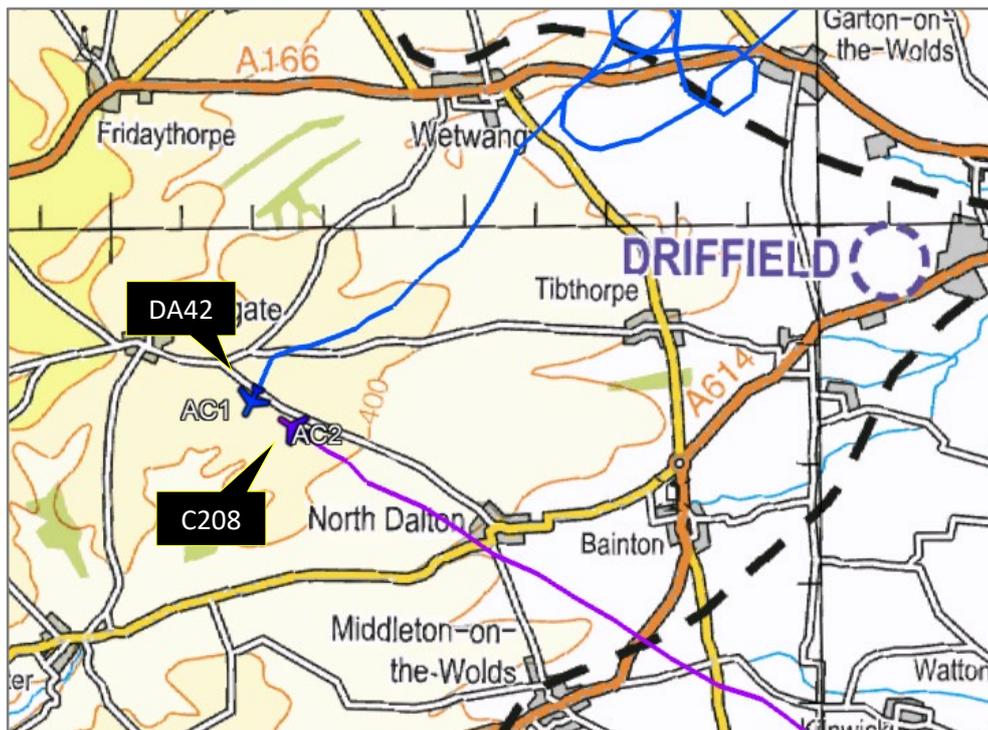
Figure 2 – Aircraft positions at 1503:29 (MLAT data)
