**AIRPROX REPORT No 2025225**

Date: 18 Oct 2025 Time: 1121Z Position: 5141N 00030W Location: ivo Sarratt Bottom

**PART A: SUMMARY OF INFORMATION REPORTED TO UKAB**

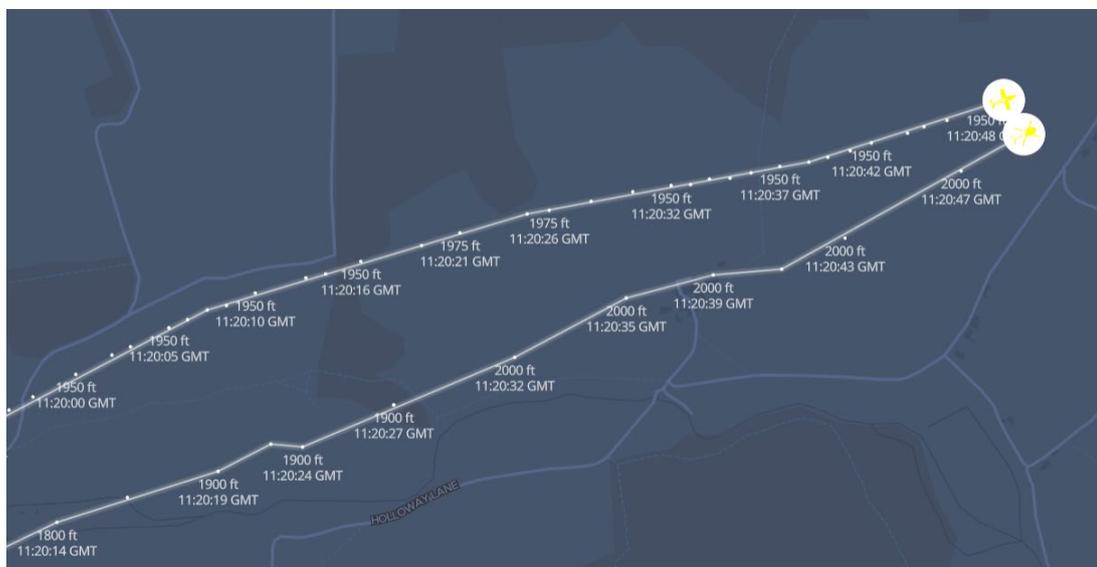
Figure 1: Airspace Analyser CPA 1120:50

Board members first discussed the pilots' reports, and noted from the radar replay that the R44 instructor had only turned away after passing the second, leading, aircraft. Correlation of the R44 instructor's narrative of events with the radar replay indicated that they had only described their encounter with the leading aircraft, the aircraft with which the EV97 pilot had been flying in trail. Members wondered whether the R44 instructor might not have seen the EV97; that the R44 instructor's track before they had passed the other, leading, aircraft could have been purely coincidentally aligned with the EV97 track and that the R44 instructor had, in fact, not seen the EV97 at all. After further discussion, the Board discounted this speculation on the basis that the R44 instructor had also turned right as the EV97 pilot had made a small turn to the right and had then closed on the EV97 and climbed to about the same level, before CPA, after which the R44 instructor had abruptly turned left, in close proximity to and in front of the EV97, and had taken up a track which paralleled the other, leading, aircraft's track. The Board noted that, on passing the leading aircraft, the R44 instructor had descended and turned right, as had been described in their narrative. Members accepted that there had been a possibility that the R44 instructor had not seen the EV97 but felt that this was unlikely, given the aircrafts' relative tracks and altitudes.

Board members then discussed the manner in which the R44 instructor had overtaken the EV97. They had plainly not overtaken the EV97 in accordance with the regulations regarding overtaking (**CF1**), specifically by passing without remaining 'well clear' and by not avoiding passing in front. Given that they had most likely been aware of the EV97's proximity, their overtake manoeuvre had been ineffective in that they had passed in very close proximity to the EV97 (**CF2**). The R44 instructor had had no situational awareness of the EV97 (**CF3**), that is awareness of the other aircraft's proximity before sighting it, and members wondered whether a FIS from Farnborough North or fitment of a TAS in the R44 might have helped. The Board agreed that the EV97 pilot had obtained situational awareness on
