AIRPROX REPORT No 2025226

Date: 20 Oct 2025 Time: 1101Z Position: 5307N 00014W Location: 2NM NW RAF Coningsby

PART A: SUMMARY OF INFORMATION REPORTED TO UKAB

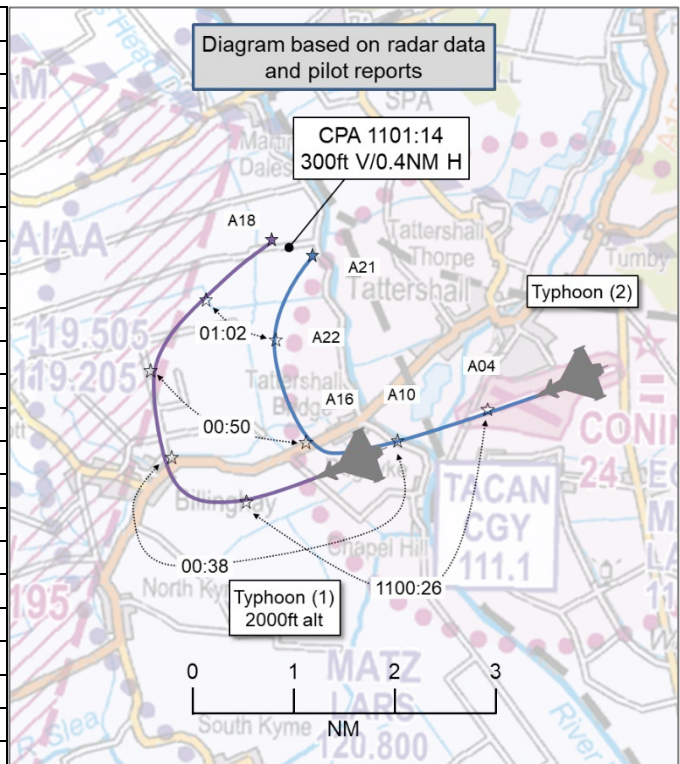
CPA occurred at 1101:14 indicating 300ft vertical separation and 0.4NM laterally.
