AIRPROX REPORT No 2025228

Date: 30 Oct 2025 Time: 1118Z Position: 5222N 00130W Location: Coventry ATZ

PART A: SUMMARY OF INFORMATION REPORTED TO UKAB

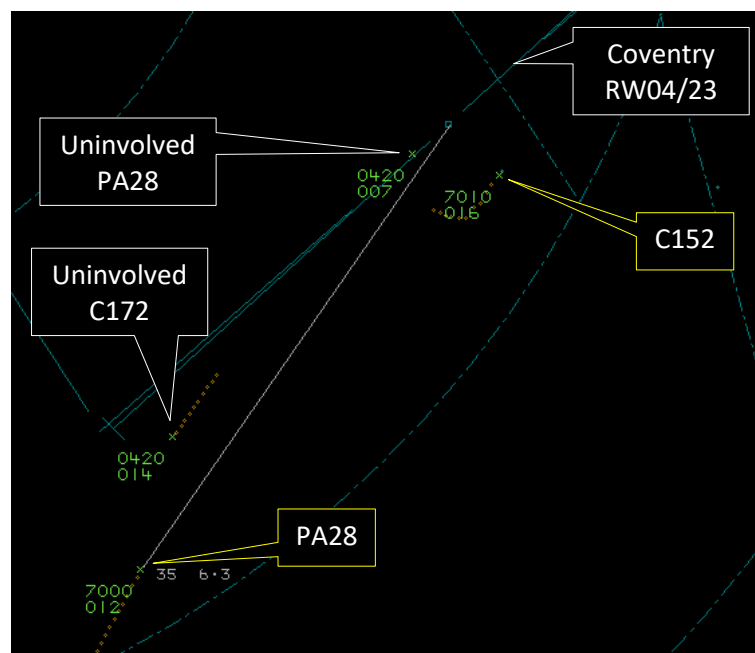
Figure 1 - Aircraft positions at 1115:10

An uninvolved C172 had departed from RW23 at approximately 1112 to the south-west and had subsequently passed abeam the Airprox PA28, left-wing to left-wing, at approximately 1115:40. An uninvolved PA28 had departed to the south-east, and first appeared on the radar replay at 1115:10, when the Airprox PA28 had been at a distance of 6.3NM from Coventry Airport (Figure 1).

Members next reviewed the timings of the encounter. It was noted that the AFISO had recalled that the pilot of an uninvolved PA28 "*had recently departed from RW23 to the south-east*". Figure 1 (above), with a timestamp of 1115:10, shows that the pilot of the uninvolved PA28 had just taken off when the Airprox PA28 had been 6.3NM from the airfield. It had been subsequent to that, that the AFISO recalled that the pilot of the Airprox PA28 had reported that they had been 10NM from the airfield. Whilst the timings displayed in the NATS radar replay appeared to have differed slightly to those provided in the Coventry Unit investigation, it was clear to members that the pilot of the PA28 had provided an inaccurate position report. Members agreed that that information had led the Coventry AFISO to have constructed an inaccurate mental model (**CF2**) and had then inadvertently misidentified the outbound PA28 as the inbound Airprox PA28. That is, the outbound PA28 may have appeared to have been at the start of the downwind leg where the inbound Airprox PA28 might have reached in the elapsed time given its pilot's reported position. However, the Airprox PA28 had actually been several miles further west and north, much nearer to the RW23 extended centreline. Members noted that the AFISO had subsequently realised the error, although that had not been in time to have passed actionable Traffic Information to either pilot. Consequently, members agreed that, essentially, the conflict had not been detected (**CF1**).

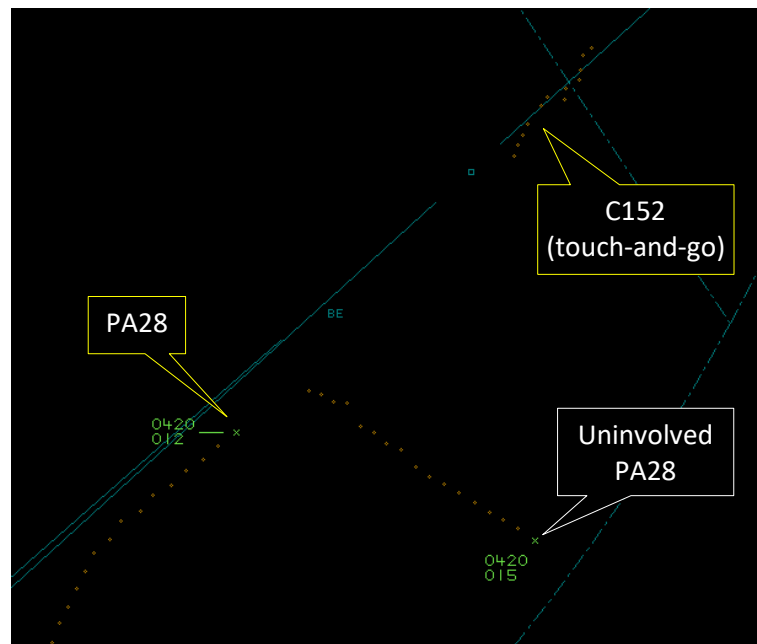
Figure 2 - Aircraft positions at 1117:34

The squawk of the Airprox PA28 was observed to change from 0240 to 0420 at 1117:34. The C152 reappeared on the radar replay at 1118:06 after a touch-and-go.

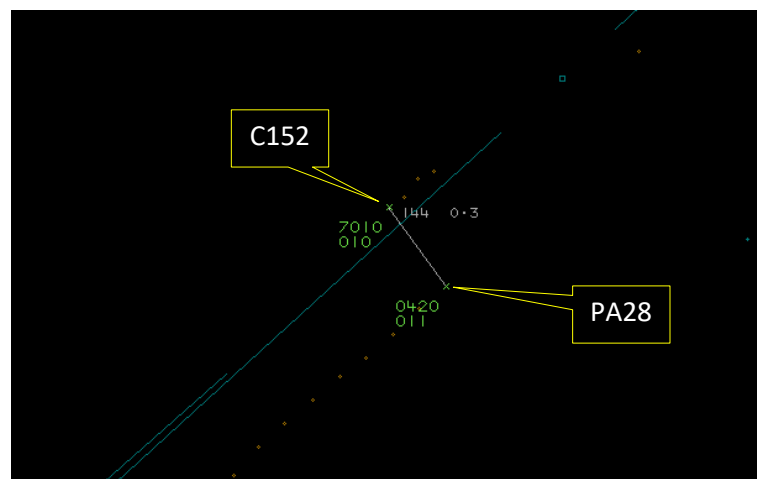
Figure 3 – CPA at 1118:18

The pilot of the C152 kindly supplied GPS track data for their flight. It was by combining the data sources that the diagram was constructed and the separation at CPA determined.
