**AIRPROX REPORT No 2025231**

Date: 05 Nov 2025 Time: 1325Z Position: 5143N 00020E Location: Norton Heath

**PART A: SUMMARY OF INFORMATION REPORTED TO UKAB**

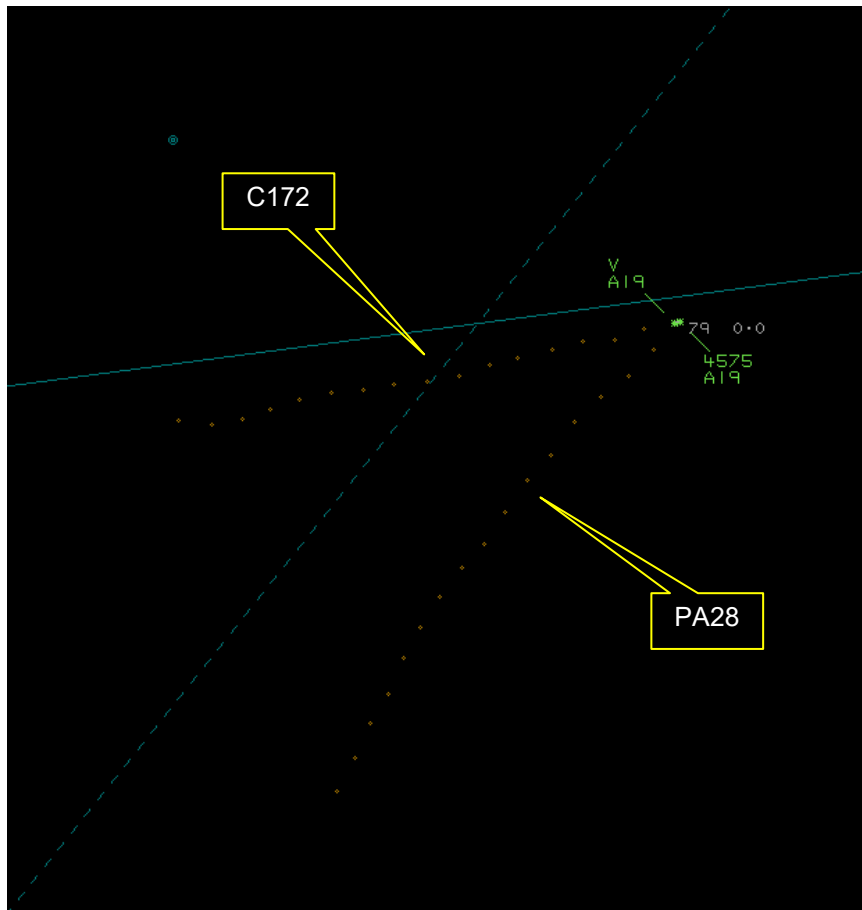
1325:12. Contacts merged, both indicated A2.0.

1325:40. Contacts separated, both indicated A2.0. It is possible, but hard to discern, that [C172 C/S] turned to the right to pass behind.

Figure 1: At CPA – 1325:22 0ft V/<0.1NM H
