AIRPROX REPORT No 2025232

Date: 08 Nov 2025 Time: 1210Z Position: 5159N 00106W Location: 4NM S of Turweston

PART A: SUMMARY OF INFORMATION REPORTED TO UKAB

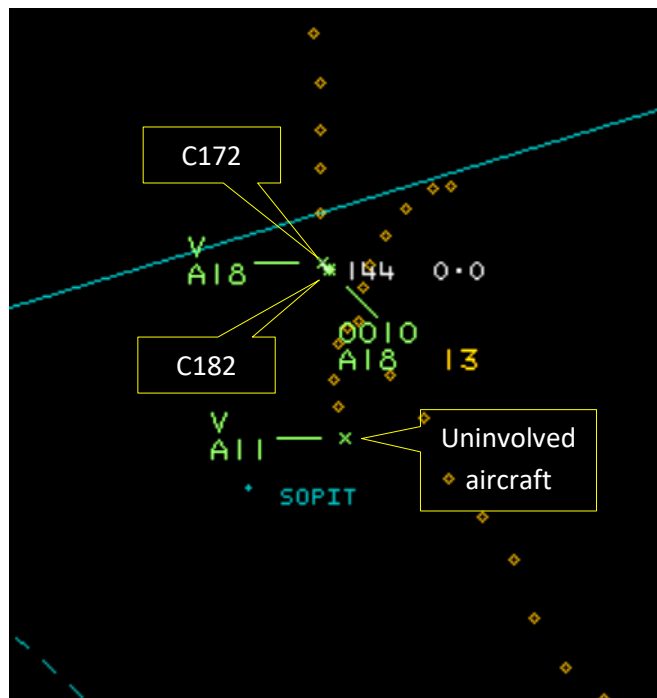
Figure 1 – Time 1210:10 radar tracks

Further analysis of third party tracking software was undertaken; the C172 was identified using ADS-B data sources and the C182 was identified using MLAT-only data sources. The pilot of the C172 supplied their GPS track data, and all tracks were coincident with the radar tracks. CPA was assessed to have occurred at 1210:10 with less than 0.1NM lateral and 0ft vertical separation, and both aircraft were seen to have turned right at or after the point of CPA.

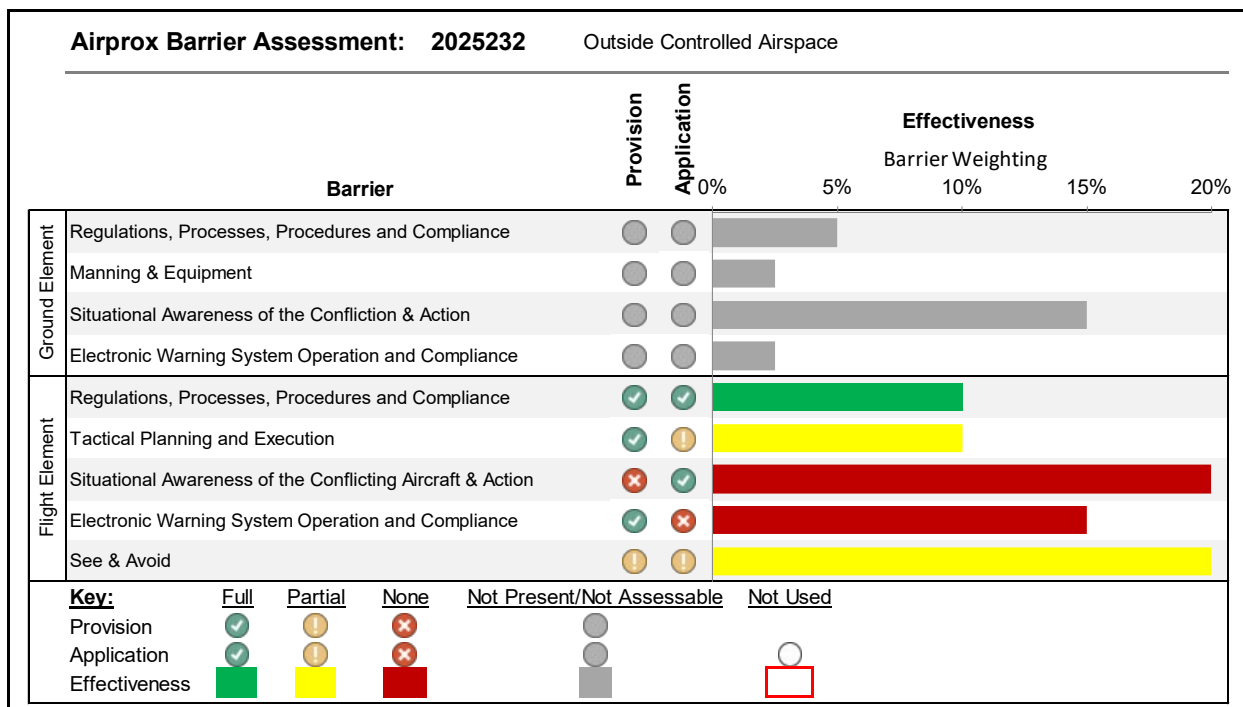
Tactical Planning and Execution was assessed as **partially effective** because The C182 pilot could have communicated their routeing intentions on the frequency to which they were tuned.

Situational Awareness of the Conflicting Aircraft and Action were assessed as **ineffective** because the C182 pilot had no situational awareness of the presence of the C172, and the C172 pilot had only generic situational awareness of the presence of the C182.

Electronic Warning System Operation and Compliance were assessed as **ineffective** because the C172’s electronic conspicuity equipment had not alerted as would have been expected.

See and Avoid were assessed as **partially effective** because both pilots had seen the other aircraft only at a late stage.
