AIRPROX REPORT No 2025233

Date: 08 Nov 2025 Time: 1143Z Position: 5204N 00105W Location: IVO Turweston

PART A: SUMMARY OF INFORMATION REPORTED TO UKAB

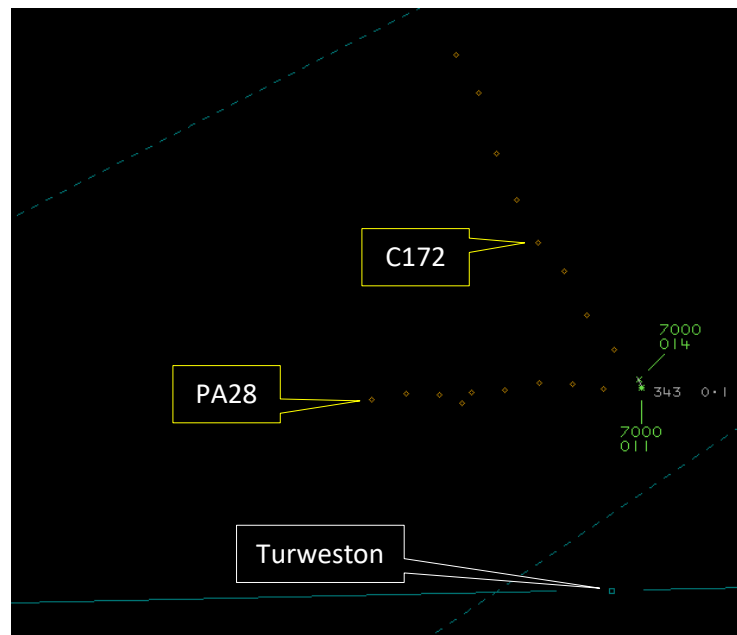
An analysis of the NATS radar replay was undertaken and both aircraft could be positively identified from Mode S data. The pilot of the PA28 kindly supplied GPS track data for their flight. The C172, but not the PA28, was observed by reference to ADS-B data sources. The diagram was constructed and the separation at CPA determined by combining the data sources.

Figure 1 – CPA at 1143:14 (1sec after CPA)
