AIRPROX REPORT No 2025234

Date: 08 Nov 2025 Time: 1516Z Position: 5231N 00214W Location: Wolverhampton

PART A: SUMMARY OF INFORMATION REPORTED TO UKAB

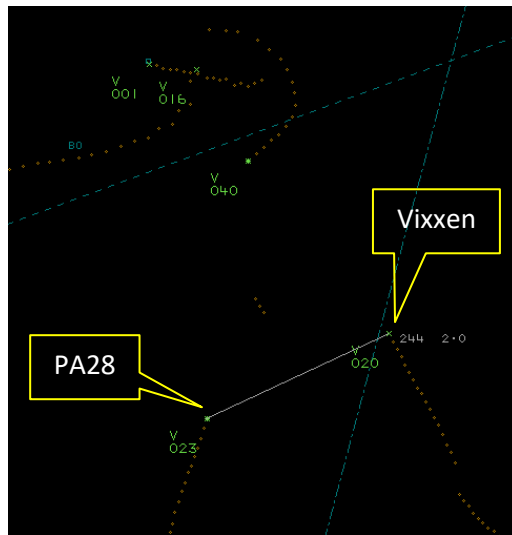
Figure 1 – 1513:27

An analysis of the NATS radar replay was undertaken. Both aircraft could be seen and identified using Mode S data. Other data sources were also assessed and the PA28 could be seen using ADS-B data, whilst the Vixxen could only be seen using MLAT data. At 1513:27 both aircraft could be seen approaching Wolverhampton airfield from the south (Figure 1). The Vixxen was slightly ahead of the PA28 and indicating 2000ft, whilst the PA28 was indicating 2300ft.

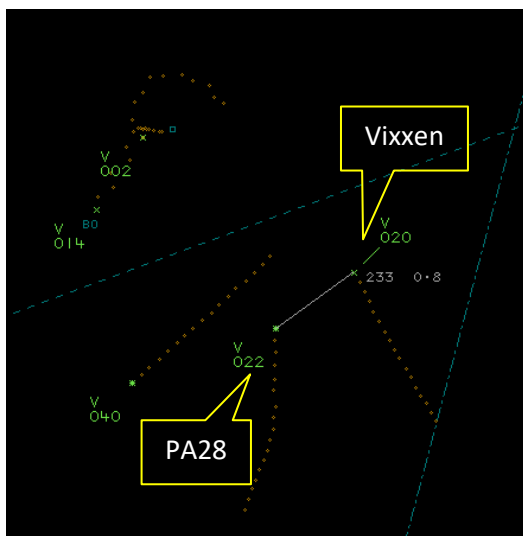
Figure 2 - 1514:41

Both aircraft continued to track towards the airfield (Figure 2) until, by 1515:28 (Figure 3), the aircraft were approximately 1NM from the airfield and 0.5NM apart, still with 300ft vertical separation. The two aircraft paralleled each other for some time (Figure 4), until CPA occurred at 1516:01, with both aircraft at the same level with 0.4NM lateral separation.

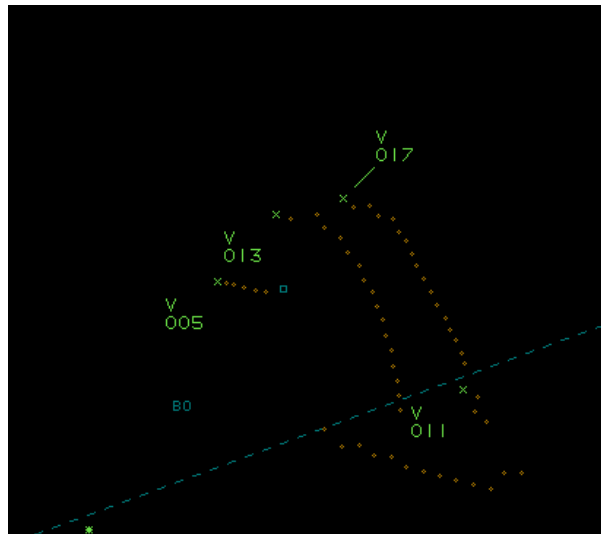
Figure 6 – 1516:09 (After CPA)

After CPA, the PA28 turned left and descended, as described by the pilot.
