**AIRPROX REPORT No 2025235**

Date: 13 Nov 2025 Time: ~1200Z Position: 5716N 00538W Location: 3.5NM E Kyle of Lochalsh

**PART A: SUMMARY OF INFORMATION REPORTED TO UKAB**

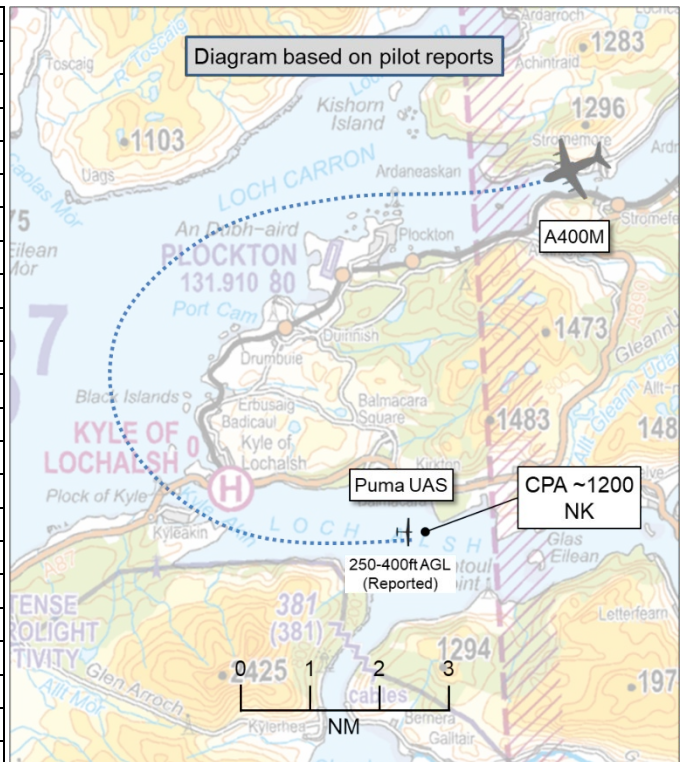
The loss of safe separation occurred when an A400M approached the Puma's operating area at a lower altitude, resulting in lateral separation of approximately 150m. The Puma was operating at 400ft AMSL, flying west-to-east in the Kyle of Lochalsh. The UAS team was focussed on the Puma throughout the flight under VLOS without distraction.

The A400M was estimated to have been at 250ft AMSL, and was observed approaching west-to-east over the Skye Bridge. Due to the short time available, and as it was assessed that the A400M was below the Puma, it was decided not to manoeuvre further away from the threat.

An analysis of the NATS radar replay was undertaken and neither aircraft was observed. Neither aircraft was observed by reference to ADS-B data sources. The entry in CADS<sup>2</sup> for the flight of the A400M is shown in Figure 1. The diagram at the top of this report was constructed by reference to the reported positions of the aircraft. The track of the A400M has been depicted with a dotted line to indicate a probable track. The separation at CPA could not be determined.

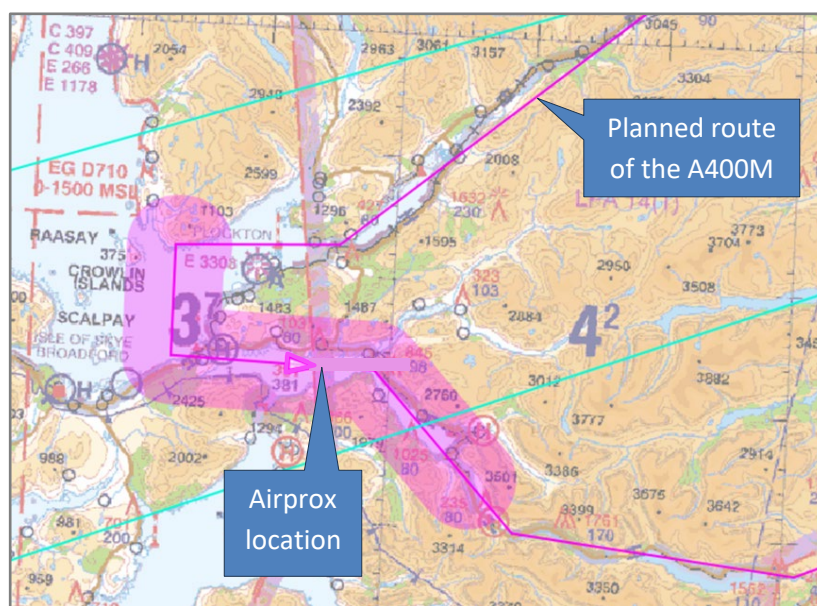
Figure 1 – The entry in CADS for the flight of the A400M. The pink arrowhead marks the planned position of the A400M for 1141 (at 250ft).
