AIRPROX REPORT No 2025239

Date: 13 Nov 2025 Time: 1735Z Position: 5213N 00013E Location: ivo Cambridge Airport

PART A: SUMMARY OF INFORMATION REPORTED TO UKAB

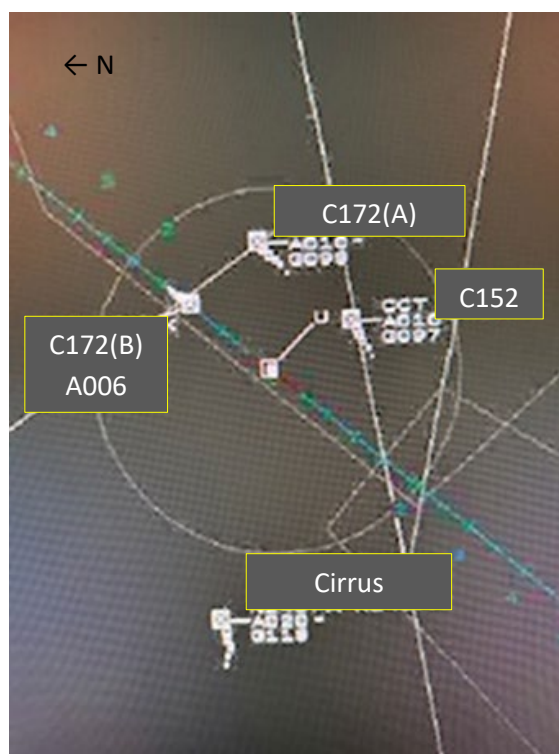
Figure 1 – screenshot at 1733:18

Figure 1 shows the position of the aircraft in the circuit when [the pilot of C172(B)] was instructed to go around at 1733:18.

[C172(B)] was indicating A006 and was within 0.5NM from touchdown, abeam [the C152] on their left-hand side. [C172(B)] was approximately 2NM ahead in the circuit at the end of the downwind leg.

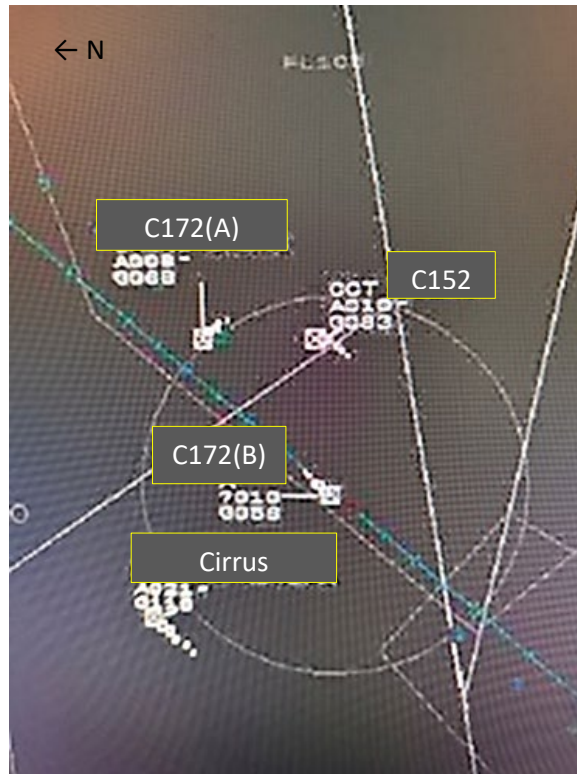
Figure 2 – screenshot at 1734:28

[The C152] was seen to commence their turn towards final at 1734:28. (Figure 2). [The C172(A)] was turning towards a 2NM final.

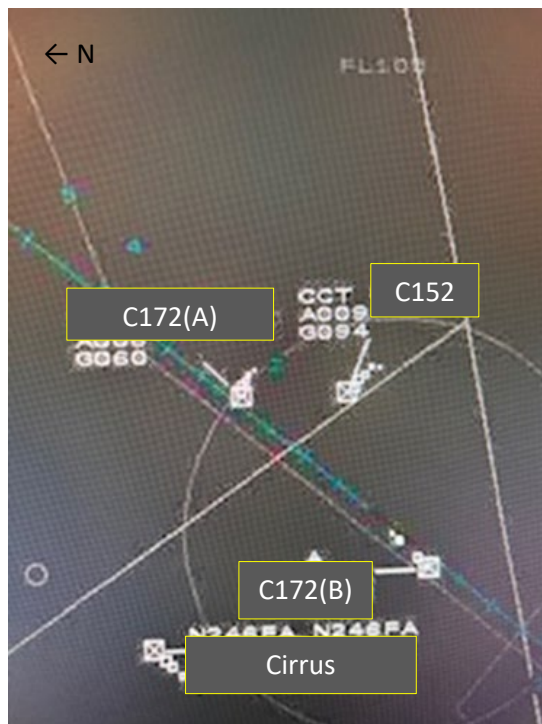
Figure 3 – screenshot at 1734:48

At 1734:48 [The pilot of C172(A)] was cleared for touch and go (Figure 3) The ATM shows [C152 c/s] routing towards a 1NM final inside [C172(A)].

[The pilot of C172(A) was] issued with touch and go clearance at 1734:48. Figure 3 clearly shows that [the C152] had turned inside [C172(A)] as this instruction was issued. The controller was not aware of the situation until the go-around instruction was issued to [the pilot of the C152] at time 1735:17.

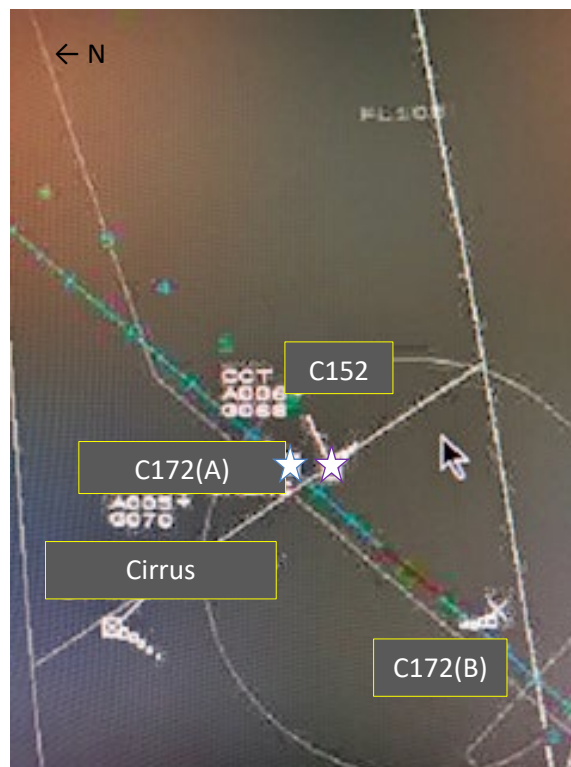
Figure 4 – screenshot at 1735:17

At 1735:17 [the pilot of the C152] was instructed to go around as the ATCO became aware of their positioning error (Figure 4).

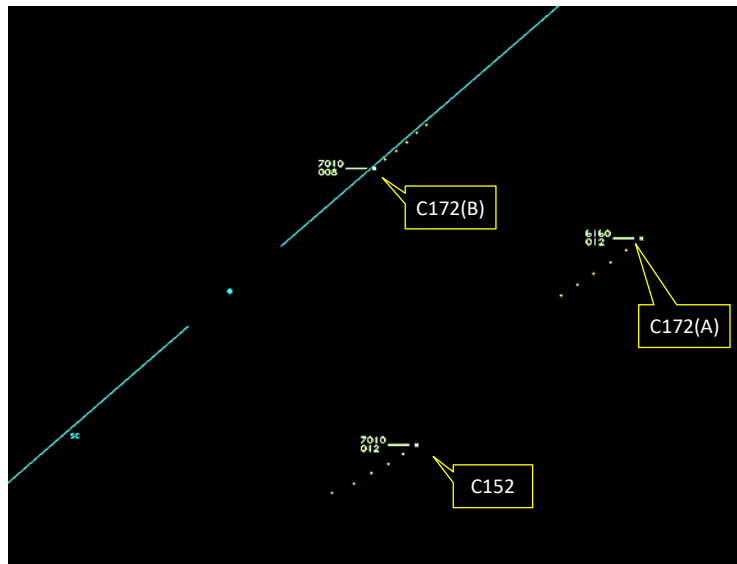
Figure 5 – 1733:40

At 1733:18, due to the previously landing aircraft being slow to clear the runway, the controller instructed the pilot of C172(B) to go around. They then instructed the [pilot of] C172(A) to report final, advising the pilot that they were 'number one' which was read back correctly by the pilot. Then, at 1733:40, the controller advised the C152 pilot that they were “*Number 2, following the Cessna 172 on base leg now, just turning left base*” to which the C152 pilot replied “*Number two – traffic in sight*” (Figure 5).

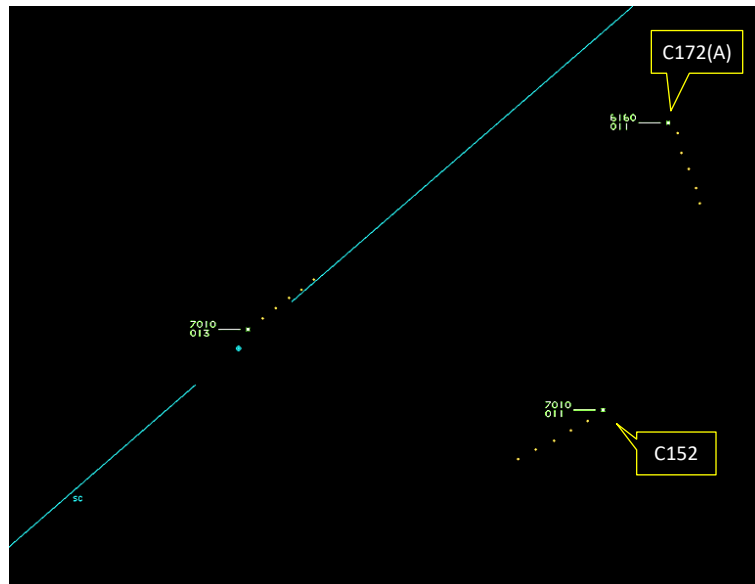
Figure 6 – 1734:20

The controller was then occupied between 1733:50 - 1734:20 dealing with the parking arrangements for the previously landing aircraft (Figure 6).

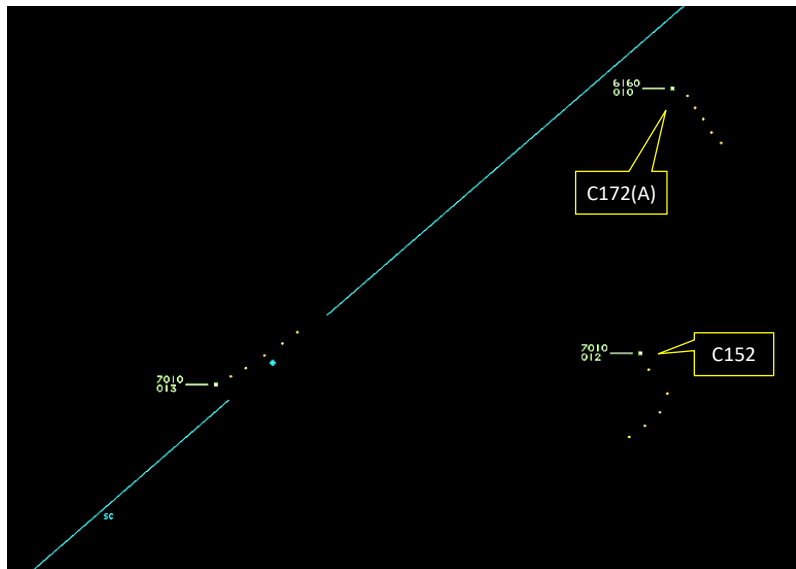
Figure 7 – 1734:34

At **1734:34** the C152 was seen on the area radar replay used in this investigation to have turned onto left base, inside [C172(A)] (Figure 7).

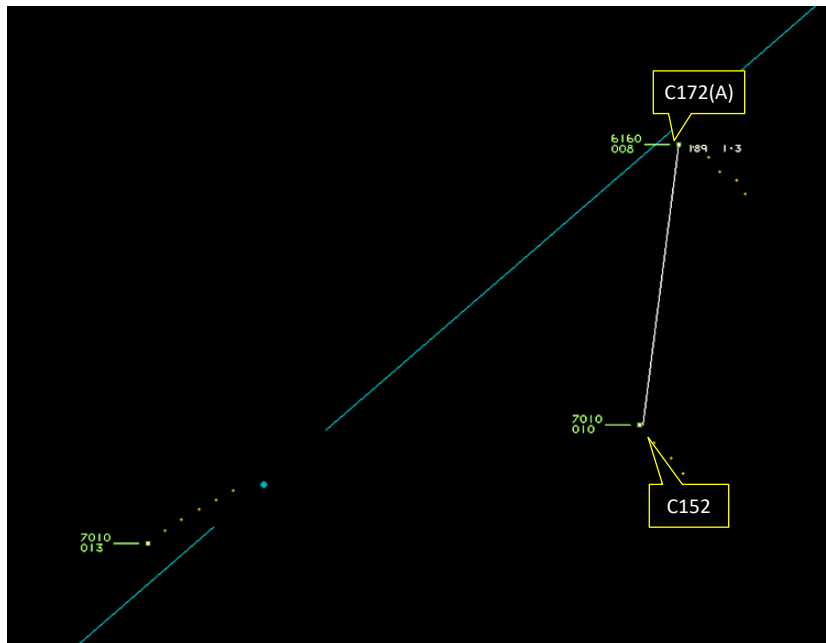
Figure 8 – 1734:48

At **1734:48** the controller cleared [the pilot of] C172(A) for a touch and go (Figure 8).

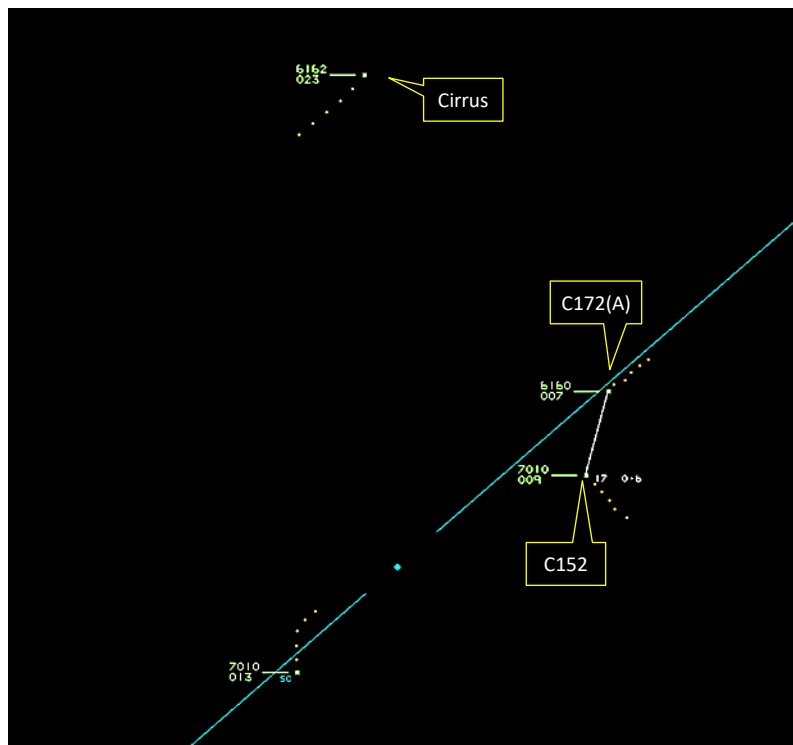
Figure 10 – 1735:12

At **1735:12** the pilot of the [Cirrus] called at the previously designated point of Waterbeach, a disused airfield north of Cambridge Airport, but the controller ignored that call and instead, at **1735:18**, instructed the pilot of the C152 to “go around. I say again go around – acknowledge. Climb immediately” (Figure 10).

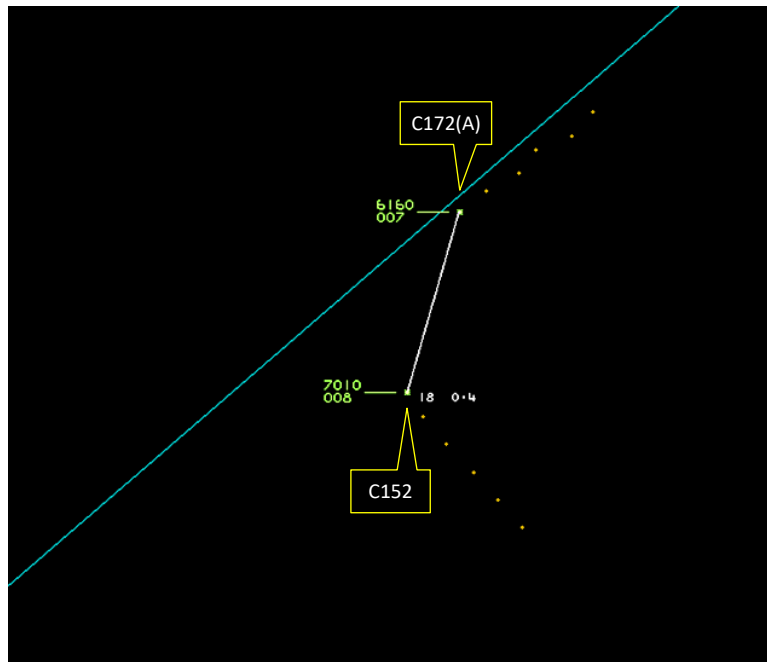
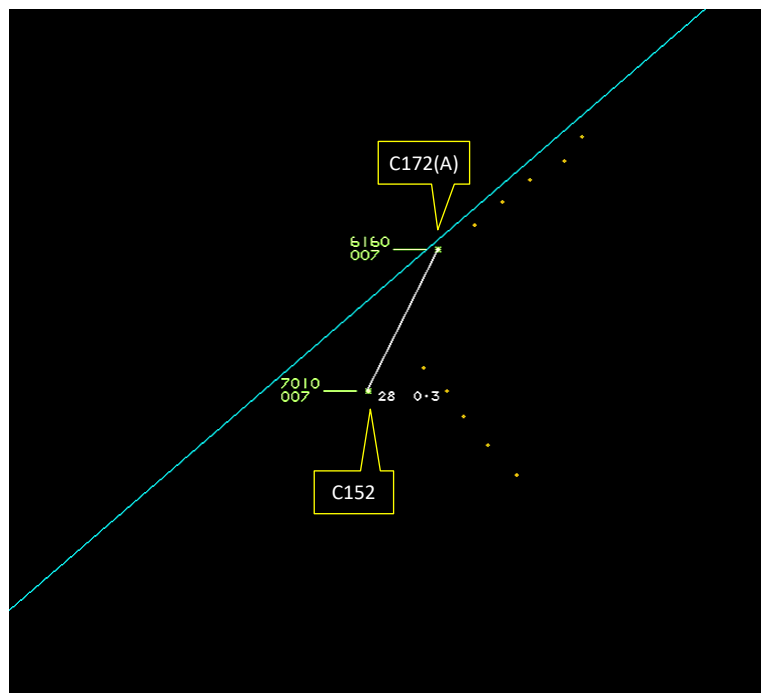
CPA occurred between **1735:18-1735:25** (Figures 11 & 12).

At **1735:25** the controller asked the pilot of C172(A) if they were visual with the C152 “just off your left-hand side” which the C172(A) pilot confirmed (Figure 12 also).

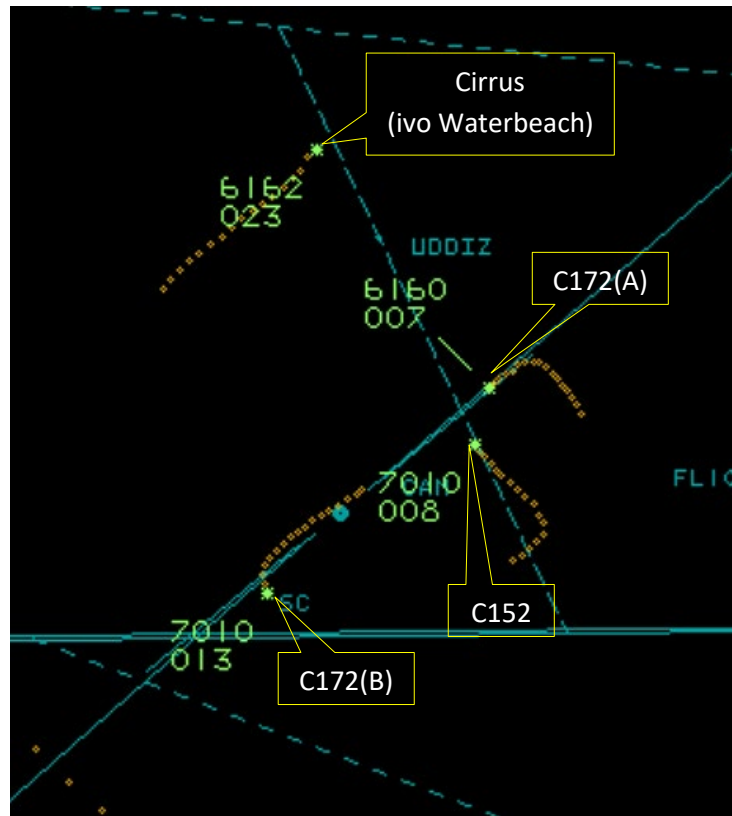
Figure 13 – Time 1735:12

An analysis of the NATS radar replay was undertaken and both aircraft were identified using Mode S data. At 1735:14, 12sec before CPA, the Cambridge circuit was seen to be active; the C152 was on base leg and C172(A) was on the final approach. C172(B) was seen going around and the Cirrus was holding at Waterbeach to the north-northwest of Cambridge Airport (Figure 13).

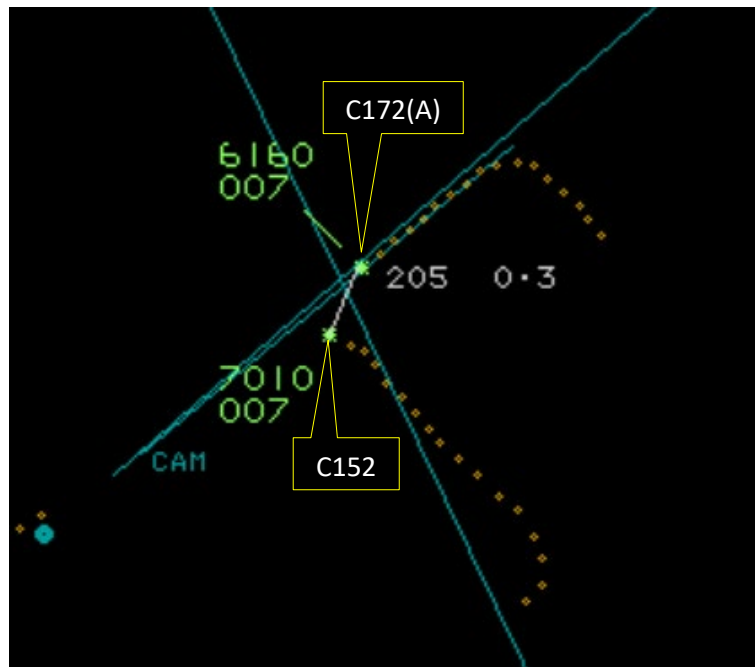
Figure 14 – Time 1735:26

CPA was assessed to have occurred at 1735:26 with 0.3NM lateral and 0ft vertical separation (Figure 14).
