AIRPROX REPORT No 2025241

Date: 20 Nov 2025 Time: 1146Z Position: 5046N 00150W Location: IVO Bournemouth Airport

PART A: SUMMARY OF INFORMATION REPORTED TO UKAB

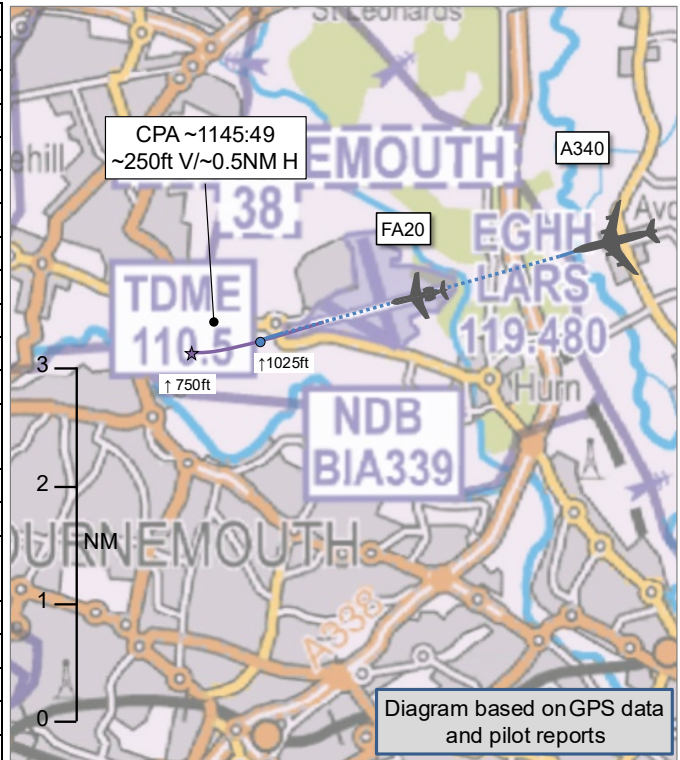
Recorded	Aircraft 1	Aircraft 2
Aircraft	A340	Falcon 20
Operator	Civ Comm	Civ Comm
Airspace	Bournemouth CTR	Bournemouth CTR
Class	D	D
Rules	IFR	IFR
Service	ACS	ACS
Provider	Bournemouth Tower	Bournemouth Tower
Altitude/FL	~750ft	~1000ft
Transponder	A, C, S+	A, C, S+
Reported		
Colours	White	Blue
Lighting	Nav, Strobe, Beacon	'Standard'
Conditions	VMC	VMC
Visibility	>10km	>10km
Altitude/FL	NK	'climbing after take-off'
Altimeter	QNH (1016hPa)	QNH
Heading	255°	255°-340°
Speed	150kt	~140kt
ACAS/TAS	TCAS II	TCAS II
Alert	None	TA
Separation at CPA		
Reported	100ft V/0.5NM H	'Unsure'
Recorded	~250ftV/ 0.5NM H

Further analysis of other data sources showed the A340 in MLAT only, and again this had a break between 1NM final and 1NM to the west, however, the FA20 could be seen on ADS-B getting airborne and climbing out to the west. Comparing the two data sources could only provide an approximation of the separation, indicating around 250ft vertical and 0.5NM lateral separation. The diagram at the top of the report has been compiled using this data.

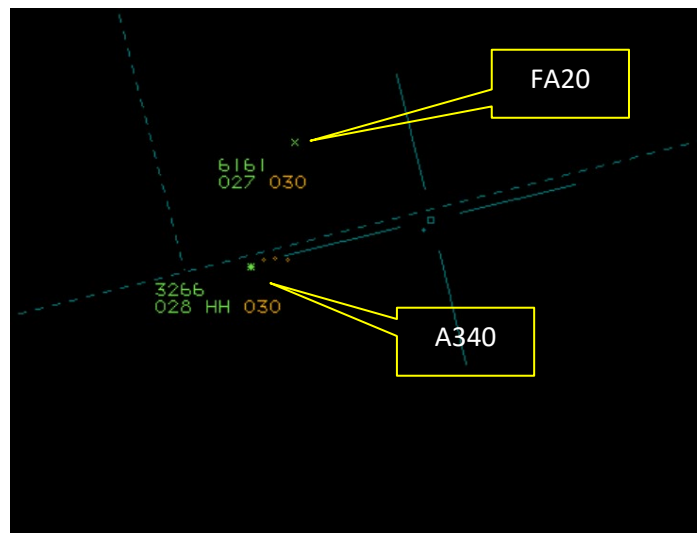
Figure 1 – 1146:39

An analysis of the NATS radar replay was undertaken. Although the A340 could be seen approaching the airfield, it disappeared from radar at around 1NM final from Bournemouth, appearing again when 2.5NM west of Bournemouth, climbing out. The FA20 did not appear on radar until 2.5NM northwest of Bournemouth, after the Airprox had occurred (Figure 1).

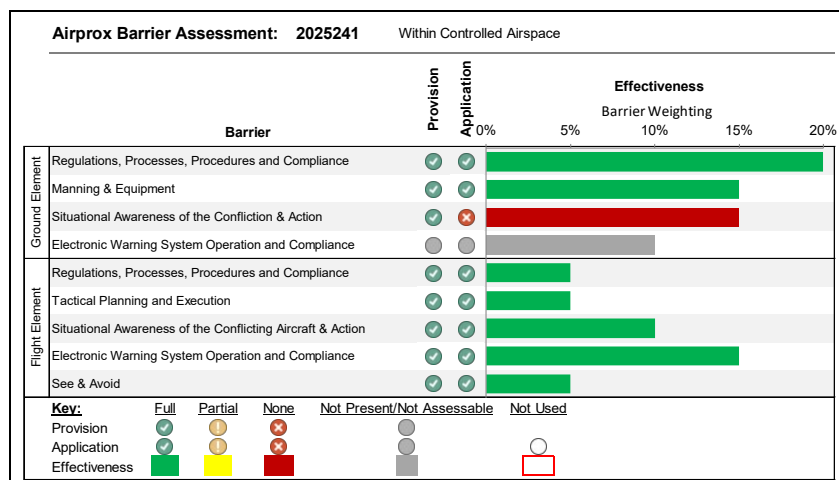
In assessing the effectiveness of the safety barriers associated with this incident, the Board concluded that the key factors had been that:

Situational Awareness of the Confliction and Action were assessed as **ineffective** because the clearances and runway occupancy decisions made by the Bournemouth Tower controller led to the A340 pilot executing the missed approach procedure and flying into proximity with the FA20.
