**AIRPROX REPORT No 2025242**

Date: 24 Nov 2025 Time: 1341Z Position: 5247N 00254W Location: 1NM NNE of Nesscliffe

**PART A: SUMMARY OF INFORMATION REPORTED TO UKAB**

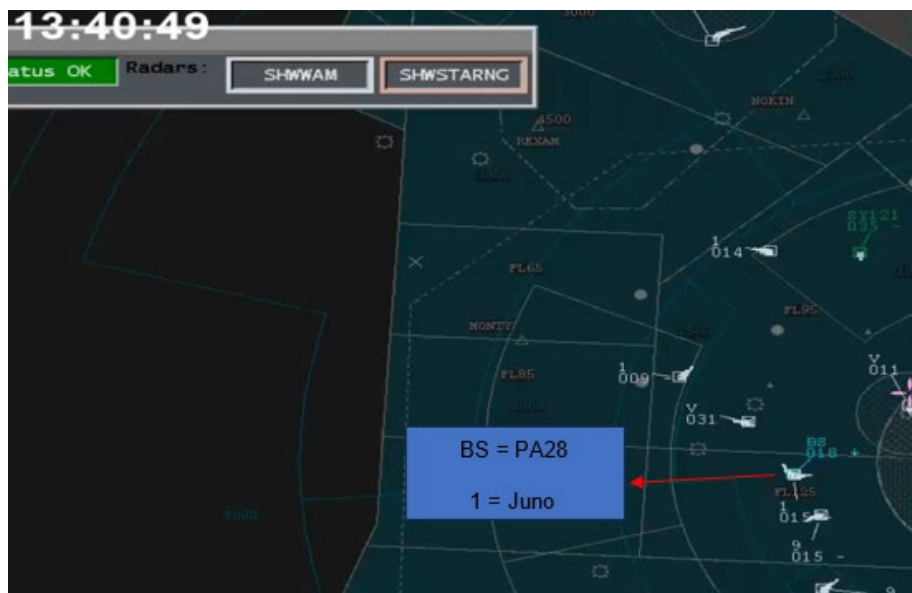
Figure 1 – Radar screen at point of CPA

CPA occurred at 1340:49, with a separation of 0.1NM laterally and an 300ft vertically. There was no mention of the Airprox or close proximity traffic from either pilot on frequency.

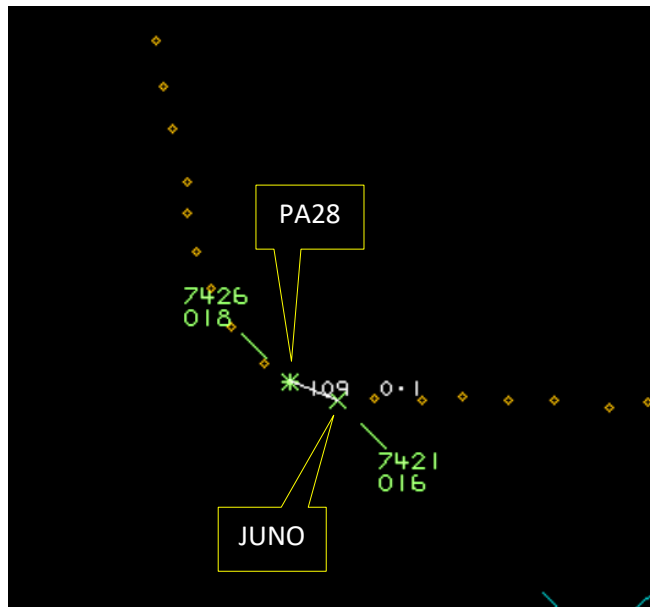
Figure 2 - Time 1340:51

An analysis of the NATS radar replay was undertaken and both aircraft were identified using Mode S data. CPA was assessed to have occurred at 1340:51 with 0.1NM lateral and 200ft vertical separation (Figure 2).

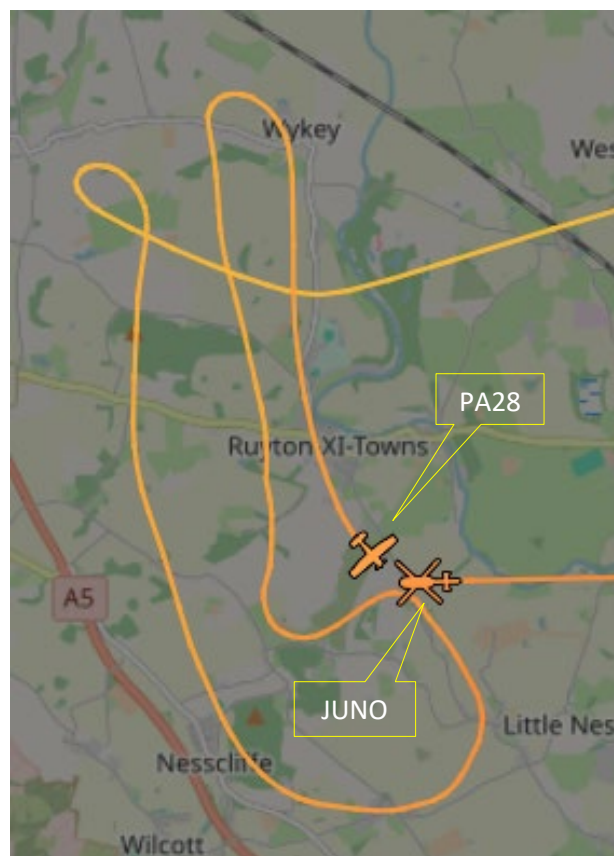
Figure 3 – Time 1340:40 prior to CPA.

Further analysis of third-party tracking software was also undertaken and both aircraft were detected using ADS-B sources. The PA28 was seen to have been manoeuvring prior to the time of the Airprox, in line with the practice forced landings exercise described, finally heading approximately south and descending. The Juno was below and to the left of the PA28, and the PA28 was seen to turn left towards the Juno (Figure 3).
