AIRPROX REPORT No 2026004

Date: 03 Jan 2026 Time: 1436Z Position: 5121N 00032W Location: Fairoaks ATZ

PART A: SUMMARY OF INFORMATION REPORTED TO UKAB

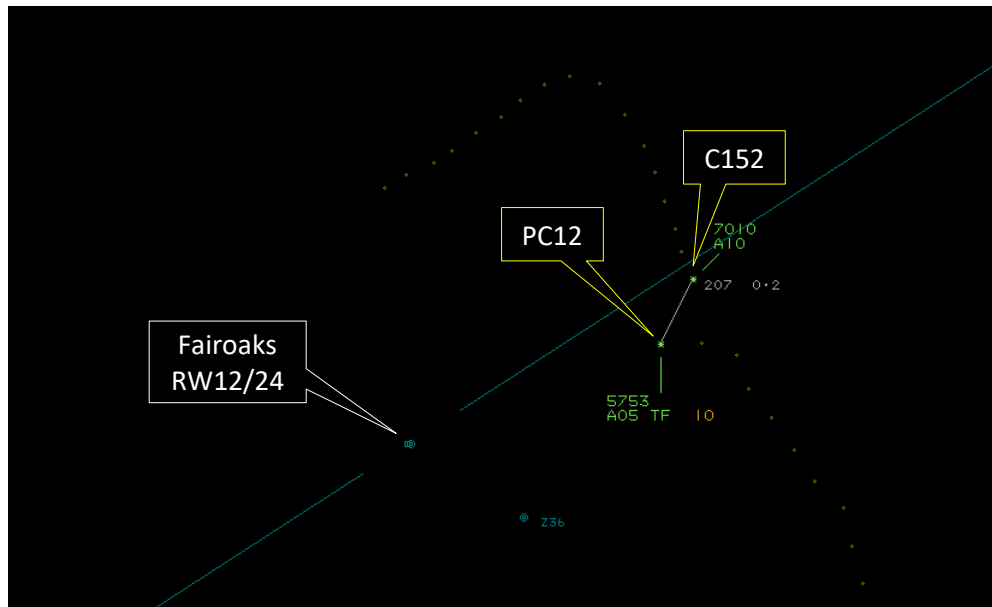
Figure 1 – CPA at 1435:51

An analysis of the NATS radar replay was undertaken and both aircraft could be positively identified from Mode S data. Both aircraft were also observed by reference to ADS-B data sources. The diagram was constructed and the separation determined from the radar data.

The C152 and PC12 pilots shared an equal responsibility for collision avoidance and not to operate in such proximity to other aircraft as to create a collision hazard.¹ An aircraft operated on or in the vicinity of an aerodrome shall conform with or avoid the pattern of traffic formed by other aircraft in operation.² When two or more heavier-than-air aircraft are approaching an aerodrome or an operating site for the purpose of landing, aircraft at the higher level shall give way to aircraft at the lower level, but the latter shall not take advantage of this rule to cut in front of another which is in the final stages of an approach to land.³

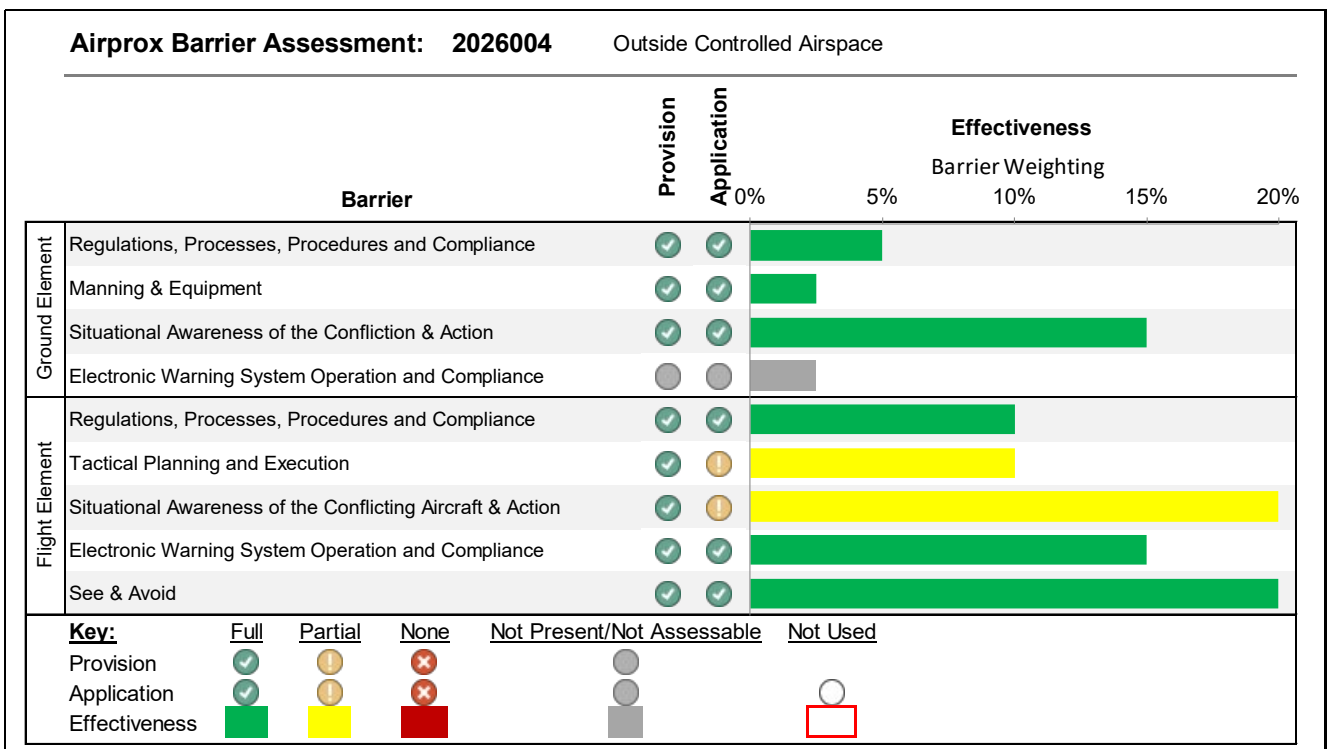
In assessing the effectiveness of the safety barriers associated with this incident, the Board concluded that the key factors had been that:

Tactical Planning and Execution was assessed as **partially effective** because the pilot of the PC12 had not conformed with, or avoided, the pattern of traffic in the circuit.

Situational Awareness of the Conflicting Aircraft and Action were assessed as **partially effective** because, despite situational awareness of the presence of the C152, the pilot of the PC12 did not integrate into the circuit correctly.
