**AIRPROX REPORT No 2026005**

Date: 16 Jan 2026 Time: 1301Z Position: 5155N 00210W Location: Gloucester Airport

**PART A: SUMMARY OF INFORMATION REPORTED TO UKAB**

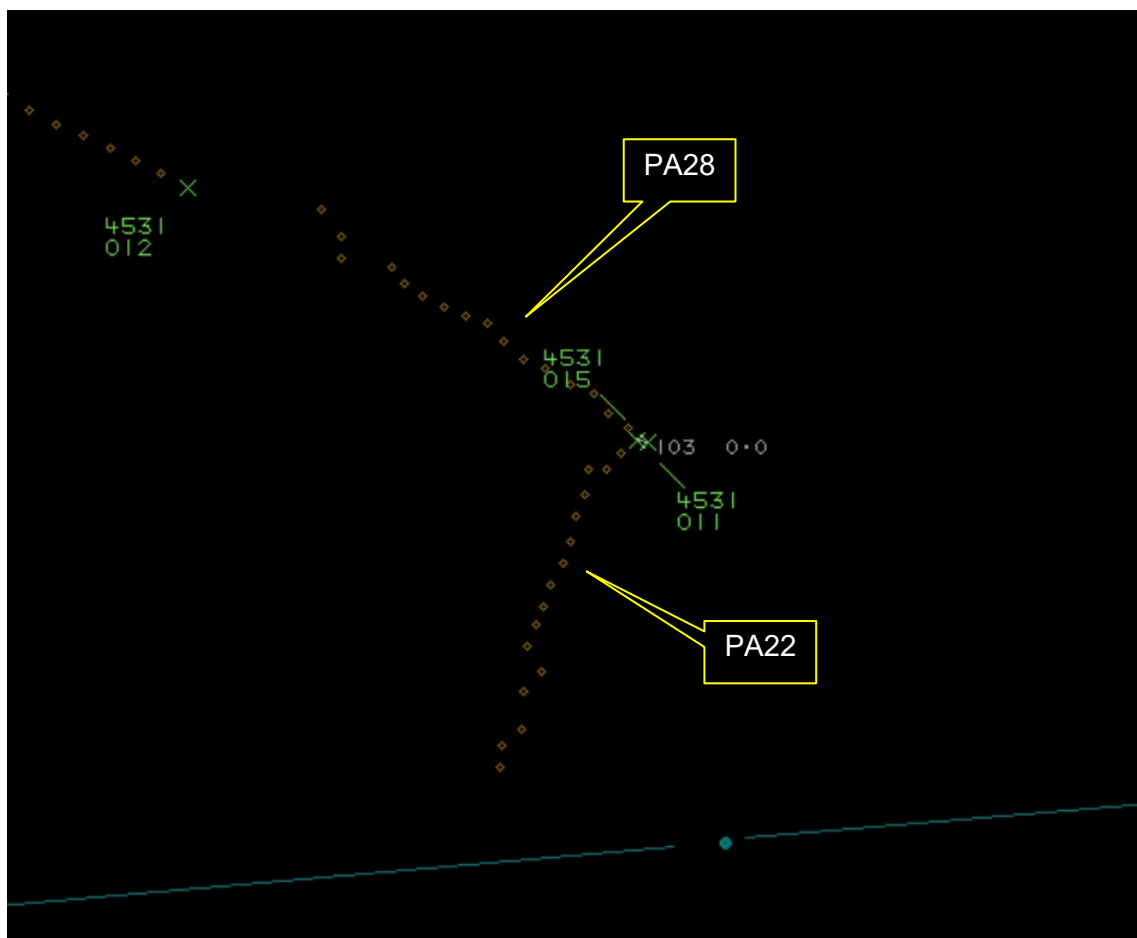
Figure 1: CPA (1330:32) 400ft V/ <0.1NM H

Both aircraft were tracked by radar and identified through Mode S data.
