**AIRPROX REPORT No 2026015**

Date: 03 Mar 2026 Time: 1144Z Position: 5256N 00332W Location: 2.5NM NE of Bala

**PART A: SUMMARY OF INFORMATION REPORTED TO UKAB**

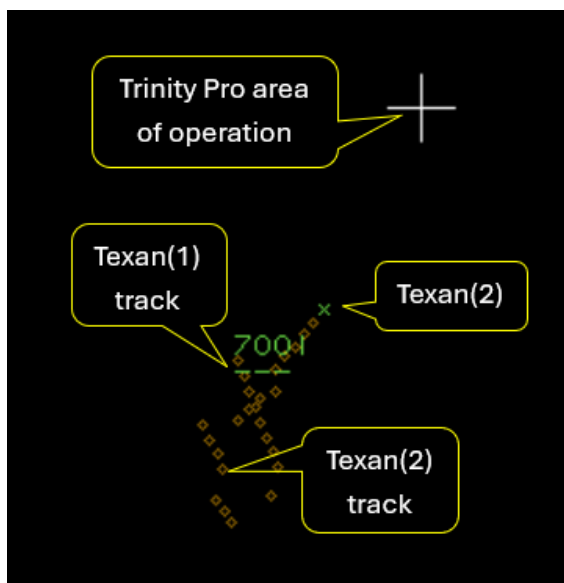
Figure 1 – Time 1143:32

An analysis of the NATS radar replay was undertaken and the Texan pair was detected using Mode S data. The Texan pair was seen to have turned towards the Trinity Pro drone's area of operation at 1143:32 (Figure 1), after which they were no longer visible on radar until after 1147, and to the north of the position of the reported Airprox.

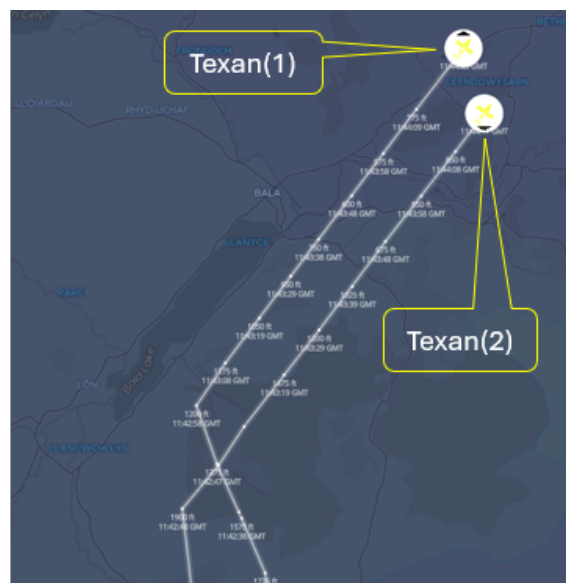
Figure 2 – Time 1144:23

Further analysis of third-party aircraft tracking software was undertaken and the Texan pair was detected using ADS-B data. The pair was seen to enter to the Trinity Pro's area of operation at 1144:23 (Figure 2).

CPA was assessed to have been at 1144:23 with a lateral separation of less than 0.6NM and vertical separation unknown.
