AIRPROX REPORT No 2026018

Date: 10 Mar 2026 Time: 1048Z Position: 5124N 00129W Location: E of Hungerford

PART A: SUMMARY OF INFORMATION REPORTED TO UKAB

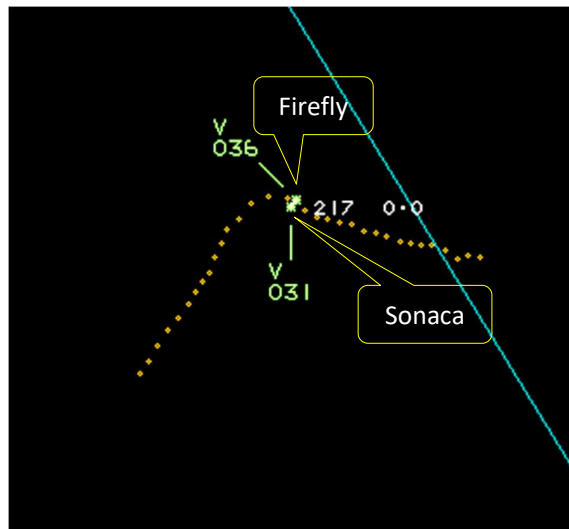
Figure 1 – Time 1048:03 CPA

An analysis of the NATS radar replay was undertaken and both aircraft were detected using Mode S data. CPA was assessed to have occurred at 1048:03 with 500ft vertical and less than 0.1NM horizontal separation (Figure 1) although, due to the dynamic nature of the aircraft involved, the altitude readouts displayed are likely to have suffered from a degree of 'lag' and, therefore, the recorded vertical separation may not be accurate. See Figure 2 for the next radar sweep 4sec after CPA.

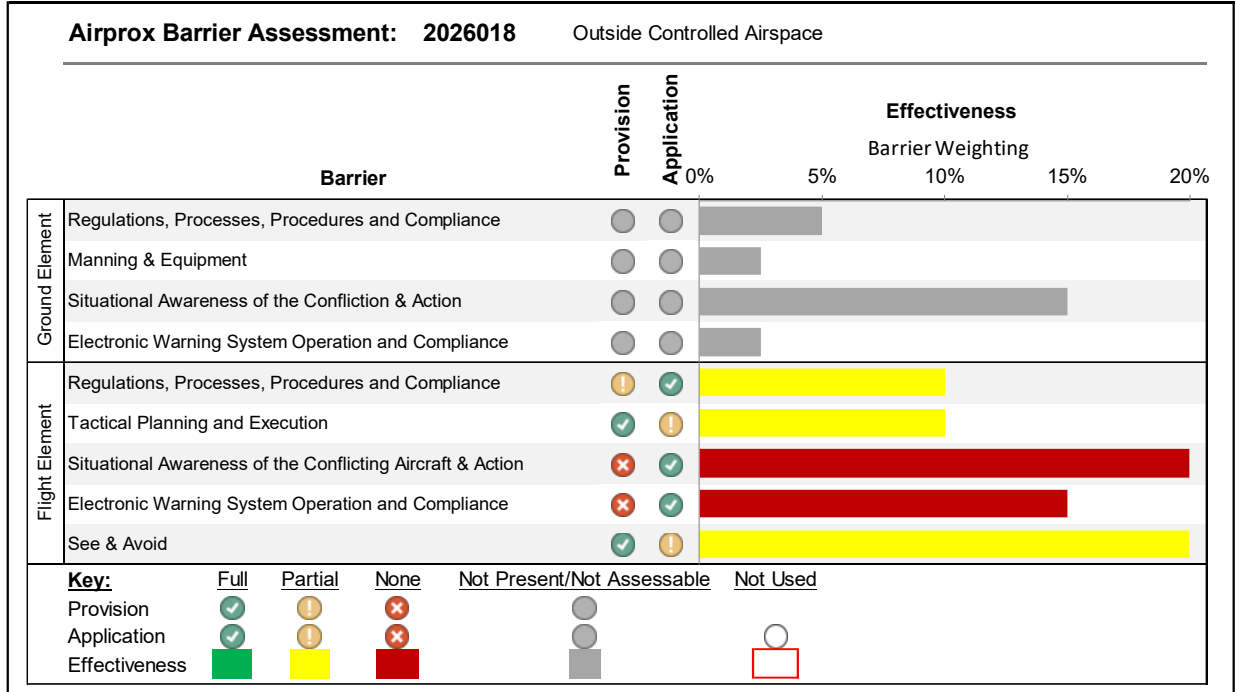
In assessing the effectiveness of the safety barriers associated with this incident, the Board concluded that the key factors had been that:

Regulations, Processes, Procedures and Compliance were assessed as **partially effective** because the Firefly company's procedures had not mandated use of the 7004 aerobatic squawk during UPRT exercises.

Tactical Planning and Execution was assessed as **partially effective** because neither the pilot of the Sonaca nor the pilot of the Firefly had been in receipt of a FIS nor, in the case of the Firefly, had the aircraft been displaying a 7004 aerobatic squawk.

Situational Awareness of the Conflicting Aircraft and Action were assessed as **ineffective** because neither pilot had situational awareness of the other aircraft.

Electronic Warning System Operation and Compliance were assessed as **ineffective** because the electronic conspicuity equipment fitted in the Sonaca had been unable to detect the Firefly.

See and Avoid were assessed as **partially effective** because the Firefly pilot had not seen the Sonaca, and the Sonaca pilot had little time to react to the manoeuvring of the Firefly.
