AIRPROX REPORT No 2026019

Date: 04 Mar 2026 Time: 1350Z Position: 5531N 00211W Location: 2NM SSW of Hethpool

PART A: SUMMARY OF INFORMATION REPORTED TO UKAB

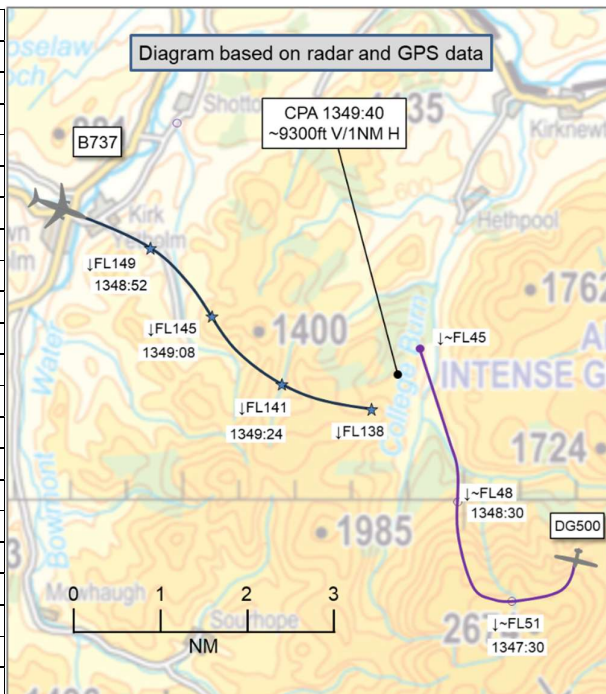
Recorded	Aircraft 1	Aircraft 2
Aircraft	B737	DG500
Operator	CAT	Civ Gld
Airspace	Scottish FIR	Scottish FIR
Class	G	G
Rules	IFR	VFR
Service	Deconfliction	Listening Out
Provider	Newcastle Radar	Milfield Base
Altitude/FL	↓FL138	4785ft (~FL45)
Transponder	A, C, S+	Not fitted
Reported		
Colours	Company	White
Lighting	Std	None
Conditions	VMC	VMC
Visibility	>10km	>10km
Altitude/FL	'Descending'	4700ft
Altimeter	SPS (1013hPa)	QFE (1023hPa)
Heading	NK	340°
Speed	NK	90kt
ACAS/TAS	TCAS II	FLARM
Alert	None	None
	Separation at CPA	
Reported	Not seen	10,000ft V/3NM H
Recorded	~9300ft V/ 1.0NM H

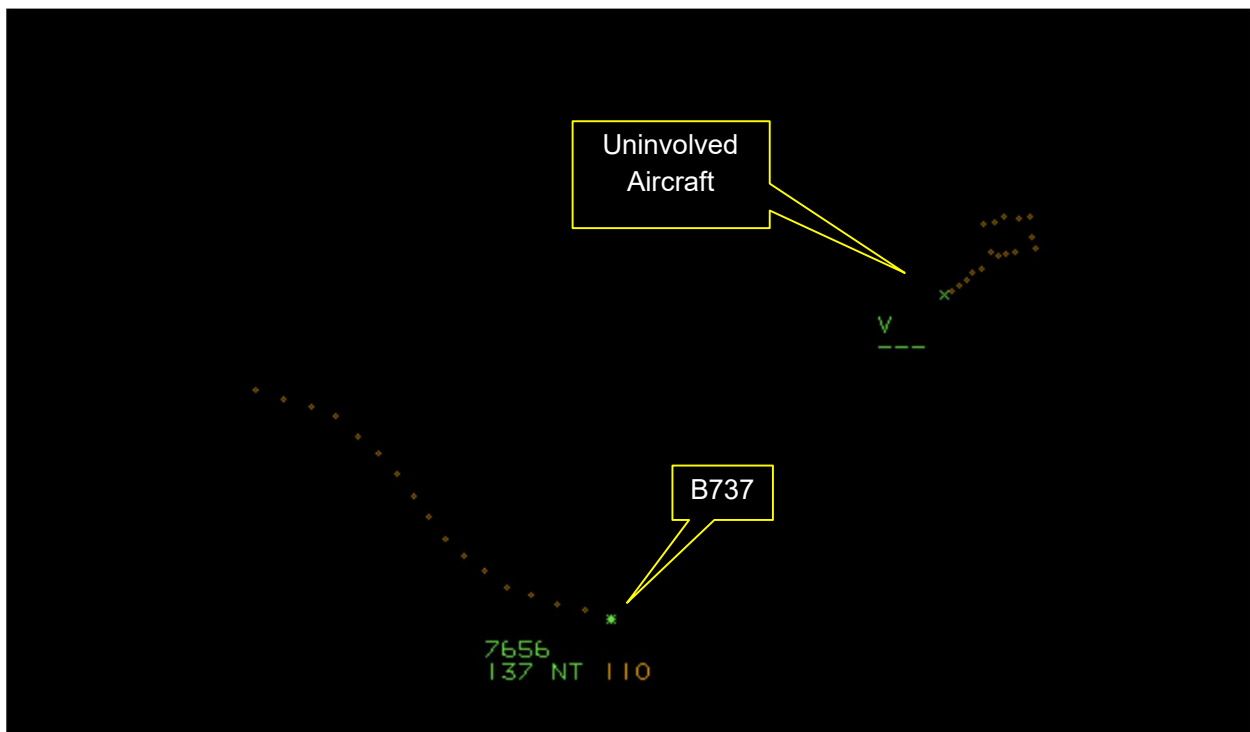
Figure 1: at CPA (1339:40) ~9300ft/1NM

The B737 was tracked via radar and identified through Mode S data. The DG500 did not appear on radar (leading up to and immediately after CPA) but was tracked and identified via its onboard [branded EC] equipment. The diagram at page 1 was constructed using both radar and GPS data sources, with altitudes correlated through conversion to the Standard Pressure Setting to give approximate pressure altitudes for both aircraft at CPA.

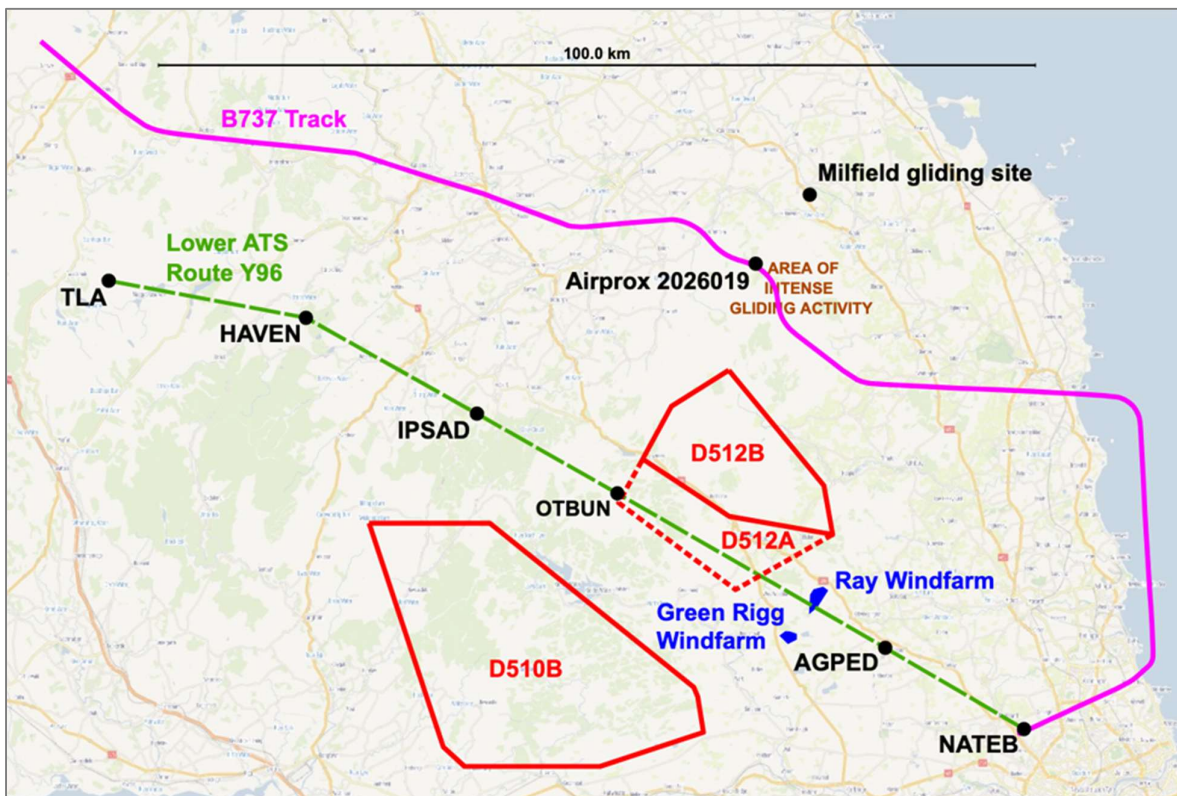
Figure 2

Examination of other instances of this flight number arriving from the northwest into Newcastle shows that they are normally routed to the southwest of D512B, either passing through or to the southwest of D512A – presumably depending on the activation status of the latter. These appear to be following Lower ATS Route Y96.² However, we understand from the reports that on the incident date, “TERMA” was out of service, and that this is radar equipment which is not affected by the wind farms immediately under the usual approach route. Further, there was no definitive information available on the activation status of D512A. Consequently, the B737 was routed to the northeast of D512B, directly through the centre of an area marked on the CAA 1:500,000 VFR chart as an “Area of Intense Gliding Activity”. These are shown in figure 2.
