**AIRPROX REPORT No 2026020**

Date: 14 Mar 2026 Time: 1138Z Position: 5413N 00115W Location: 1.5NM W Sutton Bank

**PART A: SUMMARY OF INFORMATION REPORTED TO UKAB**

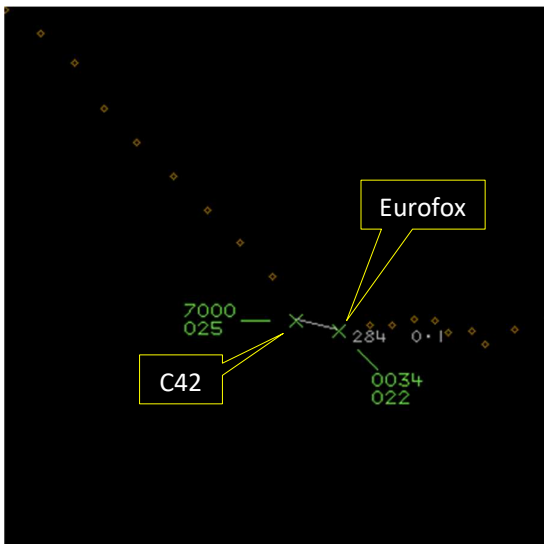
Figure 1 - 1138:08 (2sec before CPA)

The diagram was constructed and the separation at CPA determined from the radar data. The moment of CPA was assessed to have occurred between the radar sweeps at 1138:08 and 1138:12 (Figures 1 and 2). The altitude of the Eurofox has been shown as an estimate as it had been at 1900ft 2sec before CPA and at 2000ft 2sec after CPA.
