AIRPROX REPORT No 2026024

Date: 19 Mar 2026 Time: 1435Z Position: 5116N 00016W Location: 3.5NM NE Dorking

PART A: SUMMARY OF INFORMATION REPORTED TO UKAB

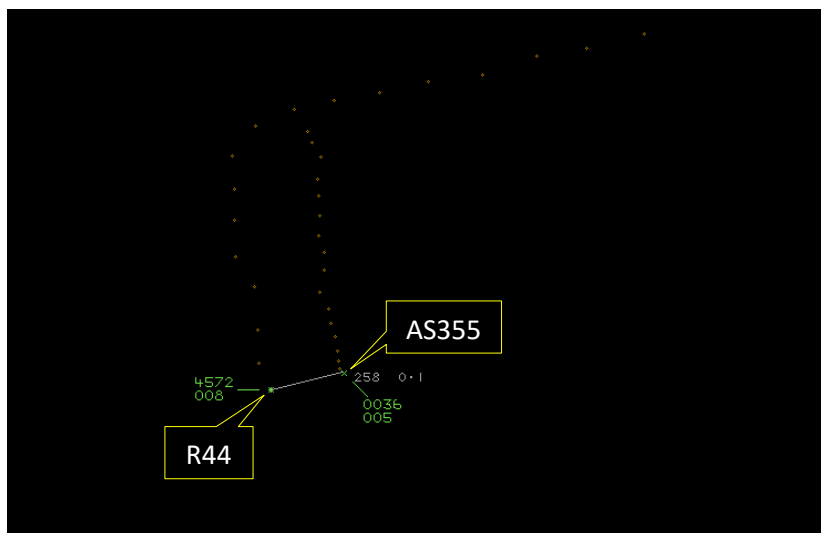
Figure 1 – CPA at 1435:06

An analysis of the NATS radar replay was undertaken and both aircraft could be positively identified from Mode S data (Figure 1). Neither aircraft could be observed by reference to ADS-B data sources. Both pilots kindly supplied GPS track data for their flights. It was by combining the data sources that the diagram was constructed. The vertical separation at CPA was determined from the GPS track data, and has been shown in the diagram as an approximate value due to rounding.

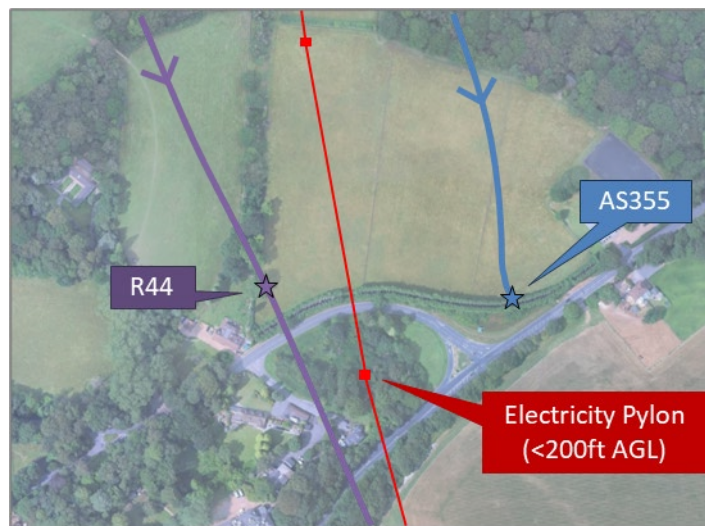
At the moment of CPA, the R44 had been at approximately 530ft AGL (1100ft AMSL over terrain with an elevation of 570ft) and had a lateral separation of approximately 230ft from the electricity transmission lines (which are at an estimated height of 100-150ft AGL) (Figure 2).

Figure 2 – The tracks of the AS355 and R44. The stars mark the moment of CPA.
