**AIRPROX REPORT No 2026029**

Date: 19 Mar 2026 Time: 1415Z Position: 5050N 00018W Location: Shoreham ATZ

**PART A: SUMMARY OF INFORMATION REPORTED TO UKAB**

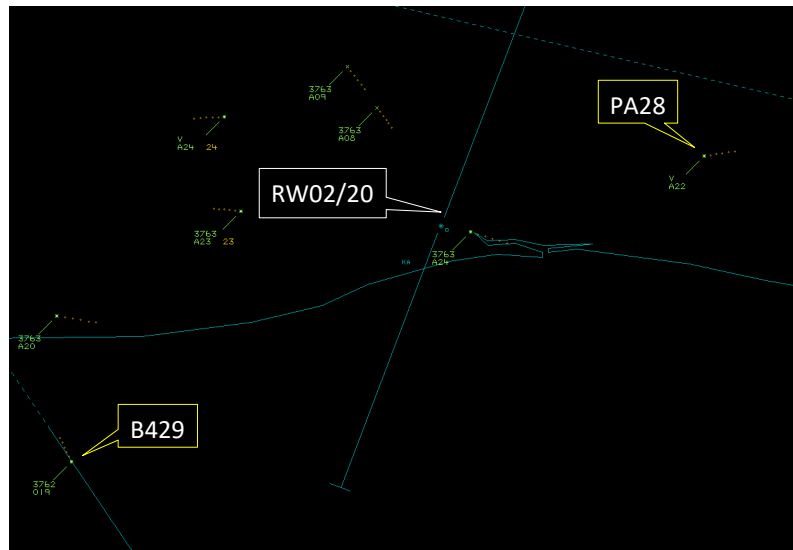
Figure 1 – 1406:38

At 1406:38, the B429 pilot reported at the Initial Approach Fix for the RNP approach to RW02 and was instructed to report established on the Final Approach Track (Figure 1).

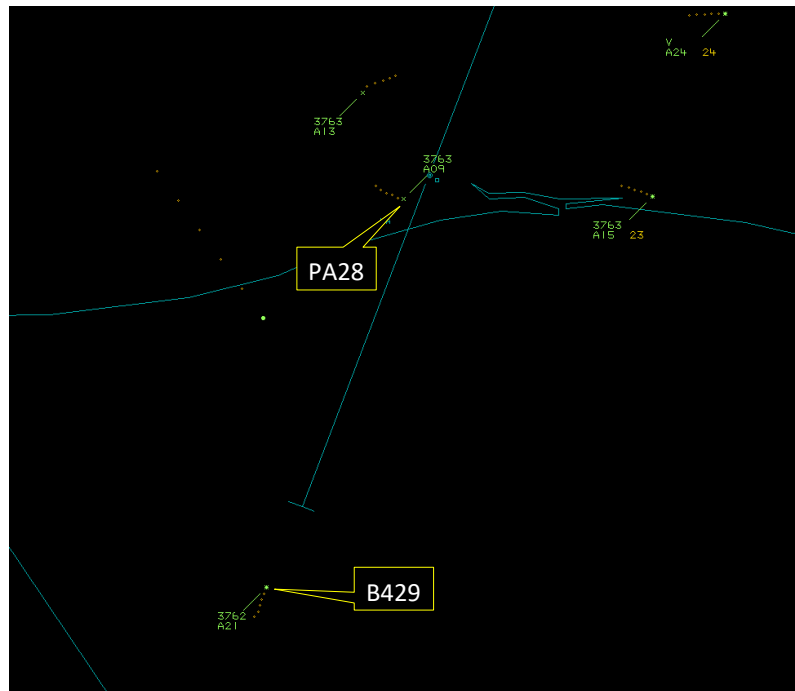
Figure 2 – 1410:18

At 1410:18, the B429 pilot reported established on the Final Approach Track and was instructed by the controller to report passing the Final Approach Fix. The controller then passed their missed approach instructions. The radar replay showed the PA28 passing above the RW02 final approach track (Figure 2).

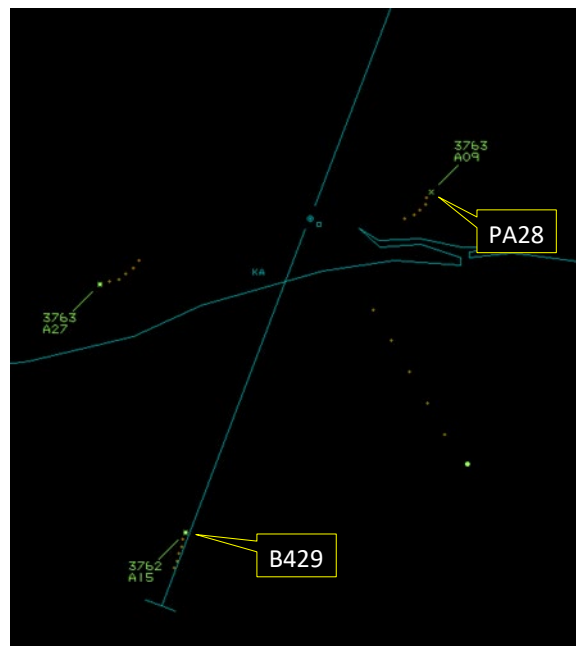
Figure 3 – 1411:55

At 1411:55, the PA28 pilot reported: *“downwind for landing”*. The controller replied: *“Number 1 report on – correction, at the end of the downwind leg make a right-hand orbit please – report rolling out. I do have instrument traffic inbound”*. The pilot replied: *“one right-hand orbit at end of downwind”* (Figure 3).

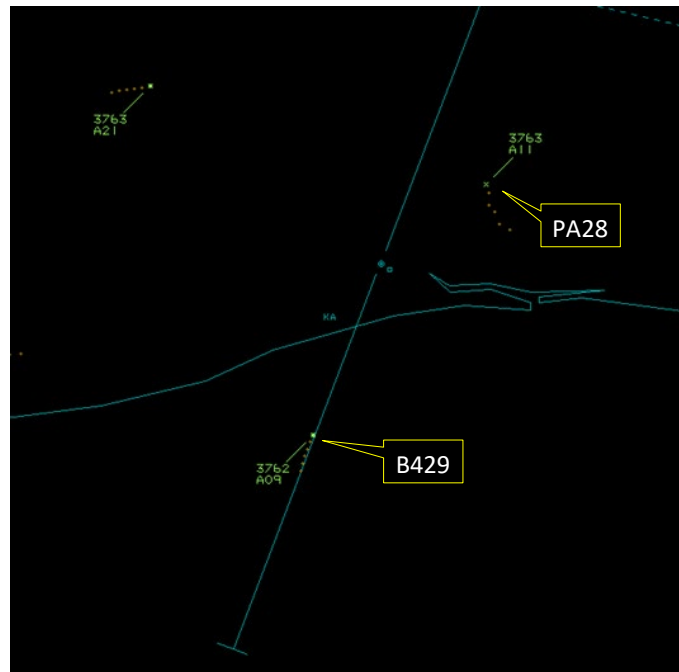
Figure 4 – 1413:08

At 1413:08, the PA28 pilot reported “orbit complete”. The controller instructed them to “report final – you’re number 2 following a Bell 429 on about a 2-mile final”. The PA28 pilot replied: “report final number 2” (Figure 4).

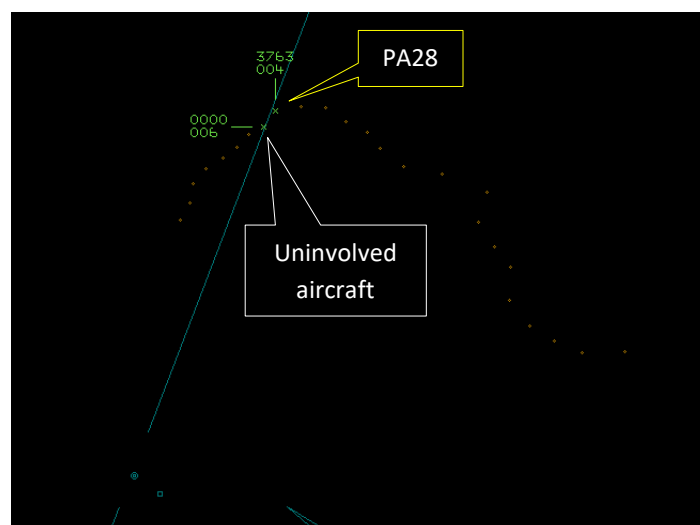
Figure 5 – 1413:50

Between 1413:25 and 1414:00, the controller was occupied with an aircraft on the ground followed by the passing of generic Traffic Information to the pilot of the recently departed aircraft on other traffic to the east of them (not the PA28) (Figure 5).

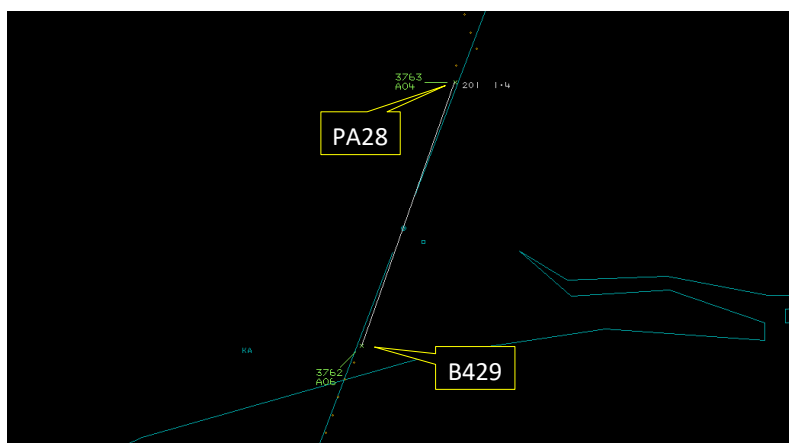
Figure 6 – 1414:22

At 1414:22, the B429 pilot reported going around which was acknowledged by the controller: *“roger”* (Figure 6).

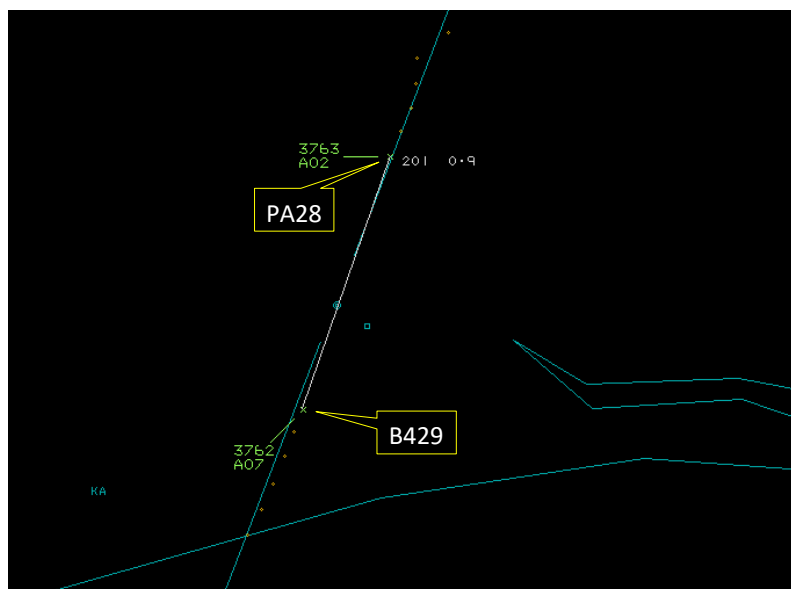
Figure 7 – 1414:34

At 1414:34, the pilot of an aircraft on the ground reported ready for departure but, before the controller could reply, the PA28 pilot reported going around. The controller replied: *“roger – caution helicopter ahead”* (Figure 7).

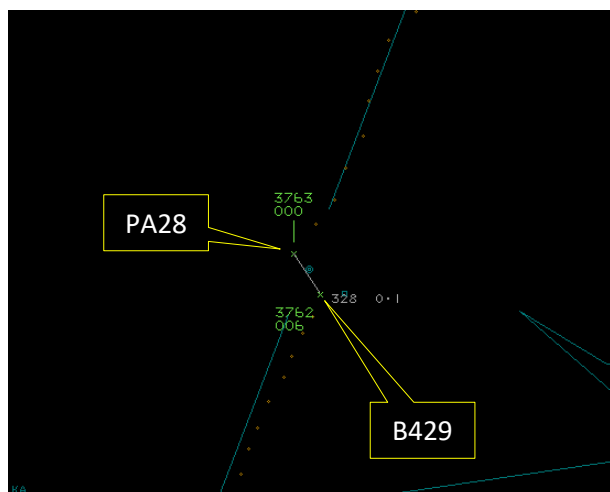
Figure 8 - 1414:58 (2sec before CPA)

The aircraft were depicted on the radar replay as having flown at Flight levels. A suitable correction was applied to determine their altitudes. The diagram was constructed and the separation at CPA determined from the radar data. The moment of CPA was assessed to have occurred between the radar sweeps at 1414:58 and 1415:02 (Figures 8 and 9).
