**AIRPROX REPORT No 2026032**

Date: 26 Mar 2026 Time: 1206Z Position: 5101N 00038W Location: 1NM SSW of MID VOR/DME

**PART A: SUMMARY OF INFORMATION REPORTED TO UKAB**

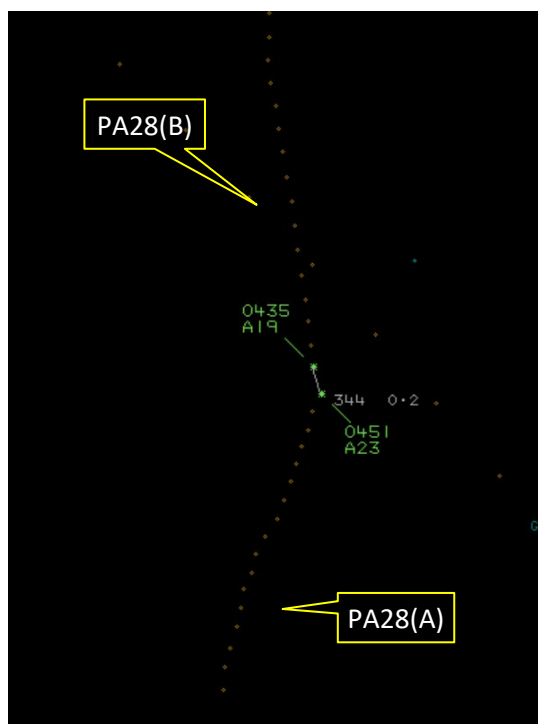
Figure 1: At CPA minus 3sec (1205:42)

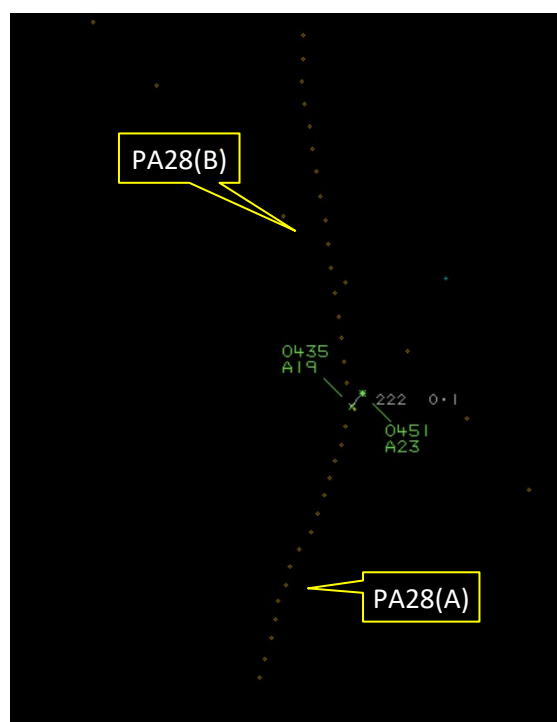
Figure 2: AT CPA + 1sec (1205:46)
