**AIRPROX REPORT No 2026033**

Date: 26 Mar 2026 Time: 1426Z Position: 5101N 00238W Location: RNAS Yeovilton

**PART A: SUMMARY OF INFORMATION REPORTED TO UKAB**

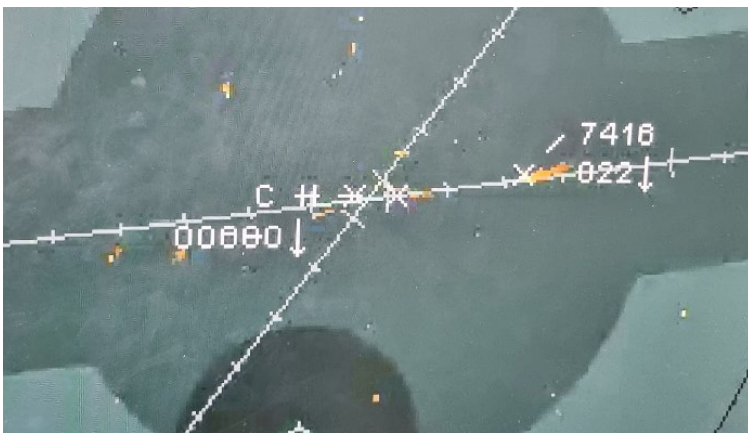
Figure 1

| Time | Callsign | Transcript |
|---|---|---|
| Figure 1. Screenshot taken of radar replay – [Tutor(A) C/S] is 2.3NM from the end of Runway 26 indicating 022 descending. | | |

At 1424:05, [Tutor(A) pilot] called 'initial', at 2.3NM from the end of RW26 at 022 descending.

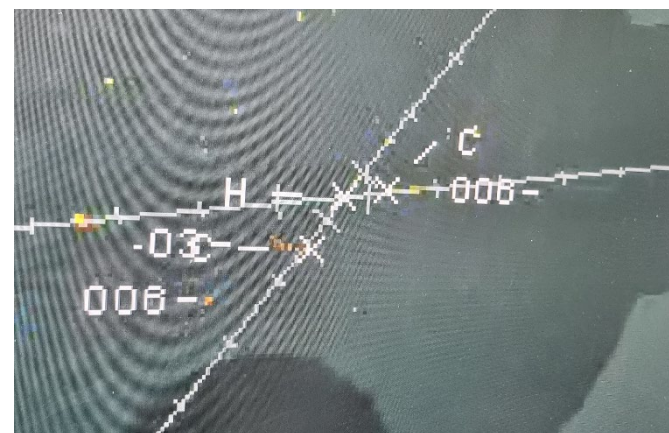
Figure 2

| Time | Callsign | Transcript |
|---|---|---|
| Figure 2. Screenshot taken of radar replay screen – [Tutor(A) C/S] is 0.3NM from the end of runway 26. Indicating 006 and level.<br>[Merlin C/S] is on the runway indicating -03 and level. The two contacts are approximately less than 1NM from each other. | | |

At 1425:16 [Merlin C/S] called 'ready for departure' followed by a clearance, with [Tutor(A) pilot] now 0.3NM from the end of RW26 indicating 006 level. [Merlin C/S] was indicating -003 and level with both aircraft approximately less than 1NM [apart].

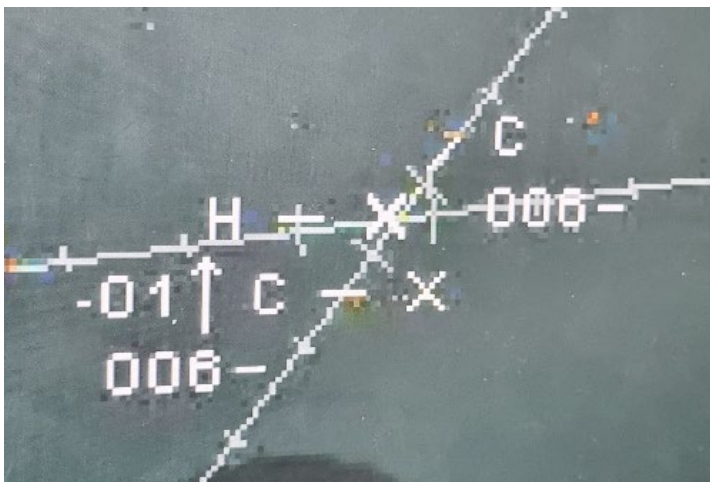
Figure 3

| Time | Callsign | Transcript |
|---|---|---|
| Figure 3. Screenshot taken of radar replay screen – both contacts of [Tutor(A) C/S] and [Merlin C/S] have merged, with 1 pixel offsetting them, [Tutor (B)] is believed to be to the north still in the deadside. [Tutor(A) C/S] is indicating 006 and level. [Merlin C/S] is indicating -01 and climbing. | | |

From [Figure 3] both aircraft have now merged with 1 pixel offsetting, [Tutor(A) pilot] is believed to be north deadside indicating 006 level. [Merlin C/S] is -001 and climbing.

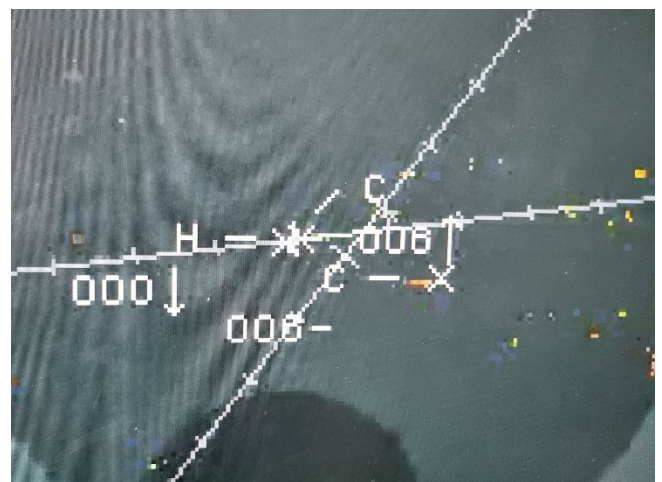
Figure 4

| Time | Callsign | Transcript |
|---|---|---|
| Figure 4. Screenshot taken of radar replay screen shows [Tutor(A) C/S] ahead of [Merlin C/S] with the radar contacts only slightly overlapping. Following the radar tracking, [Tutor(A) C/S] appears to be crossing ahead of [Merlin C/S] to join the visual circuit. [Tutor(A) C/S] is indicating 006 and climbing, [Merlin C/S] is indicating 000 and descending. | | |

[Figure 4] shows [Tutor(A) pilot] now ahead of [Merlin C/S] joining the visual circuit at 006 climbing and [Merlin C/S] 000 descending.

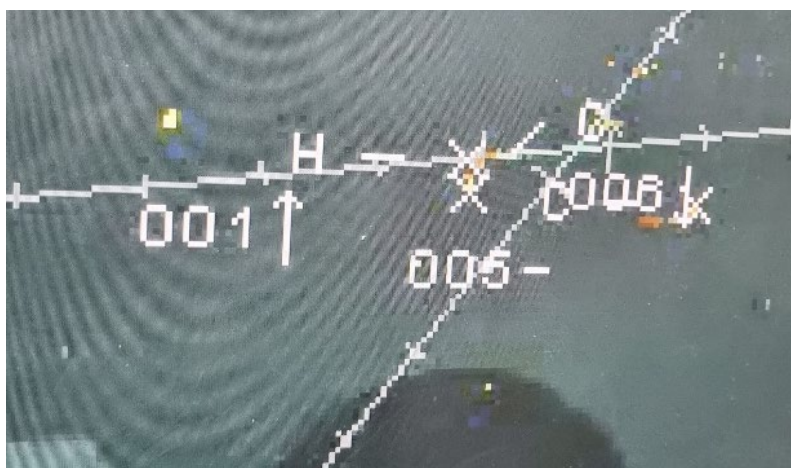
Figure 5. Screenshot taken where the radar screen now shows a strong primary and secondary track of the [Tutor(A) C/S] in the circuit in the crosswind section of the visual circuit and diverging from [Merlin C/S]. [Tutor(A) C/S] is indicating 006 and descending. [Merlin C/S] is indicating 001 and climbing.

At 1426:30 both contacts were now diverging with [Tutor(A) pilot] descending and [Merlin C/S] climbing.
