**AIRPROX REPORT No 2026041**

Date: 03 Apr 2026 Time: 1512Z Position: 5153N 00015W Location: 5NM E Luton

**PART A: SUMMARY OF INFORMATION REPORTED TO UKAB**

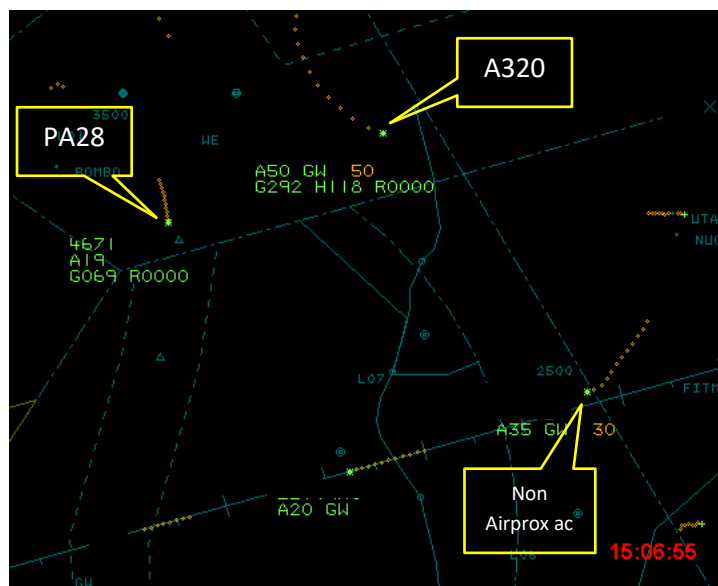
Figure 1 – Node display

This arrival sequence included two aircraft established on final approach to RW25 ([two non-Airprox aircraft]) followed by an A320 arriving from the northeast as shown in Figure 1. At 1506:55, the GW DIR passed Traffic Information on the position of [the PA28] to the pilot of [the second non-Airprox aircraft], informing them that the aircraft was *“just entering the zone from the north, will be holding two miles north of the field, working the Tower”*. Note: [The PA28 pilot] was still established on the same frequency.

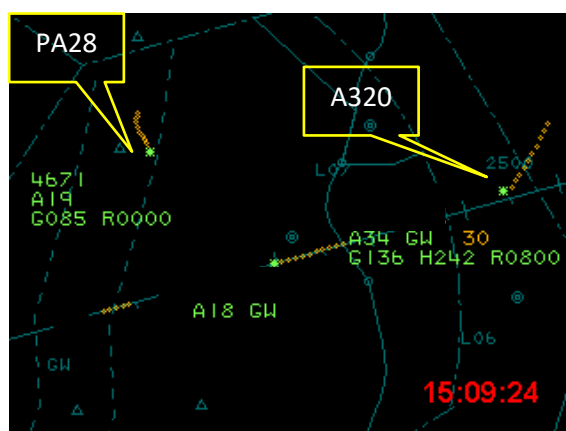
Figure 2

At 1509:09 the GW APP controller queried whether the pilot of [the PA28] had the airfield in sight and, after receiving confirmation, reiterated the earlier clearance stating, *“hold two miles north of the field, contact Tower one three two decimal five five five, callsign only”*. The pilot read back the frequency change at 1509:24 (Figure 2), 3.8NM northeast of the airfield, but omitted to read back the repeated hold confirmation and read back the frequency as *“one three two decimal five five”* which was not challenged.

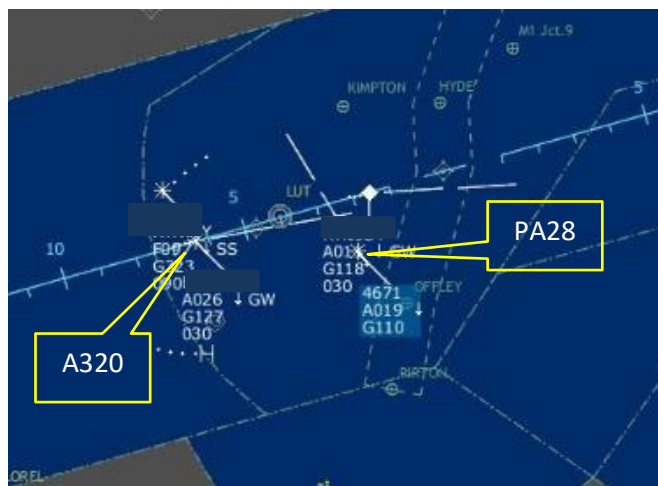
Figure 3 – GW Aerodrome Traffic Monitor (ATM). Note that the ATM image is displayed with north-south reversal to match the Luton tower orientation.

The pilot of [the PA28] reported onto the GW AIR frequency during this call, at 1510:29 (Figure 3) when 3NM northeast of the airfield (1.5NM north of a 3NM final). The GW AIR controller advised the GW APP controller that the pilot had just made contact, and both controllers agreed that the pilot was not acting as instructed.

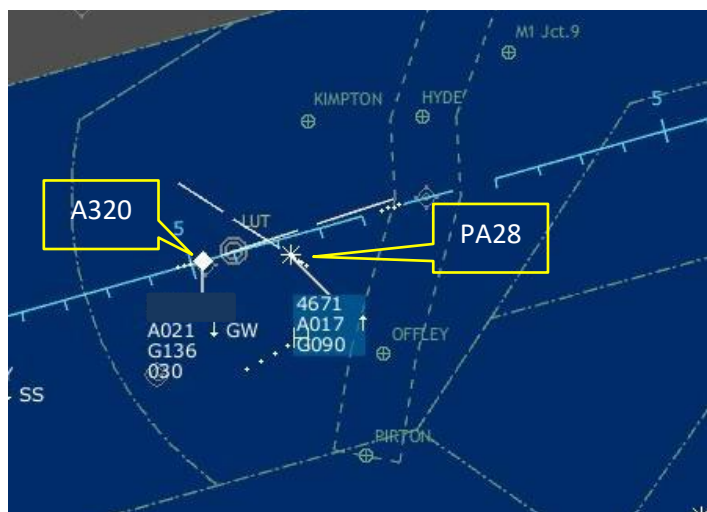
Figure 4

The GW AIR controller continued at 1511:06 “[PA28 C/S], *Traffic Information, two miles to the east of you is an inbound [company] A320*” to which the pilot responded at 1511:13 (Figure 4), “*looking for traffic, [C/S]*”. The NODE STCA alert increased to red (high level) as this was issued.

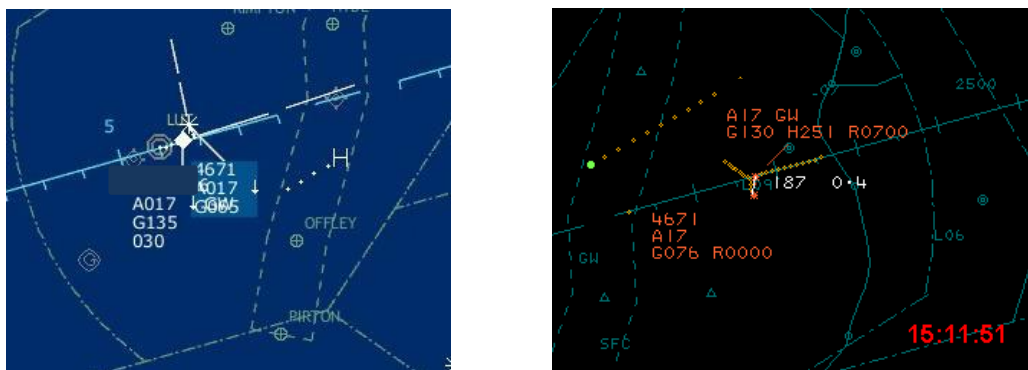
[The PA28] proceeded to cross the final approach track at 1511:31 at an altitude of 1700ft, approximately 0.9NM ahead of [the A320]. The closest point of conflict occurred at 1511:51 and was recorded on Multi-Track radar as 0.4NM and 0ft with [the PA28] tracking south of the approach track (Figure 5).

Figure 5 - Closest point of conflict between the PA28 and the A320 as displayed on the GW ATM (left) and NODE radar (right).
