**AIRPROX REPORT No 2026043**

Date: 10 Apr 2026 Time: 0939Z Position: 5355N 00300W Location: 9NM N Blackpool Airport

**PART A: SUMMARY OF INFORMATION REPORTED TO UKAB**

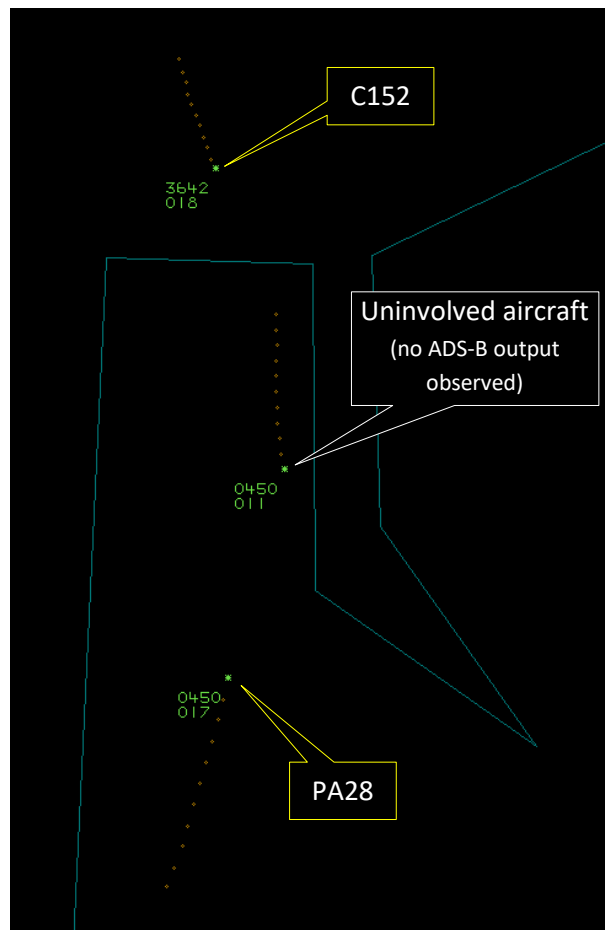
Figure 1 – Aircraft positions at 0938:19 (1min before CPA)

An analysis of the NATS radar replay was undertaken and both aircraft could be positively identified from Mode S data (Figure 1). Neither aircraft was observed by reference to ADS-B data sources.

The aircraft were depicted on the radar replay as having flown at Flight Levels. A suitable correction was applied to determine their altitudes. The diagram was constructed and the separation at CPA determined from the radar data.

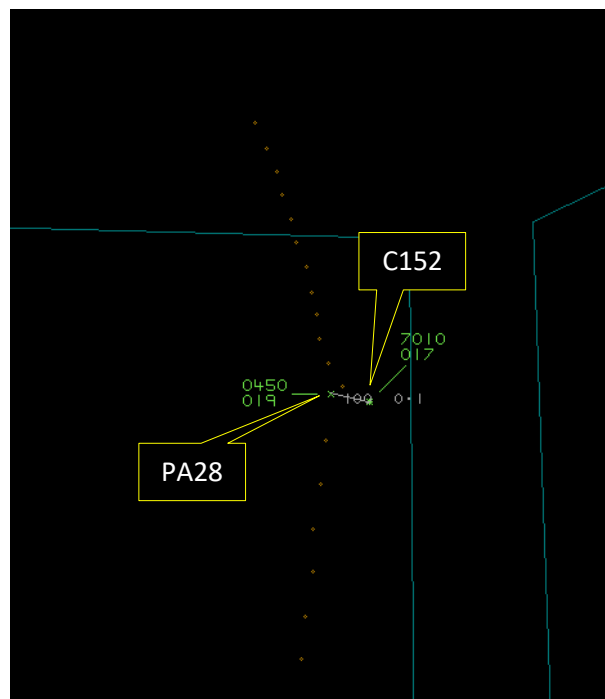
Figure 2 – CPA at 0939:19

The C152 and PA28 pilots shared an equal responsibility for collision avoidance and not to operate in such proximity to other aircraft as to create a collision hazard.<sup>2</sup> If the incident geometry is considered as head-on or nearly so then both pilots were required to turn to the right.<sup>3</sup>
