**AIRPROX REPORT No 2026045**

Date: 18 Apr 2026 Time: ~1121Z Position: 5050N 00114W Location: Lee-on-Solent ATZ

**PART A: SUMMARY OF INFORMATION REPORTED TO UKAB**

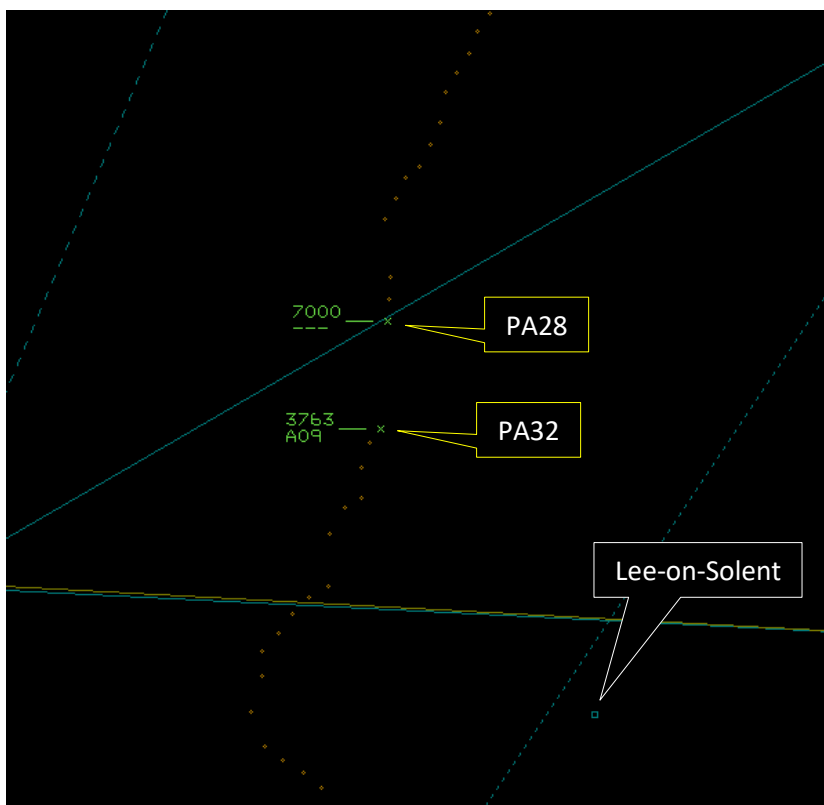
An analysis of the NATS radar replay was undertaken and the PA32 could be positively identified from Mode S data. The PA28 was identified by reference to the reported positions and altitude. No Mode C returns were observed on the replay from the PA28 after 1120:06, and primary returns faded after 1120:38. Neither aircraft was observed by reference to ADS-B data sources.

Figure 1 – 1120:38. The PA28 faded from the radar replay on the next sweep.

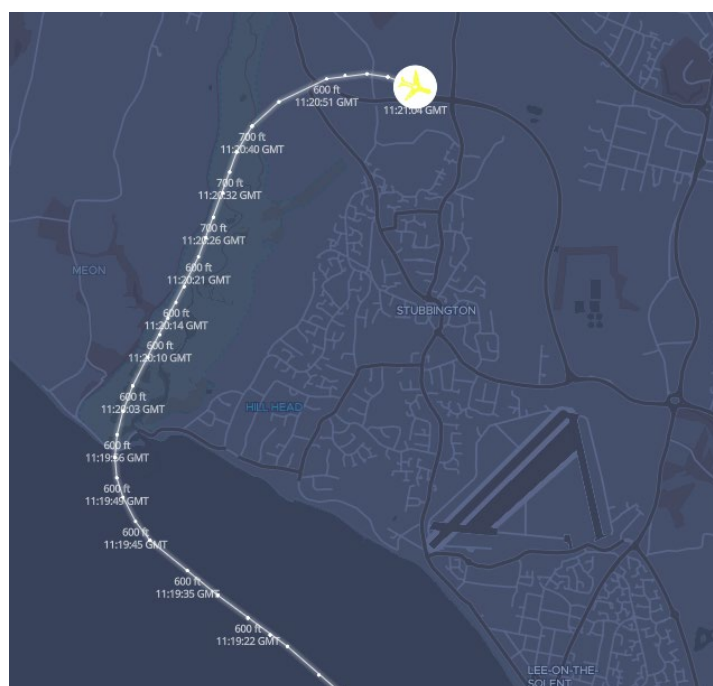
Figure 2 – The track of the PA32 (MLAT data)

The exact moment of CPA, and the minimum separation, could not be determined. The diagram has been constructed by combining the available data sources. The track of the PA28 has been shown with a dotted line to indicate a probable track.
