**AIRPROX REPORT No 2026048**

Date: 18 Apr 2026 Time: 1223Z Position: 5150N 00107W Location: 7.5NM E Oxford Airport

**PART A: SUMMARY OF INFORMATION REPORTED TO UKAB**

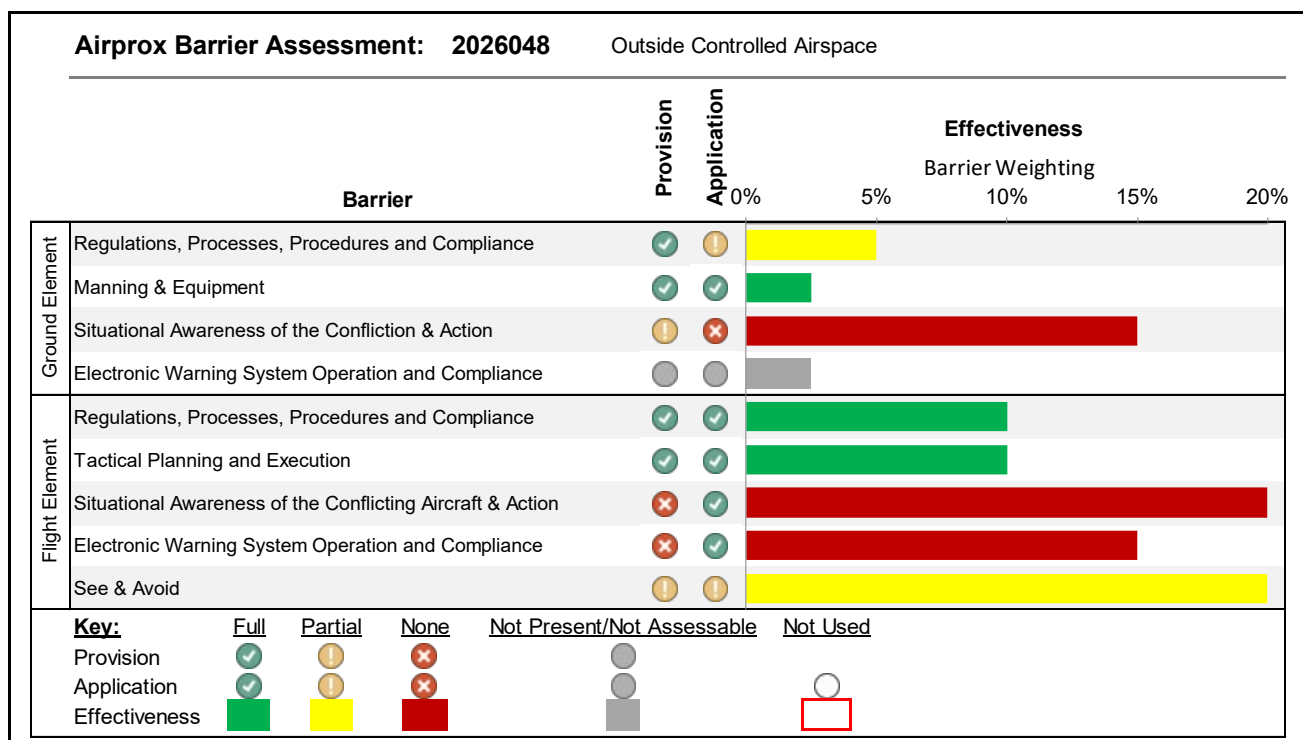
In assessing the effectiveness of the safety barriers associated with this incident, the Board concluded that the key factors had been that:

**Regulations, Processes, Procedures and Compliance** were assessed as **partially effective** because the Oxford controller had not passed Traffic Information to the C182 pilot.

**Situational Awareness of the Confliction and Action** were assessed as **ineffective** because the Oxford controller had had no situational awareness of the C182 and DG200 proximity.

**Situational Awareness of the Conflicting Aircraft and Action** were assessed as **ineffective** because neither pilot had had situational awareness of the other aircraft's proximity.

**Electronic Warning System Operation and Compliance** were assessed as **ineffective** because the DG200 TAS had not been compatible with the C182's EC and vice versa.

**See and Avoid** were assessed as **partially effective** because the DG200 pilot had seen the C182 at about CPA, effectively a non-sighting, and the C182 pilot had seen the DG200 at a late stage and had taken avoiding action.
