**AIRPROX REPORT No 2026049**

Date: 19 Apr 2026 Time: 1131Z Position: 5342N 00127W Location: 2NM NE of Wakefield

**PART A: SUMMARY OF INFORMATION REPORTED TO UKAB**

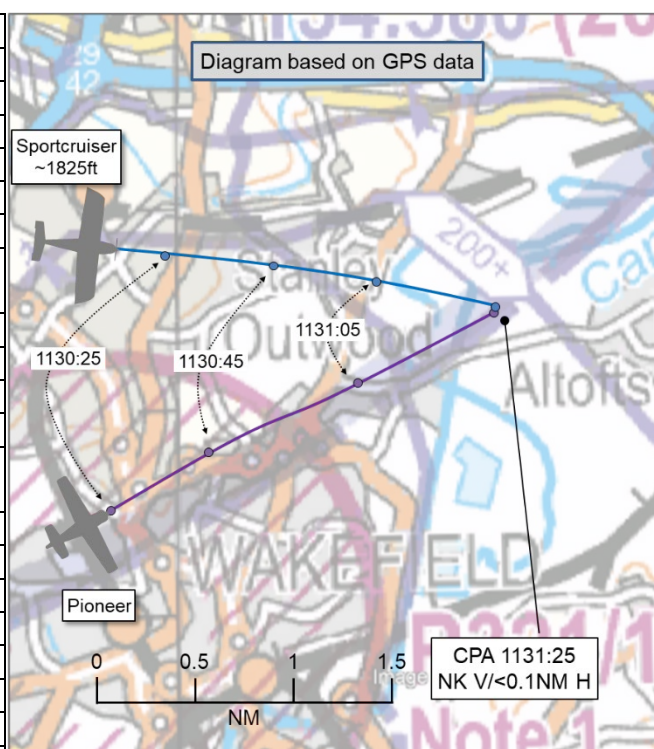
| Recorded | Aircraft 1 | Aircraft 2 |
|---|---|---|
| Reported | 100ft V/20m H | Not seen |
| Recorded | NK V/<0.1NM H | |

The Sportcruiser was seen on radar, although intermittently, and not until CPA +45sec. The Pioneer did not appear on radar. Both aircraft were displayed on the CAA's Airspace Analyser tool and the diagram at page 1 was constructed using that information. The Pioneer did not show a stable altitude reference (fluctuating between 1000ft and 43,000ft in the period of +/- 1min of CPA) and a direct altitude comparison is therefore not possible to determine.
