**AIRPROX REPORT No 2026054**

Date: 26 Apr 2026 Time: 1635Z Position: 5058N 00002W Location: 3.5NM E Burgess Hill

**PART A: SUMMARY OF INFORMATION REPORTED TO UKAB**

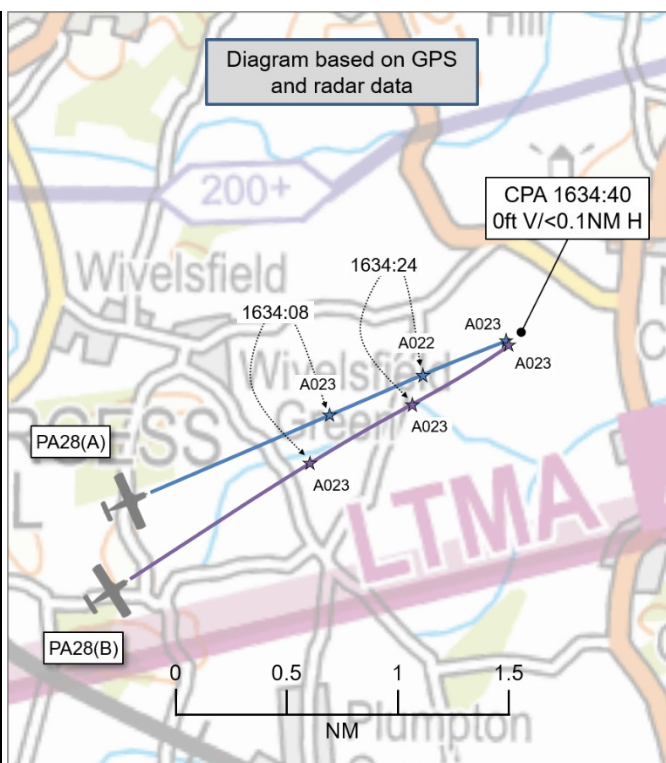
| Recorded | Aircraft 1 | Aircraft 2 |
|---|---|---|
| Reported | 0ft V/10m H | 0ft V/50m H |
| Recorded | 0ft V/<<0.1NM H | |

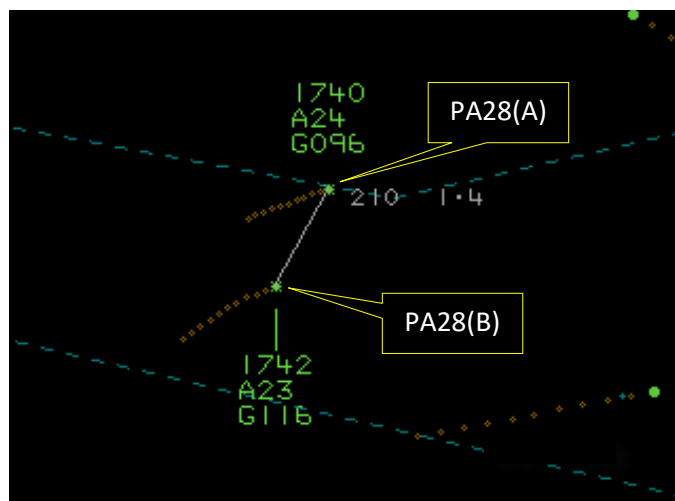
Figure 1 – 1631:09

The LARS controller called the pilot of [PA28(B)] at 1631:09 and advised, "*Caution, just traffic off to your left-hand side, converging, similar level*". The pilot responded, "*Copy the traffic, we'll keep a good lookout*".

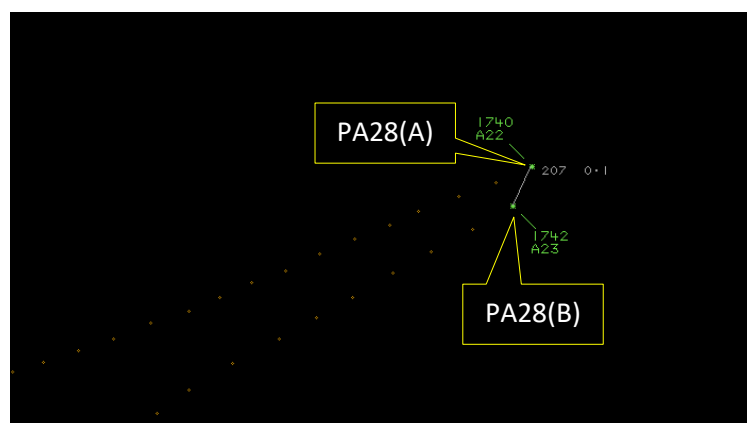
At 1634:30, the pilot of [PA28(B)] reported they were visual with the traffic (Figure 2).

Figure 2 – The pilot of PA28(B) reported visual with PA28(A) at 1634:30

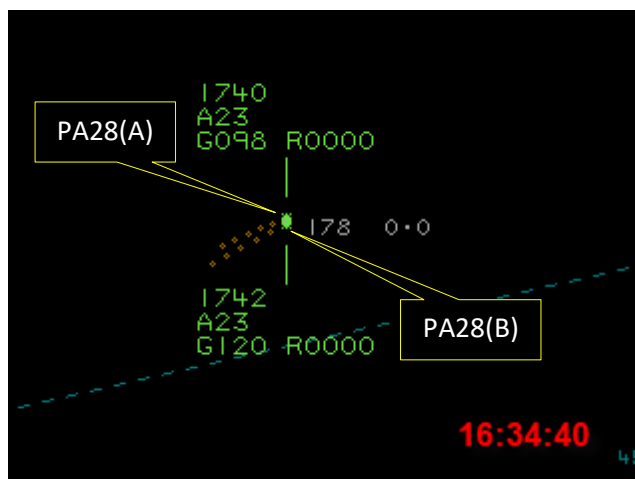
Figure 3 – CPA at 1634:40

The Closest Point of Approach between [PA28(A)] and [PA28(B)] occurred at 1634:40 and was measured on the NODE Multi-Track Radar as 0.0NM and 0ft (Figure 3). The event took place in Class G airspace where there were no separation requirements. There was no report of the conflict on the frequency from either pilot.

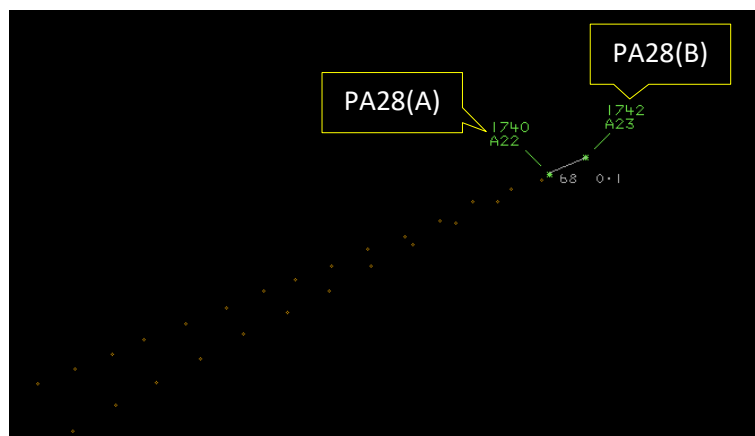
Figure 3 – 1635:02 (22sec after CPA)

An analysis of the NATS radar replay was undertaken and both aircraft could be positively identified from Mode S data. Neither aircraft was observed by reference to ADS-B data sources. The pilot of PA28(A) kindly supplied GPS track data for their flight. It was by combining the data sources that the diagram was constructed and the separation at CPA determined.

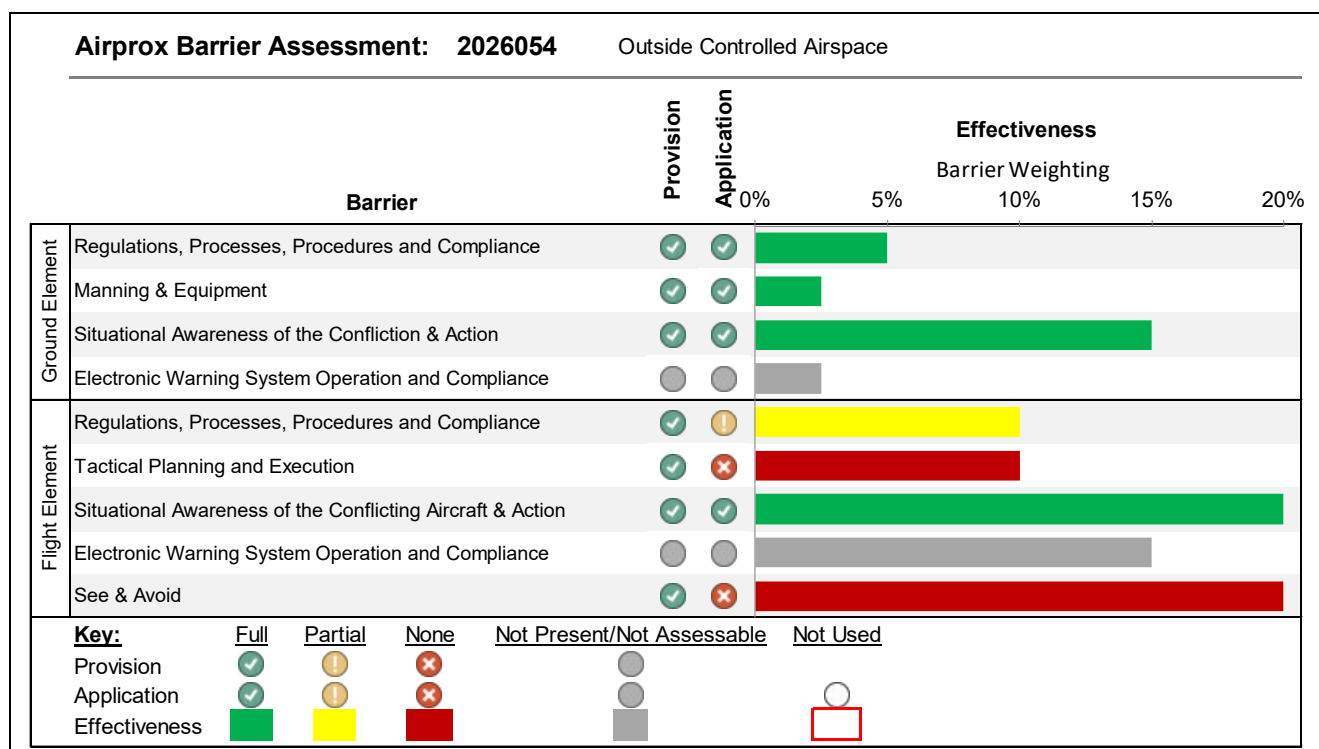
**Regulations, Processes, Procedures and Compliance** were assessed as **partially effective** because the pilot of PA28(B) had operated in such a way as to have created a collision hazard.

**Tactical Planning and Execution** was assessed as **ineffective** because the pilot of PA28(B) had not executed their overtaking manoeuvre correctly. Upon becoming concerned at the proximity of PA28(B), the pilot of PA28(A) had not adapted their dynamic plan to have resolved the situation.

**See and Avoid** were assessed as **ineffective** because the pilot of PA28(B) had not provided adequate separation from PA28(A) during their overtake manoeuvre.
