**AIRPROX REPORT No 2026055**

Date: 25 Apr 2026 Time: ~1716Z Position: 5205N 00208W Location: Defford

**PART A: SUMMARY OF INFORMATION REPORTED TO UKAB**

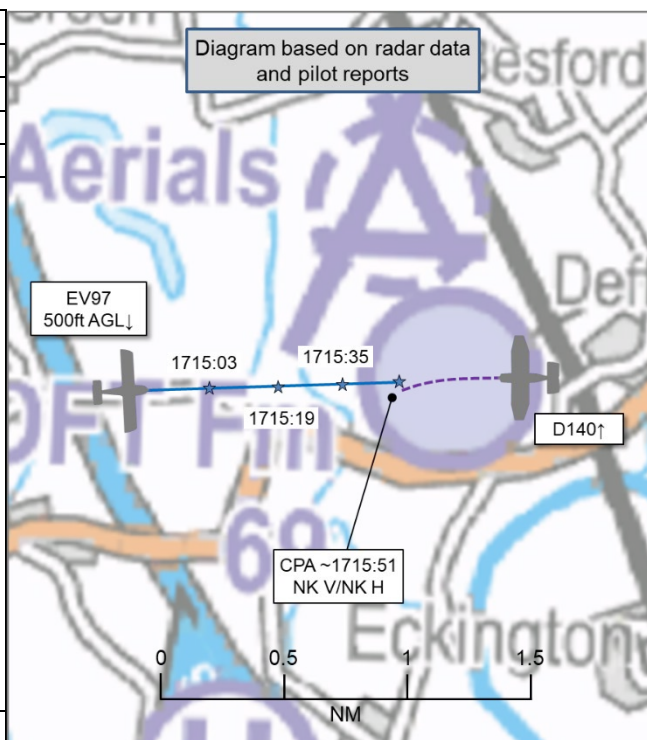
**THE EV97 PILOT** reports that, whilst returning from [...] to [...] at approximately 10 miles east of the field, they made an initial blind transmission on SafetyCom (135.480MHz). The wind was calm and, due to the significant glare from the low setting sun, they elected to join downwind for RW09RH to maintain better visibility and broadcasted their intentions accordingly. While established on the downwind leg, they made a second blind call to confirm their position. Shortly thereafter, they identified an aircraft low in their 2 o'clock position, established on short final for RW09. The EV97 pilot turned and called 'final' at their usual 1.5 miles, maintaining a visual on the aircraft ahead as it touched down. As the EV97 pilot continued the approach, they observed that the aircraft failed to vacate at the only available runway exit. Assuming the pilot's ground roll had simply carried them beyond the exit point, they reduced their speed to allow them time to vacate. However, the aircraft continued to the far eastern end of the runway. At first, the EV97 pilot thought they were going to pull off the runway and clear it [to allow them] to land, but they began a backtrack. Given their relatively high taxi speed, the EV97 pilot assumed the pilot had identified them and was quickly returning to the exit point to clear the runway. Instead, the aircraft accelerated and rotated on RW27, climbing directly toward them in a head-on conflict. The EV97 pilot was about to execute a standard avoiding turn to the right but, before they did, the other aircraft performed a sharp left turn and passed down their starboard side at approximately the same altitude, with a lateral separation of maybe 150m. As the approach and runway were now clear, the EV97 pilot continued to land. No transmissions were heard from the other aircraft on SafetyCom throughout their airfield approach or during the incident. [The EV97 pilot reports that] their [branded EC equipment] did not detect any active signals from the other aircraft. The incident was witnessed by a person mowing the airfield. Post-flight, that person identified the other aircraft as being based at a private strip [to the west of Defford]. The EV97 pilot believes this incident represented a complete disregard for safety and fundamental airmanship. [The EV97 pilot opined that] it was of particular concern that the other pilot chose to depart on RW27 directly into a blindingly low setting sun, which severely compromised their

ability to see conflicting traffic. It is also highly irregular that the pilot elected to depart against the very circuit direction they themselves had just established and utilised for landing. By taking off in the opposite direction to an active approach, without maintaining a listening watch or a visual lookout especially in high-glare conditions, the pilot created an entirely avoidable and high-risk head-on conflict.

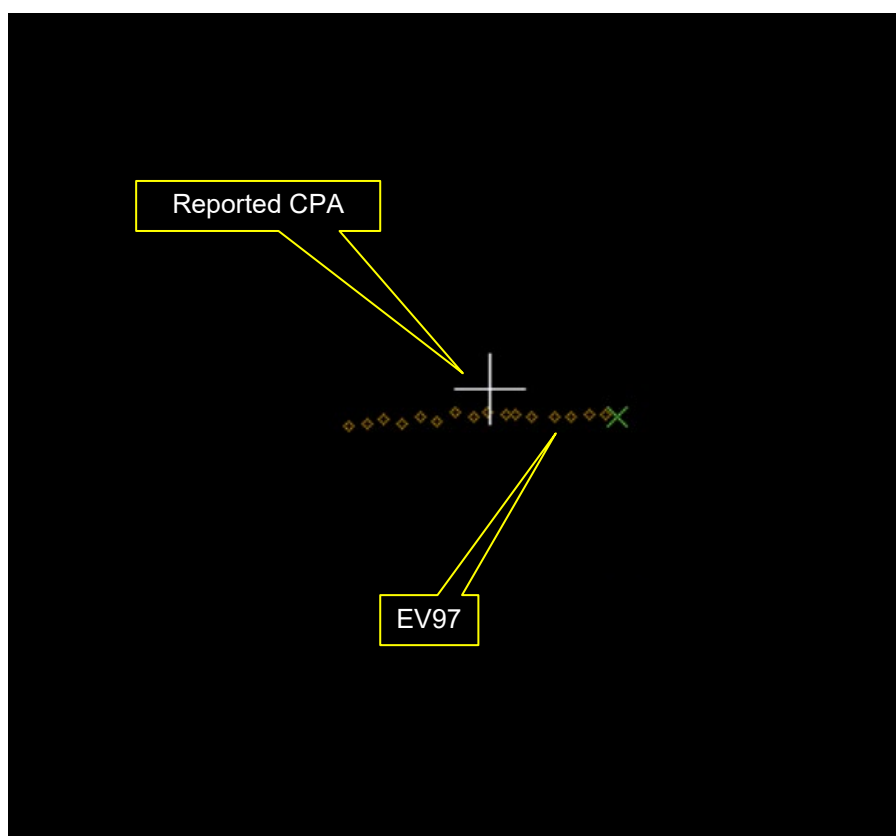
Figure 1: At 1716:23 (~CPA +32sec)

The EV97 was tracked by radar and identified via Mode S data. The D140 did not show on radar. Neither aircraft was displayed on ADS-B/MLAT tracking tools available to the UKAB Secretariat within 3min of CPA.
