**AIRPROX REPORT No 2026056**

Date: 27 Apr 2026 Time: 0951Z Position: 5143N 00135W Location: IVO Brize Norton

**PART A: SUMMARY OF INFORMATION REPORTED TO UKAB**

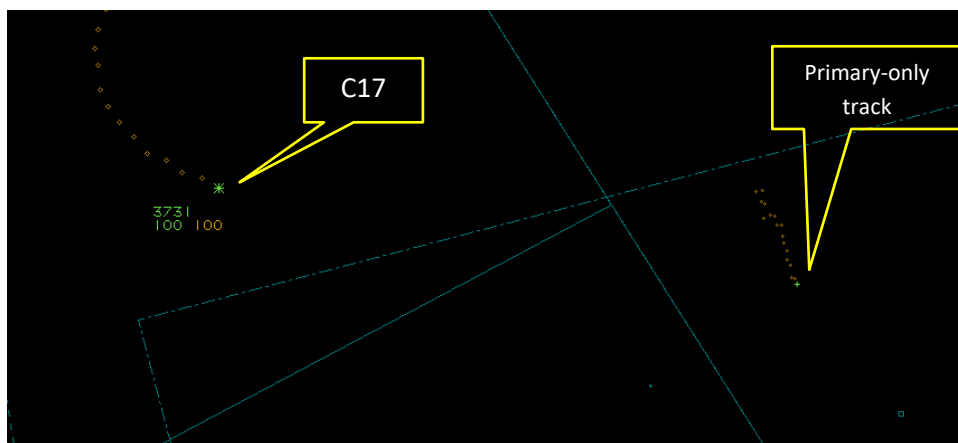
Figure 1 - 0947:52

An analysis of the NATS radar replay was undertaken, the C17 could be seen and identified using Mode S data. A primary-only track could be detected, transiting southbound approximately through the Brize Norton overhead, no height information was available. Further analysis of ADS-B data sources was undertaken, but only the C17 could be seen.

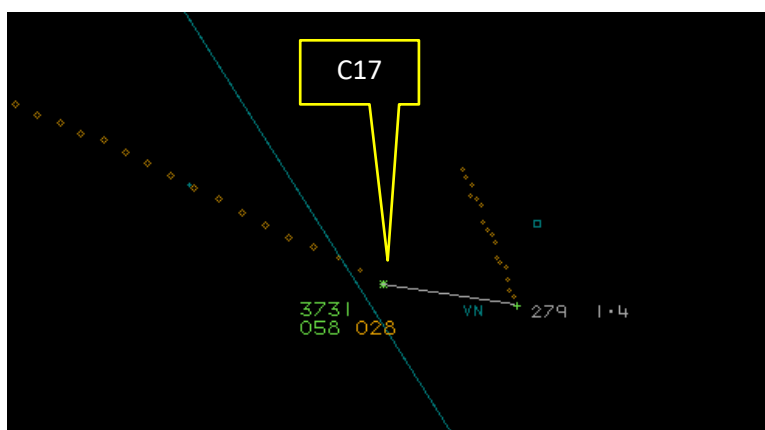
Figure 2 - 0950:11

At 0950:10, the Brize Norton controller passed Traffic Information to the C17 "*intermittent contact 12 o'clock two miles crossing left-to-right slow moving no height information*".

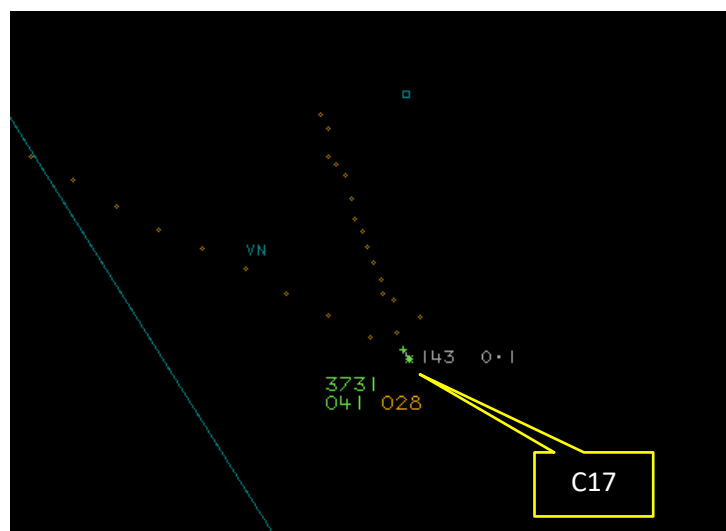
Figure 3 - CPA 0950:41

CPA occurred at 0950:38 with 0.1NM lateral separation. There was no report of the vertical separation.

The C17 could be seen to descend, converging with the unknown aircraft until CPA at 0950:41 (Figure 3). Radar CPA was 0.1NM laterally, but the horizontal CPA was likely to have been between radar sweeps and, because the height of the light aircraft was unknown, vertical separation could not be ascertained.
