**AIRPROX REPORT No 2026062**

Date: 29 Apr 2026 Time: 1435Z Position: 5357N 00028W Location: 2NM S Driffield

**PART A: SUMMARY OF INFORMATION REPORTED TO UKAB**

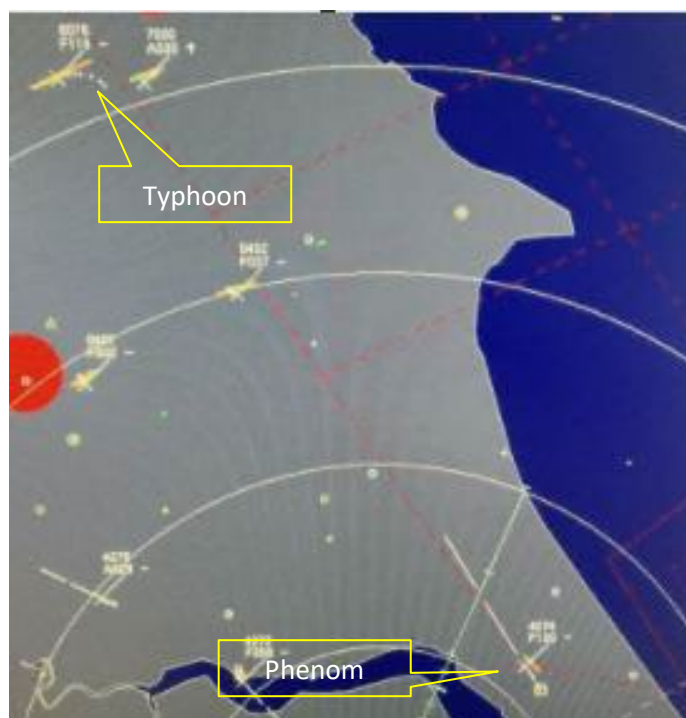
Figure 1 – Humberside radar screenshot

1431:45 [Phenom C/S] (4274) – 6.5NM NW of OTR on a NW track. [Typhoon C/S] (6076) – 35NM NW of OTR on a reciprocal track. The aircraft were approximately 27NM apart from each other.

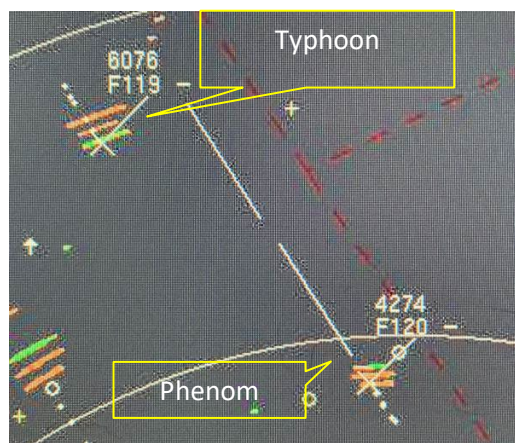
Figure 2

1433:40 [Typhoon C/S] and [Phenom C/S] were steady on reciprocal tracks approximately 10NM apart and approximately 1NM laterally separated. Mode 'C' FL119/FL120.

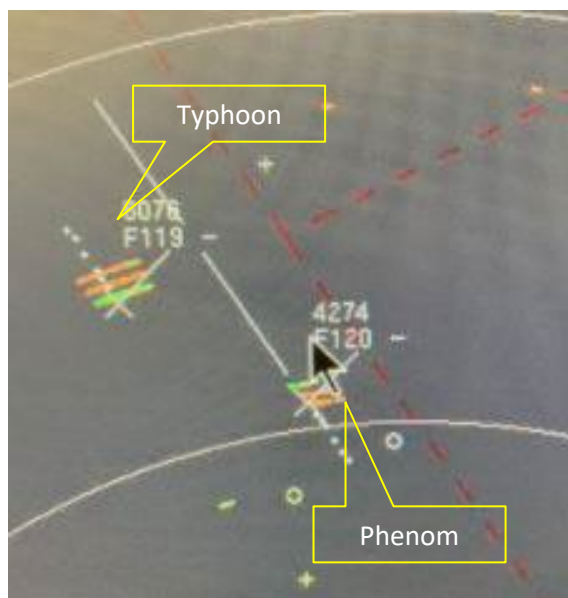
Figure 3

1434:10 Both conflicting aircraft were now approximately 5NM apart and approximately 2NM laterally separated. Mode 'C' indicated FL119/FL120.

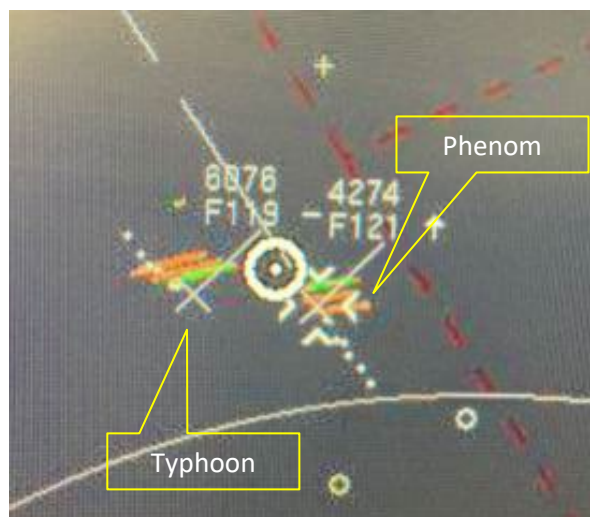
Figure 4

1434:30 The controller's mouse toggled [Phenom C/S], the Typhoon turned left towards [Phenom C/S] and passed underneath.

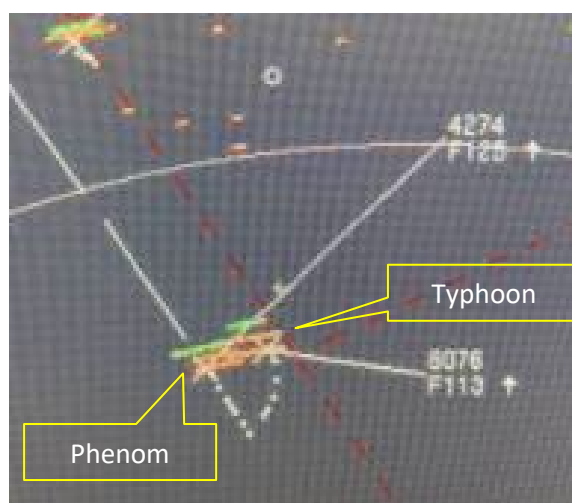
Figure 5

1435:11 "[Phenom C/S], *got the traffic in sight, co-level, same track, approximately, 1...3NM on my right.*"

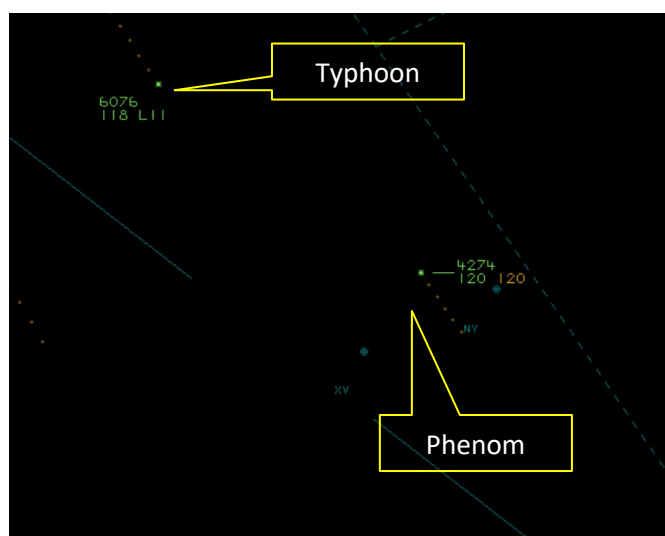
Figure 6 – 1433:55

An analysis of the NATS radar replay was undertaken, and both aircraft could be seen and identified using Mode S data, see Figure 6, with the Typhoon routeing southbound at FL118 and the Phenom northbound at FL120.

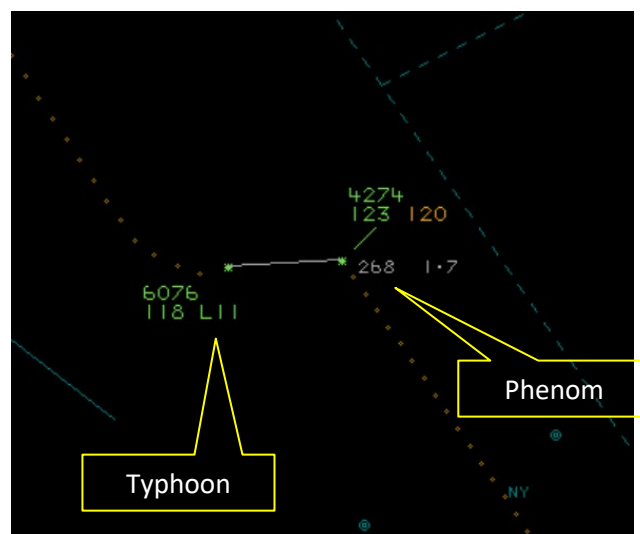
Figure 7 – 1434:30

The two aircraft continued on their respective headings until, at 1434:30, the Typhoon started to turn onto an easterly heading, towards the Phenom (Figure 7).

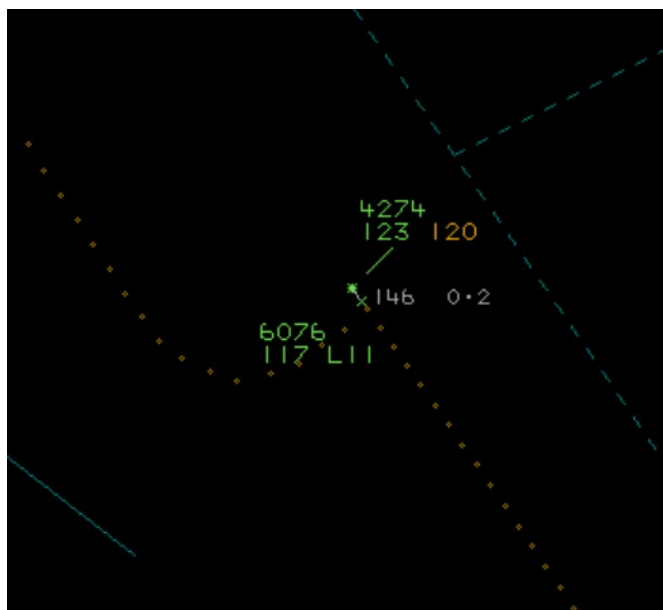
Figure 8 - Radar CPA 1434:46

Radar CPA occurred at 1434:46 with radar separation indicating 0.2NM and 600ft, although actual CPA was likely to have been between radar sweeps, therefore the separation was assessed to be less than 0.2NM.

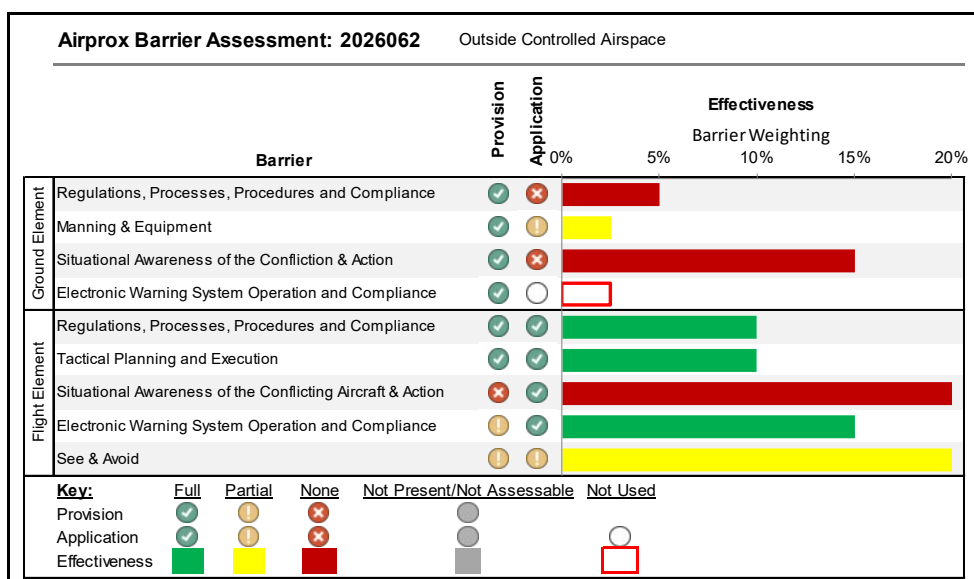
**Situational Awareness of the Conflicting Aircraft and Action** were assessed as **ineffective** because the Typhoon pilot had not received any prior situational awareness on the other aircraft.

**See and Avoid** were assessed as **partially effective** because the Typhoon pilot had not seen the Phenom until a late stage and the Phenom pilot, although initially visual with the Typhoon, had not considered it a threat until it turned towards them, resulting in the necessity of late avoiding action.
