**AIRPROX REPORT No 2026069**

Date: 09 May 2026 Time: 1308Z Position: 5144N 00007E Location: IVO North Weald

**PART A: SUMMARY OF INFORMATION REPORTED TO UKAB**

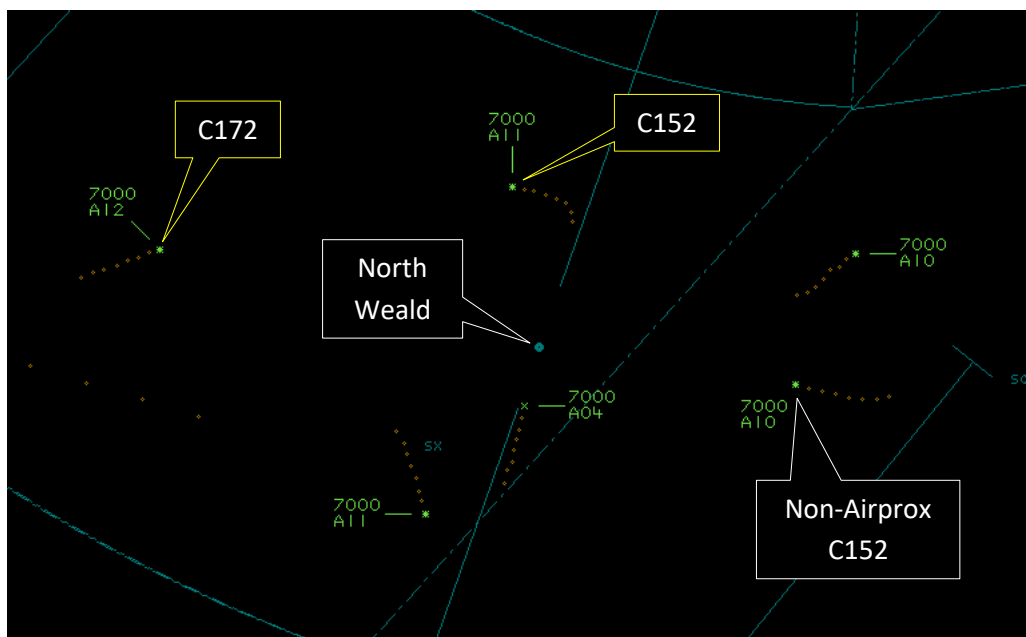
Figure 1 – Aircraft positions at 1307:04

An analysis of the NATS radar replay was undertaken and both aircraft could be positively identified from Mode S data (Figure 1). The C152, but not the C172, was observed by reference to ADS-B data sources. The pilot of the C172 kindly supplied GPS track data for their flight. The diagram was constructed and the separation at CPA determined by combining the data sources.

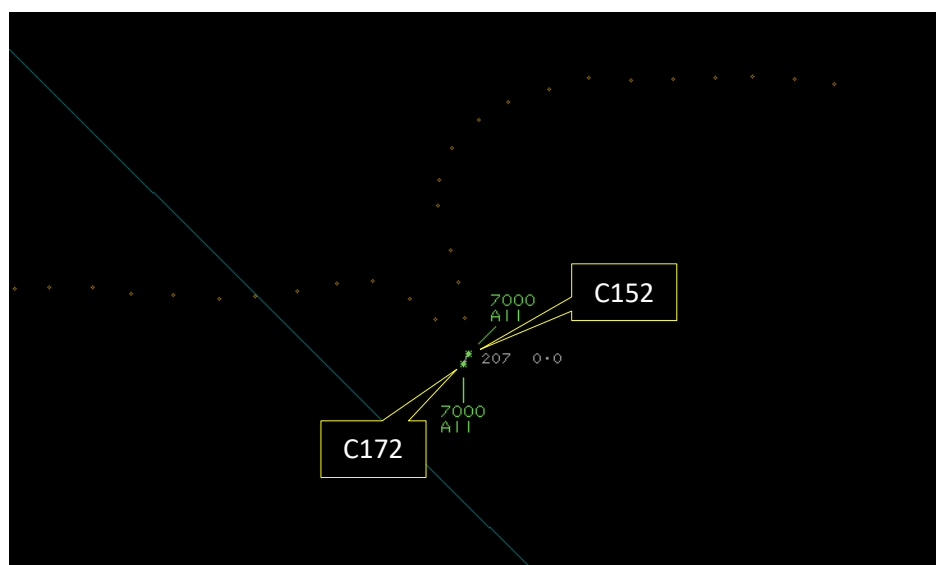
Figure 2 – CPA at 1308:14

Concluding their discussion, member's thoughts turned to the matter of the risk of collision. Although both pilots had had generic situational awareness of the presence of the other aircraft, the pilot of the C152 had not sighted the C172 in time to have taken any avoiding action, and the pilot of the C172 had sighted the C152 late. It was agreed that the C172 pilot had taken urgent avoiding action to have increased the separation at the last minute, and members agreed that safety margins had been reduced much below the norm. The Board concluded that there had been a risk of collision (**CF6**) and assigned Risk Category B to this event.

*The North Weald aerodrome operator considers additional mitigations to mid-air collision for aircraft joining the visual circuit.*

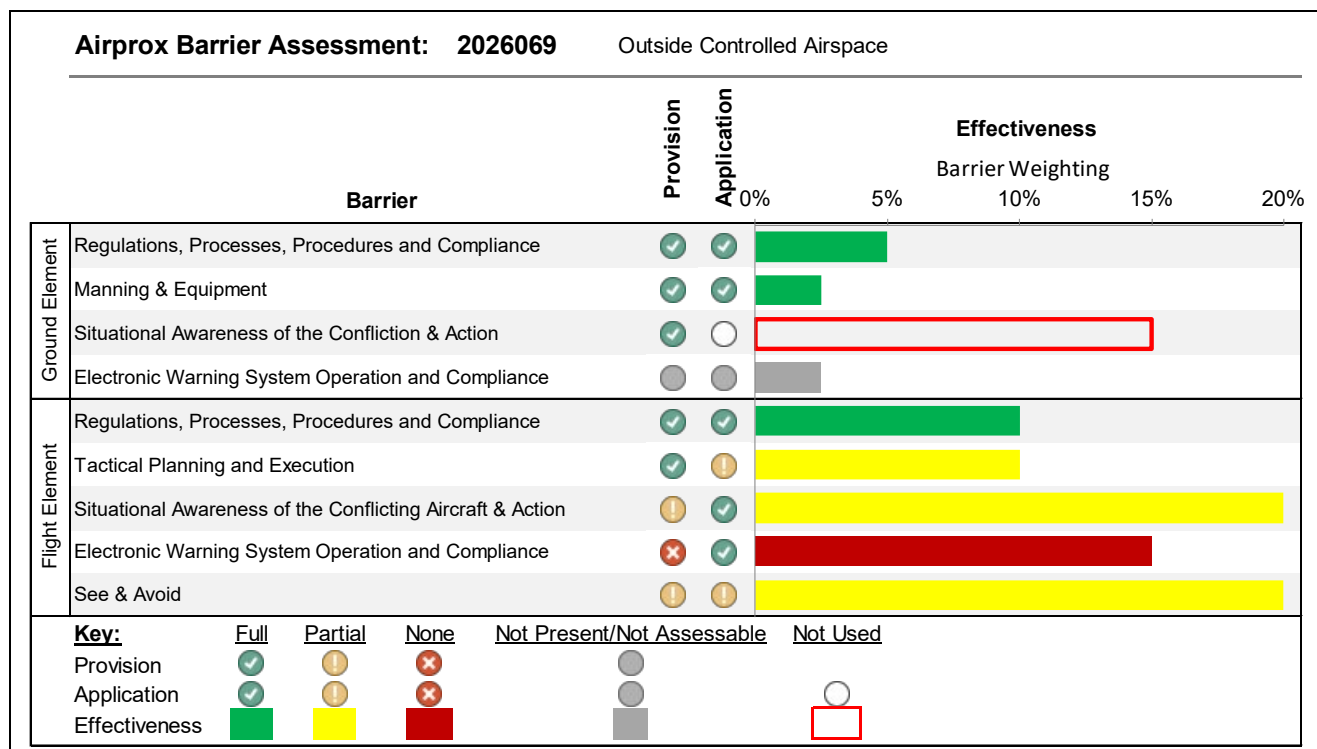
In assessing the effectiveness of the safety barriers associated with this incident, the Board concluded that the key factors had been that:

**Situational Awareness of the Confliction and Action** were assessed as **not used** because the North Weald AGO had not been permitted to have sequenced the traffic in the circuit.

**Tactical Planning and Execution** was assessed as **partially effective** because the pilot of the C172 had not conformed with, nor effectively avoided, the pattern of traffic in the circuit.

**Situational Awareness of the Conflicting Aircraft and Action** were assessed as **partially effective** because both pilots had only generic situational awareness of the presence of the other aircraft.

**Electronic Warning System Operation and Compliance** were assessed as **ineffective** because the EC device fitted to the C152 would not have been expected to have detected the C172.

**See and Avoid** were assessed as **partially effective** because the pilot of the C172 had sighted the C152 late. The pilot of the C152 had not sighted the C172 until the moment of CPA.
