**AIRPROX REPORT No 2026070**

Date: 01 May 2026 Time: 1554Z Position: 5143N 00053W Location: Bledlow

**PART A: SUMMARY OF INFORMATION REPORTED TO UKAB**

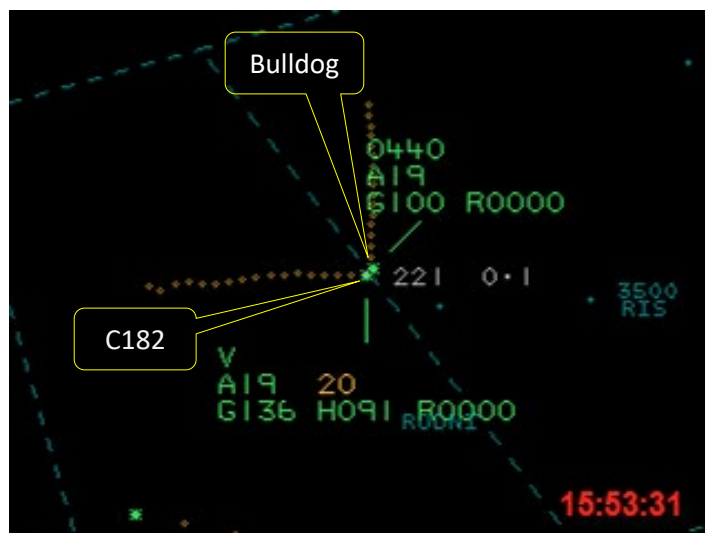
Figure 1

The closest point of approach between [the Bulldog] (squawk 0440) and the other aircraft (squawk 7000, displayed as V) occurred at 1553:31 measured on the Multi-Track Radar as 0.1NM and 0ft. This interaction was within Class G airspace and there were, therefore, no separation requirements. (Figure 1).

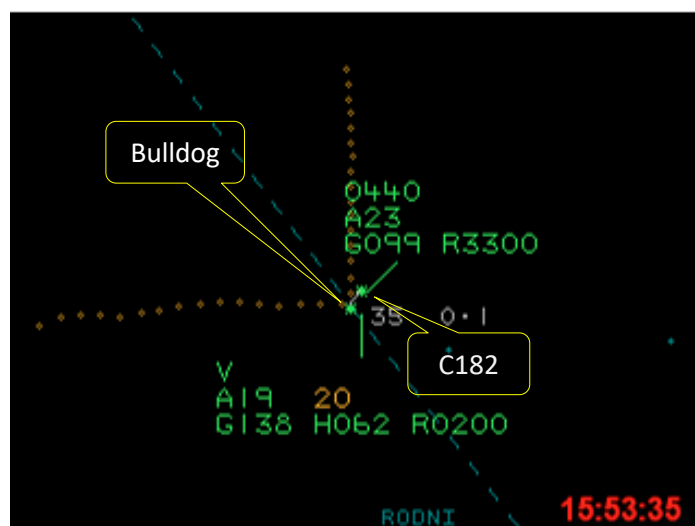
Figure 2

[The pilot of the Bulldog] initiated a climb, such that one radar update later, at 1553:35, there was a 400ft vertical separation between the two aircraft (Figure 2).

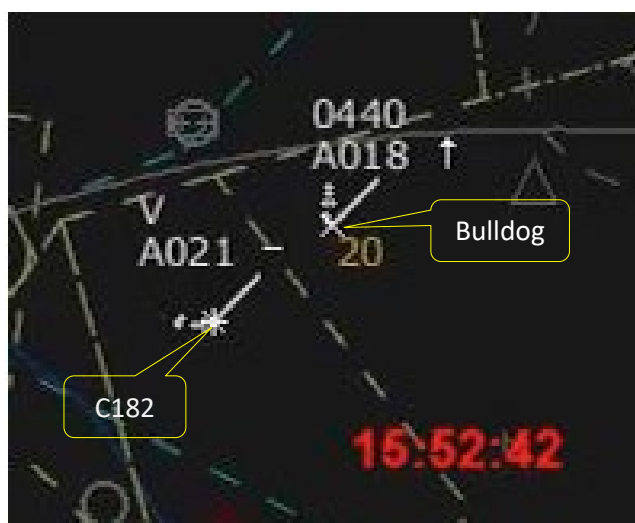
Figure 3

At the time of this change, there was 300ft vertical separation between [The Bulldog] (0440) and the VFR aircraft (V). (Figure 3).

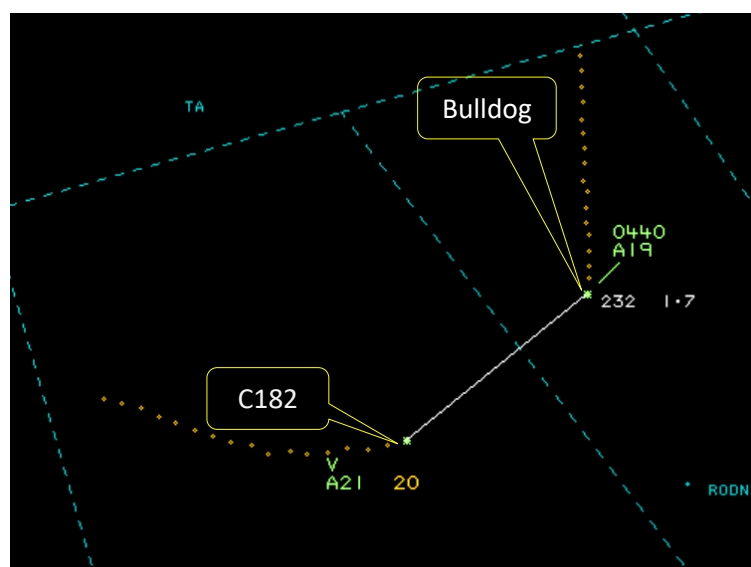
The C182 was seen to be heading approximately east at an altitude of 2000ft with occasional, minor, changes to their altitude. The Bulldog was initially seen at 1600ft in a gentle 300ft/min climb to 1900ft, 200ft below the level of the C182 which had made a brief 100ft height gain from the 2000ft baseline altitude to 2100ft at 1552:59 (Figure 4).

Figure 4 – Time 1552:59 C182 above the Bulldog.

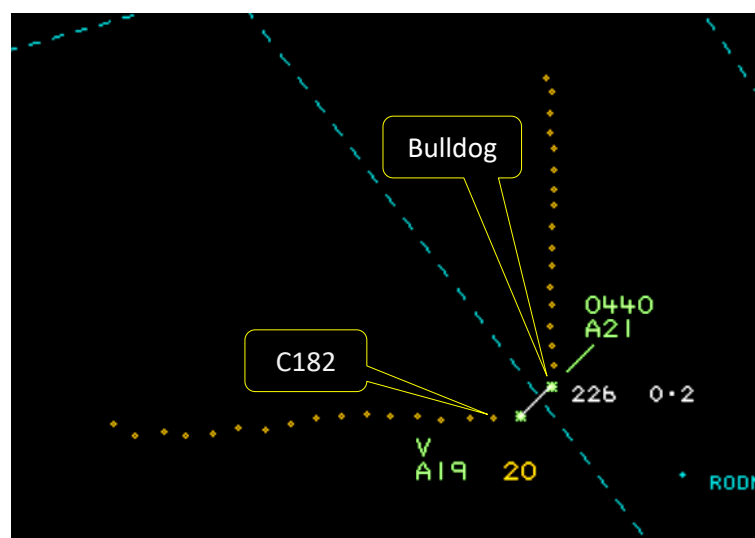
A further 200ft climb was recorded for the Bulldog 4sec before CPA, at 1553:31, as the Bulldog climbed above the level of the C182 which had registered a brief 100ft height loss below its 2000ft baseline to 1900ft, with 0.2NM lateral separation (Figure 5).

Figure 5 – Time 1553:31 C182 below the Bulldog

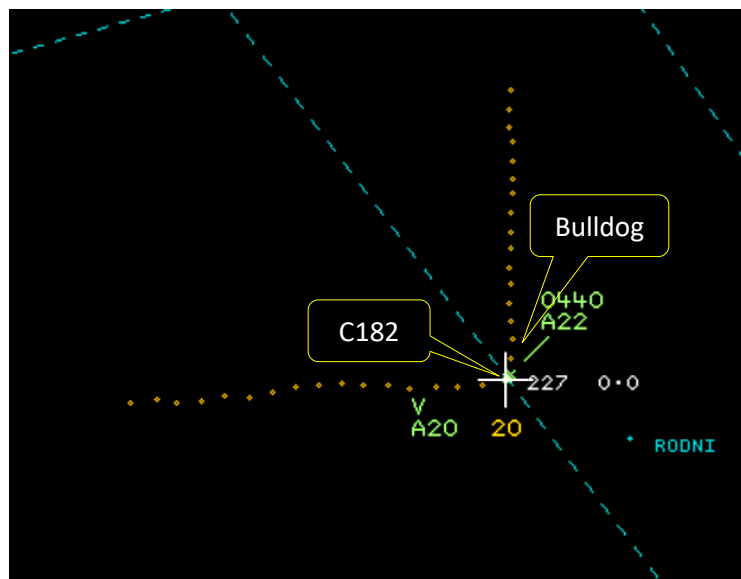
Both aircraft increased their altitude by CPA. The C182 returned to its baseline altitude of 2000ft, and the Bulldog had continued its climb to 2200ft. CPA was assessed to have occurred at 1553:35 with 200ft vertical and less than 0.1NM lateral separation (Figure 6).

Figure 6 – Time 1553:35 CPA
