**AIRPROX REPORT No 2026079**

Date: 24 May 2026 Time: 1034Z Position: 5202N 00037W Location: 2.2NM S of Cranfield Airport

**PART A: SUMMARY OF INFORMATION REPORTED TO UKAB**

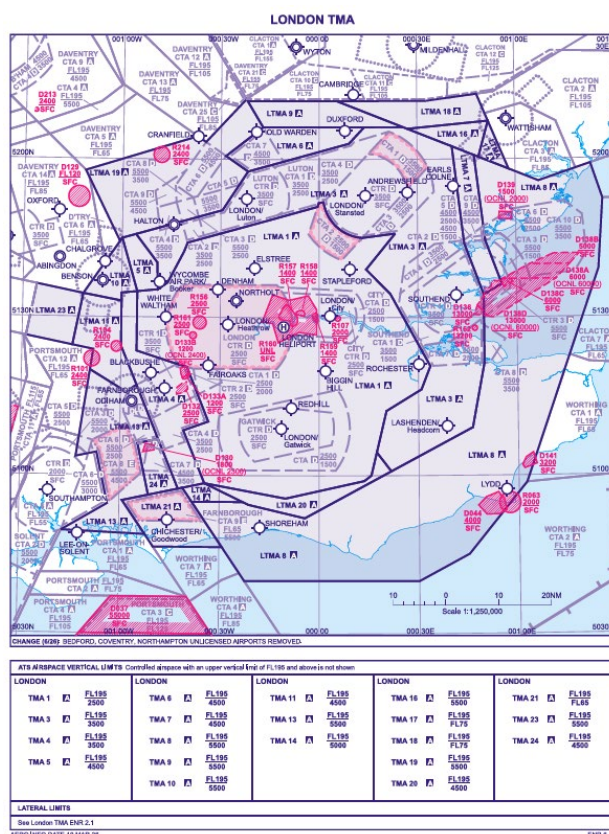
Figure 1

The London TMA base in the vicinity of Cranfield is notified as 5500ft in LTMA 9 and 19:

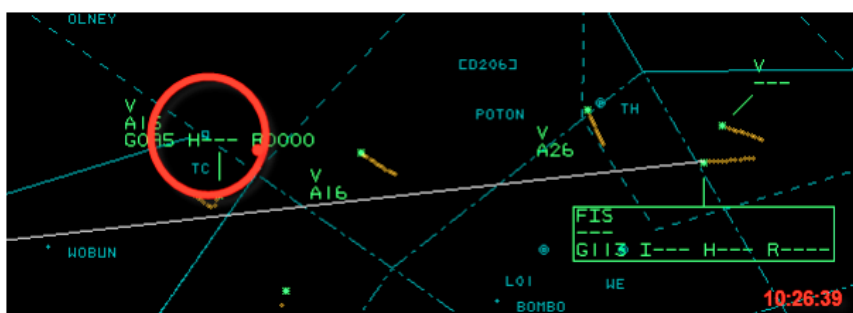
Figure 2

The pilot-reported routeing suggested that it would track to the south of Cranfield ATZ where the UK AIP stipulated radius was 2NM and up to altitude 2360ft. Therefore, the pilot reported altitude would also ensure that the [C182] would remain outside the ATZ (Figure 2).

Note: From departure from [departure airfield], [the C182 transponder's] Mode-C was not displayed.

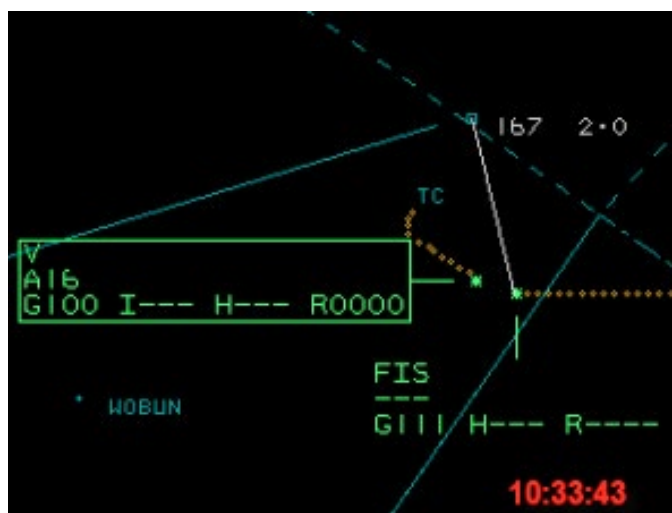
Figure 3

[The PA28] reappeared on radar at 1033:01 climbing through altitude 1300ft for 1600ft and turned towards the approaching [C182] that was maintaining their lateral track. The NODE Radar range and bearing tool suggested [that the C182] remained outside the lateral boundary of the Cranfield ATZ (Radius 2NM) (Figure 3).

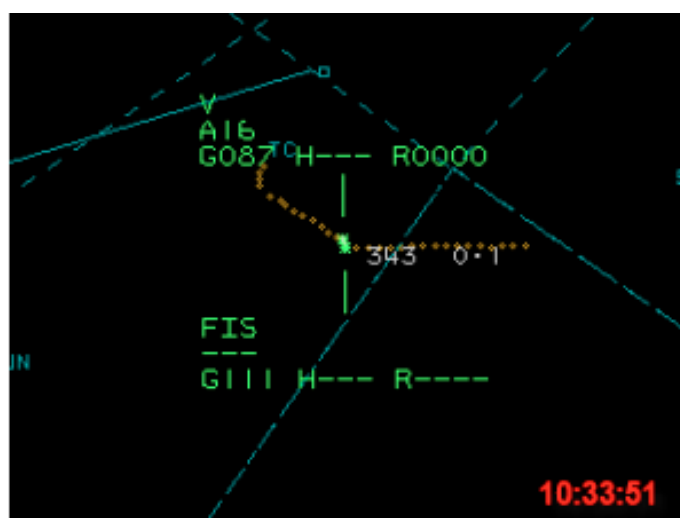
Figure 4

The subsequent closest point of approach occurred at 1033:51 and was recorded on NODE Multi-Track Radar as 0.1NM with no Mode-C data for [the C182] available (Figure 4).

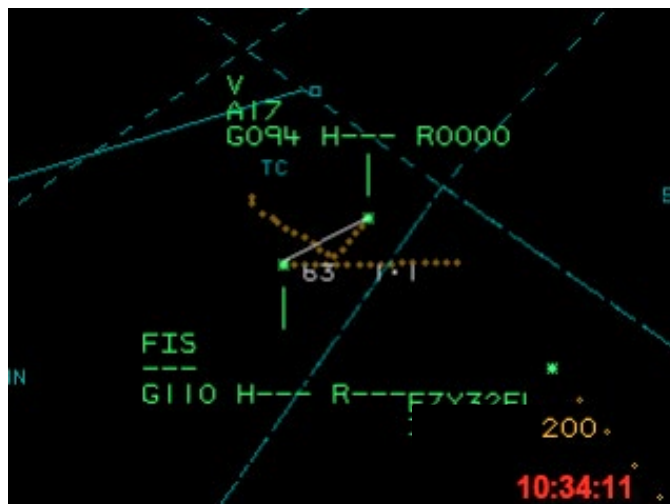
Figure 5

Radar data suggested that the pilot of [the PA28] enacted a significant lateral avoidance manoeuvre to resolve the confliction (Figure 5).

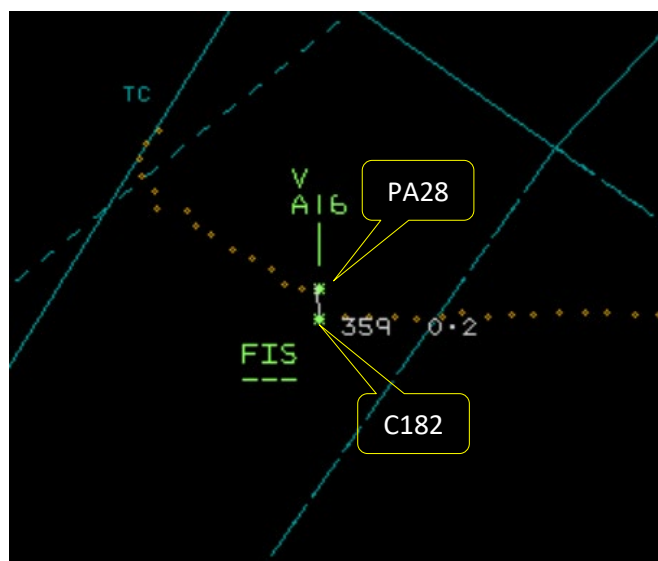
Figure 5 – CPA Time 1033:54

The NATS radar replay, CAA Airspace Analyser and other third-party tracking software were reviewed. Both aircraft were identified through Mode S data (Figure 5), but neither aircraft was observed by reference to ADS-B data sources.

Both the PA28 and C182 pilots provided their GPS navigation track and altitude data, and CPA was assessed, from the GPS data available to the UKAB Secretariat, to have occurred at 1033:54 with 0.2NM lateral and 900ft vertical separation.
