**AIRPROX REPORT No 2026081**

Date: 25 May 2026 Time: 0912Z Position: 5203N 00113W Location: Farthinghoe

**PART A: SUMMARY OF INFORMATION REPORTED TO UKAB**

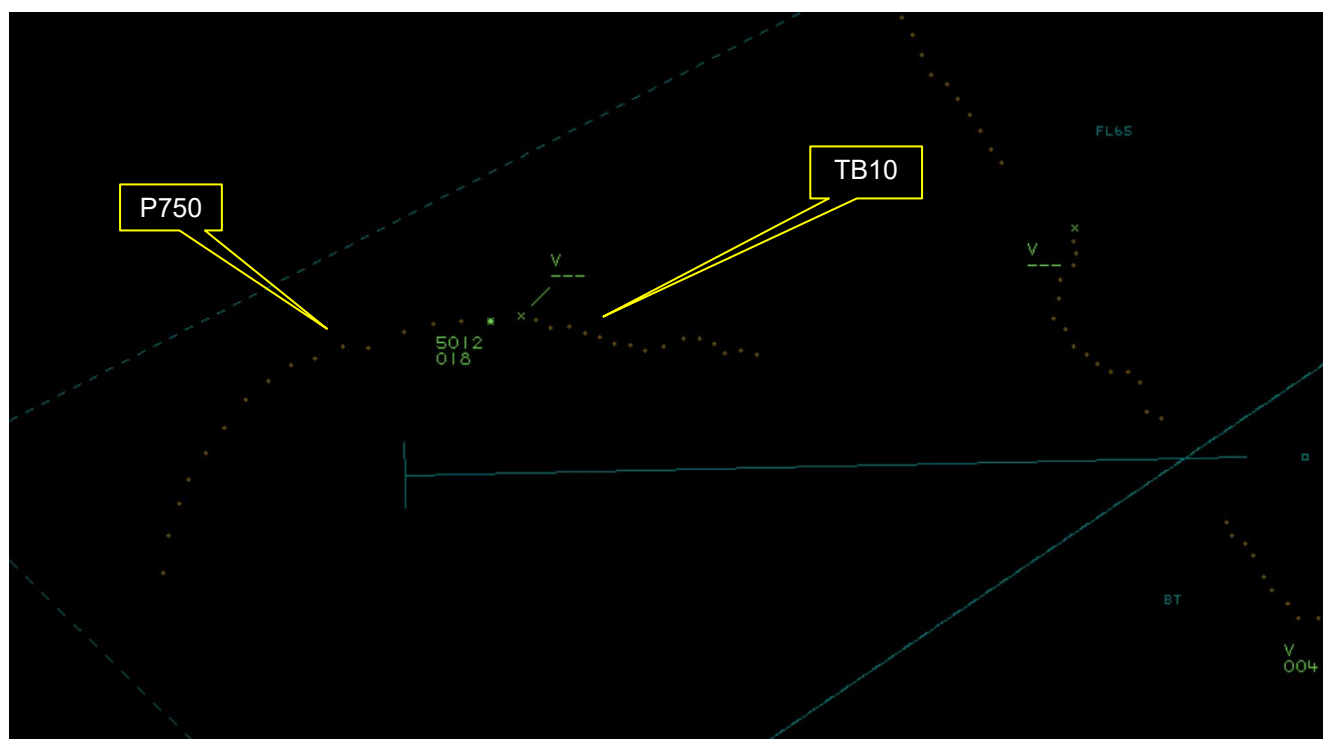
Figure 1: At CPA minus 3sec (0911:42)

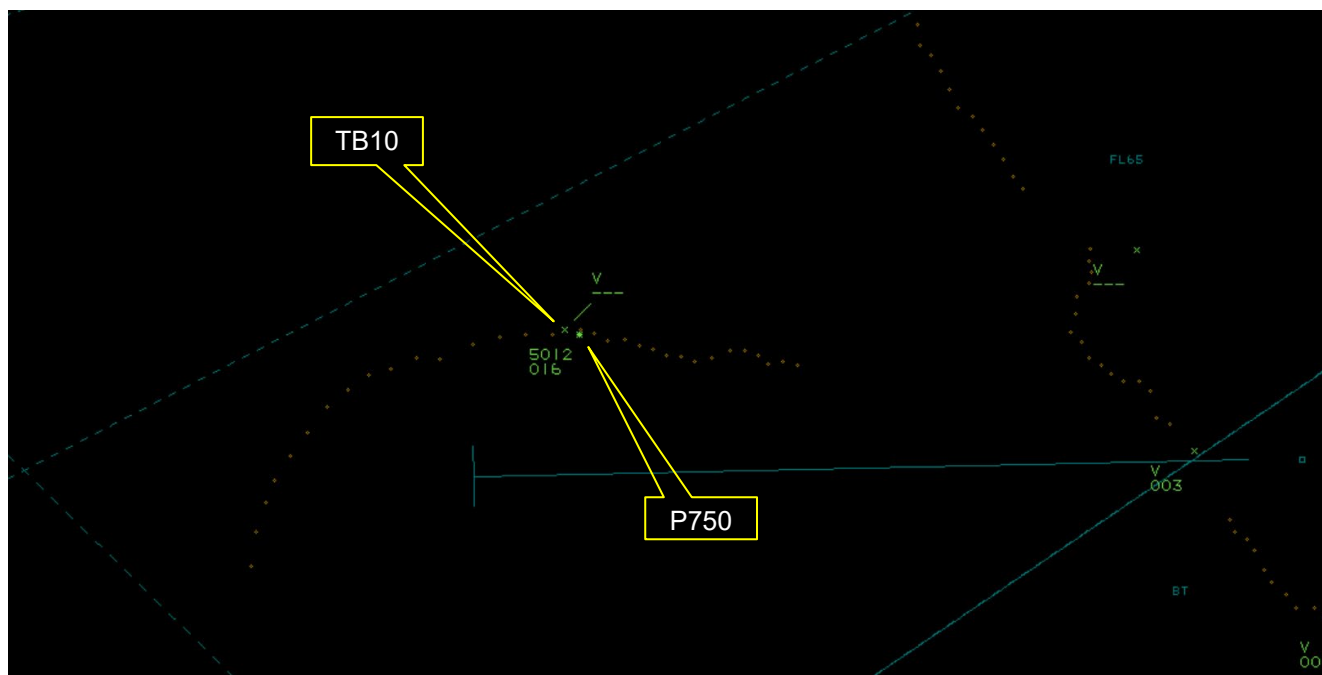
Figure 2: At CPA + 1sec (0911:46) the TB10 is 0.9NM north of the Turweston centreline.
