UK AIRPROX BOARD

Book Number 15

**Airprox in UK Airspace
Involving General Aviation Pilots**

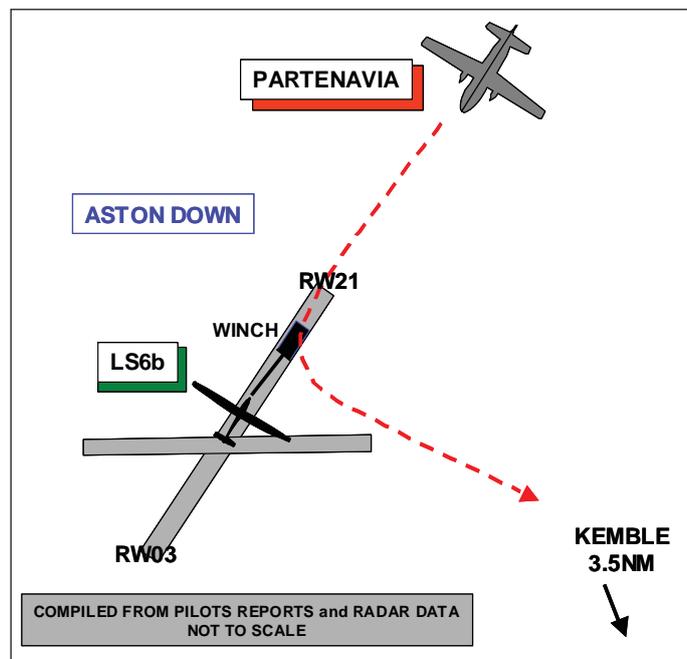
AIRPROX REPORT No 052/07

THE LS6 GLIDER PILOT reports that he was launching by winch at 70kt to 1500ft agl in a white single seat glider from the S end of RW03 at Aston Down Airfield. The launch crew reported the sky clear above and behind and he saw nothing airborne ahead. The glider was approaching 1000ft agl in the normal winch launching attitude (nose up 45°) when observers on the ground noticed an oncoming twin-engined ac one mile away on the reciprocal course of 210° lined up on the RW, estimated (by the observers) to be at approximately 4-500ft agl. As the oncoming ac reached the threshold of RW21 it banked hard to the L above the winch and left the airfield in the direction of Kemble at the same height.

At that point he noted a glider about 300ft above and climbing. He also noted a winch wire (trailing from below the glider) and realised that he was approaching the wrong field so he executed a steep left turn to avoid going underneath the glider. He then called Kemble Radio and told them he had approached the wrong airfield and about one minute later they advised him that Aston Gliding had called them and so he asked them to apologise on his behalf.

Cause: The Partenavia pilot entered a promulgated and active glider site and flew into conflict with the glider on a winch launch.

Efforts need to be made to bring to the attention of the GA community the great danger inherent in overlying a winch launch site below the advertised cable launch height.

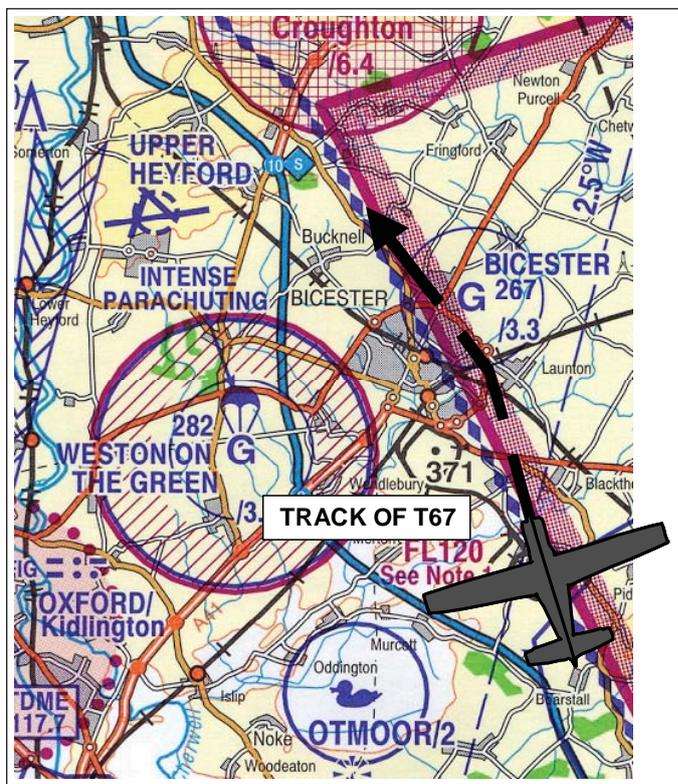
AIRPROX REPORT No 081/07

THE ASK 13 GLIDER PILOT reports that during a normal local training flight he was teaching thermalling technique while soaring with another glider. He was climbing through 1200ft at 45kt in a thermal with the other glider 100ft below him on the opposite side of the thermal circle so he was maintaining a good lookout with respect to it. He then noticed a landing light about 200m away on his right side, at the same level and approaching rapidly. He took control from his student, dived the glider and rolled his wings level to get out of the way and the ac passed just to their side, 50ft above them. He noticed that it was yellow with a blue spinner and was a Slingsby T67, possibly with a blue underside. The T67 maintained straight and level flight, heading approximately 270° at about 1200ft AGL. The ac then flew directly overhead Bicester airfield where winch launching up to a height of approx 1400ft AGL. He assessed the risk as being very high.

Cause: The T67 pilot flew through a notified and active glider launch site and into conflict with a glider which he did not see.

Recommendation: The CAA should review the depiction of glider launch sites on VFR charts with a view to making them more conspicuous.

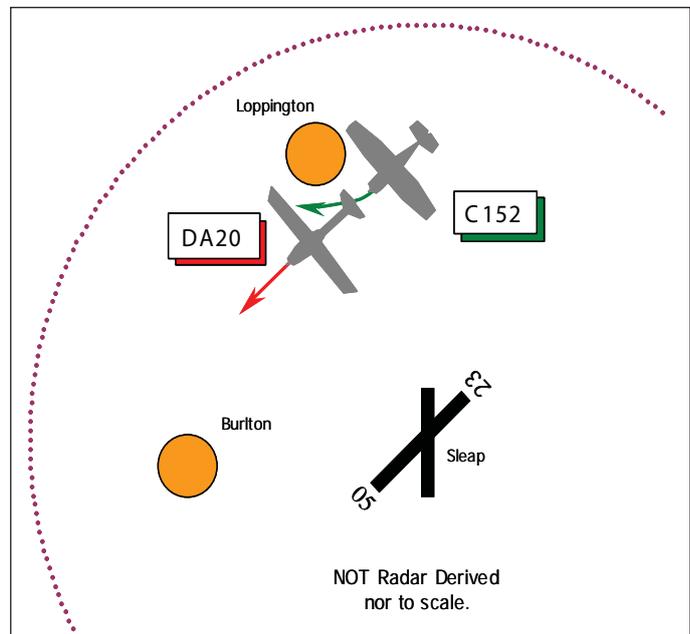
THE C152 PILOT reports that his ac has a red/white colour scheme and the HISLs were on whilst flying in the LH circuit for RW05 at Sleep. Flying in VMC some 1000ft clear below cloud with an in flight visibility of 6-7km in haze, he was in communication with Sleep RADIO A/G Station on 122.45MHz. Whilst on the LH DOWNWIND leg heading 230° (M) level at the circuit height of 1000ft QFE (1028mb) at 90kt, another pilot was heard on RT reporting DOWNWIND. A DA20 was then seen passing some 20ft above his C152 about 100ft away on the same heading. He altered course to give clearance on the DA20 and radioed its pilot to warn of the proximity of his own aeroplane. The DA20 pilot replied that his C152 had not been seen beforehand. He assessed the risk as "high".

Cause: The DA20 instructor did not integrate into the circuit correctly and descended into conflict with the C152 which was not seen.

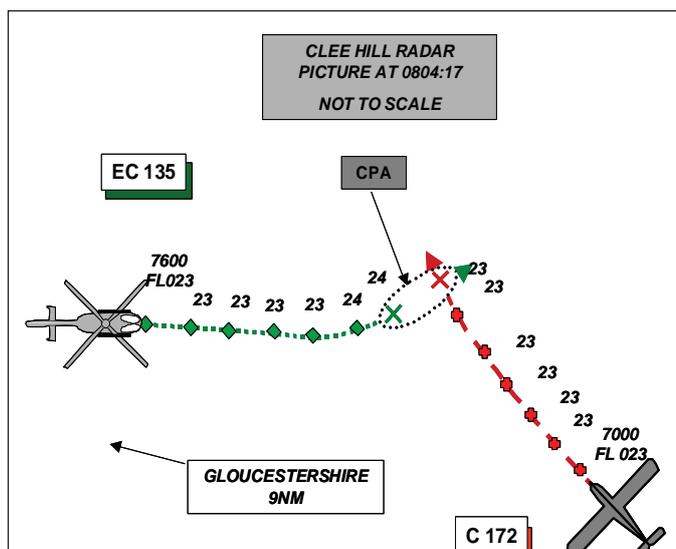
THE EC135 PILOT reports flying a training flight with a trainee pilot in the RHS on a local flight from Gloucestershire, in receipt of an APP service from them and squawking 7000 with Mode C. His trainee was the HP and they were flying level at altitude 2300ft and had been heading 080° at 100kt but had just commenced the base turn pilot for NDB/DME approach to RW27. Part way through the turn he saw what he thought to be a Cessna 172 about 500m ahead of his ac level on a NW track. The Cessna was flying in and out of cloud, as were they, the cloud structure being about 6/8 with a base of 2000ft with the tops at about 4000ft. He took control from the trainee and stopped the left turn in order to pass safely behind the Cessna. He assessed the risk as being very high.

Cause: A conflict in Class G Airspace resolved by the EC135 instructor.

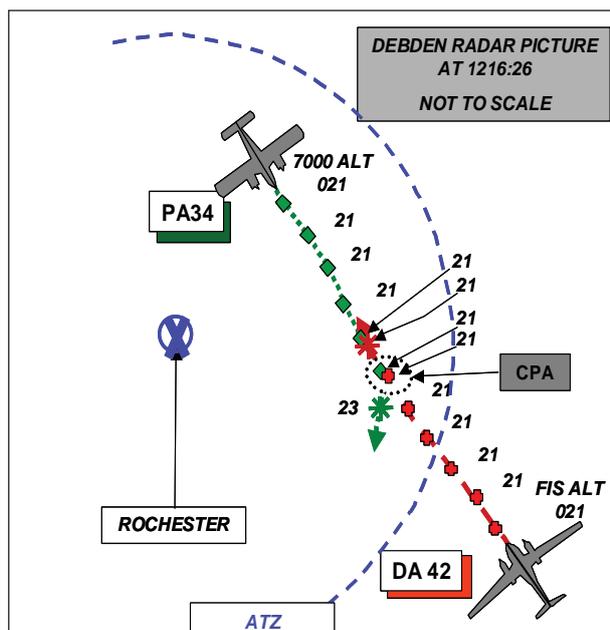
AIRPROX REPORT No 158/07

THE PA34 PILOT reports flying a red and white ac with strobes and landing lights selected on squawking 7000 with Mode C but with no TCAS fitted, on a private VFR flight from Elstree to Lydd, routeing via Rochester.

Cause: Late sightings by both pilots.

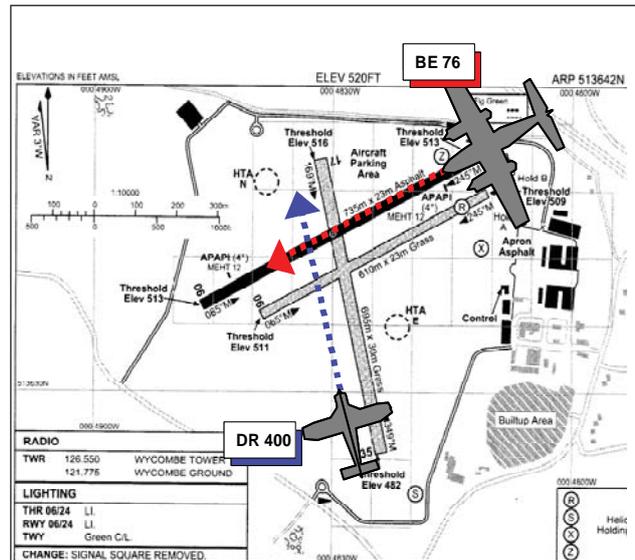
THE BE76 PILOT reports flying a blue and white ac with all lights switched on on a private IFR flight to Deauville. He was squawking 5532 with Mode C and S and was in contact with Wycombe Tower who had cleared him for take off on RW24. The wind was Northerly and the active RW for the separation of ac and gliders was RW35. He had been given notice of a glider high in the 1 o'clock of his take off track and had it in sight. The take-off roll was normal and the rotate speed of 71kt IAS was reached after about 250m [150m before the RW intersection]. After a final check of the glider and his instruments he was about to initiate rotate when a blue and white glider tug [without a glider] entered his peripheral vision 100 to 200m away and slightly to port [on RW35]. It was rotating so he deferred his rotation and as their tracks intersected the Robin crossed above him by about 30ft. He rotated at 85kts and continued to take off normally.

Cause: The DR400 pilot took off from the wrong part of the aerodrome, without ATC clearance, and flew into conflict with the BE76.

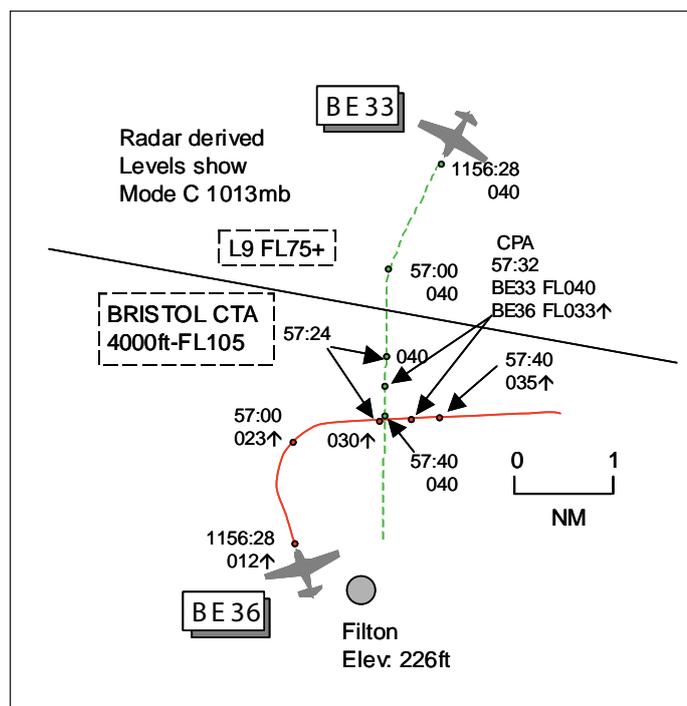
THE BRISTOL INTERNATIONAL RAD1 reports acting as an OJTI to a trainee who was working a BE33 transiting the base of CAS at altitude 4000ft. Filton had coordinated a departure routeing towards CPT VOR at altitude 3000ft which was observed departing RW27. The SSR labels merged and on separation the Filton ac was seen to be at 3700ft. No avoiding action or TI was passed as the targets had already passed each other and separation was increasing.

Cause: Following an undetected read back error, an undetected assigned altitude report and an undetected Mode C readout, Filton ATC allowed the BE36 pilot to climb into conflict with the BE33.

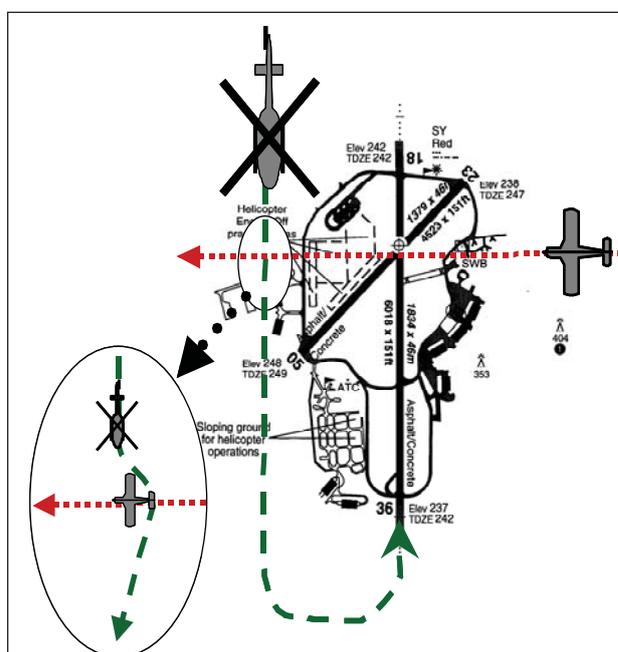
THE GRIFFIN HT1 PILOT reports flying a black and yellow ac with all lights switched on, on a training flight from Shawbury. They were heading 180° at 90kt and, while established on the downwind leg of a standard LH circuit, in communication with Shawbury TWR on UHF, but were maintaining 950ft QFE due to the proximity of small amount of cloud when the student who was the handling pilot (HP), saw a small fixed wing ac about 75m ahead of them, crossing from L to R; the HP rolled left and descended immediately to avoid the ac. After returning to the normal downwind position the HP contacted Shawbury TWR to inform them that the ac believed to be a MATZ crosser was at approx 950ft on the QFE; an earlier RT call stated that the ac was at 1300ft QFE. The HP reported the incident on the RT and spoke to the Shawbury SUP on the ground after landing and established that the ac had been handed over to Shawbury TWR and had descended below 1300ft QFE but the information was not passed or heard on UHF. He assessed the risk as being Medium.

Cause: A lack of TI and positive control by the Shawbury ADC resulted in a conflict in the visual circuit, which was resolved by the Griffin pilot.

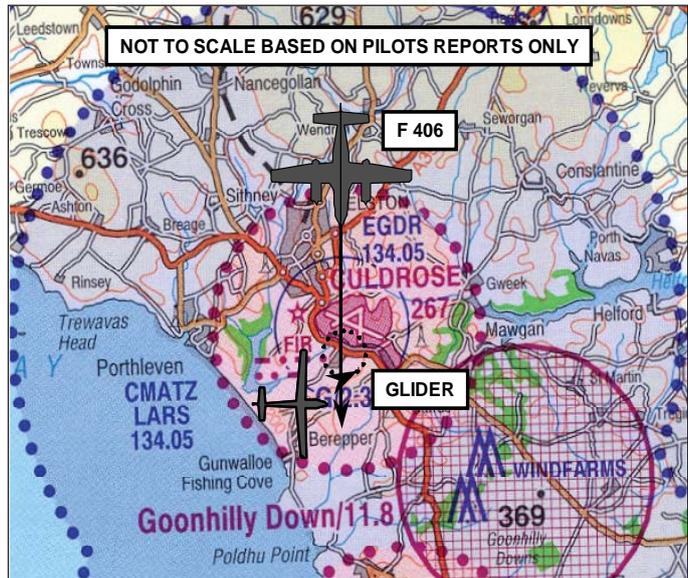
THE CAPSTAN GLIDER PILOT reports that at the time of the incident they were launching gliders at frequent intervals using a cable and auto-tow method, the launches reaching between 1000 and 1300ft but they could potentially have been a little higher depending on the wind strength and direction. He was P1 in a short training flight and was circling in thermal at 40kt and at about 1000ft, over the airfield, about 300ft S of the main RW (12) from which they were launching when he saw a twin-engine ac when it was abeam him to the N about 100ft above and displaced by 300ft horizontally. The ac was on a constant heading and by then was no longer posing a significant threat; he was not able to read the registration. Neither ac took any avoiding action and he assessed the risk as being Medium.

Cause: The F406 pilot entered the Culdrose ATZ without permission and flew into conflict with a glider which he did not see.

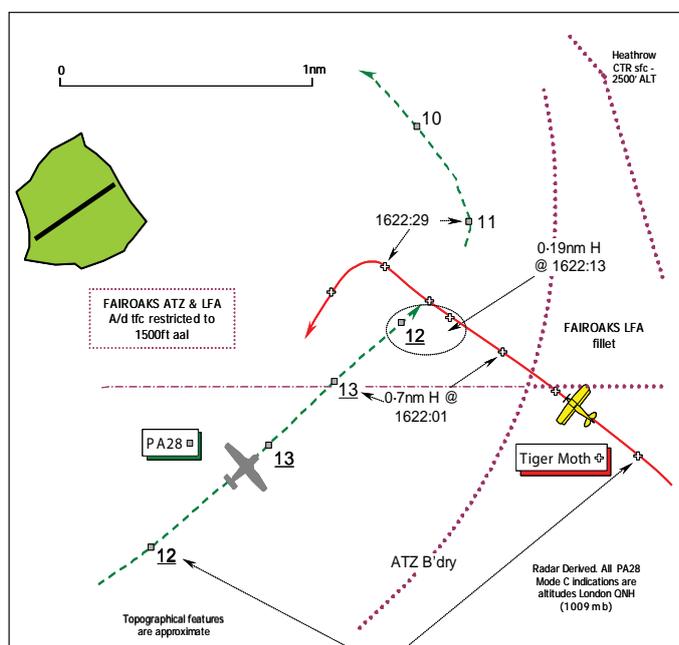
AIRPROX REPORT No 104/07

THE PA28 PILOT, a flying instructor, reports that he was flying in the LH cct pattern to RW24 at Fairoaks Aerodrome and was in receipt of a FIS from Fairoaks INFORMATION on 123.425MHz. A squawk of A7000 was selected with Mode C on.

Cause: The Tiger Moth pilot entered the Fair Oaks ATZ in contravention of Rule 45 of the Rules of the Air Regulations 2007 and flew into conflict with the PA28.

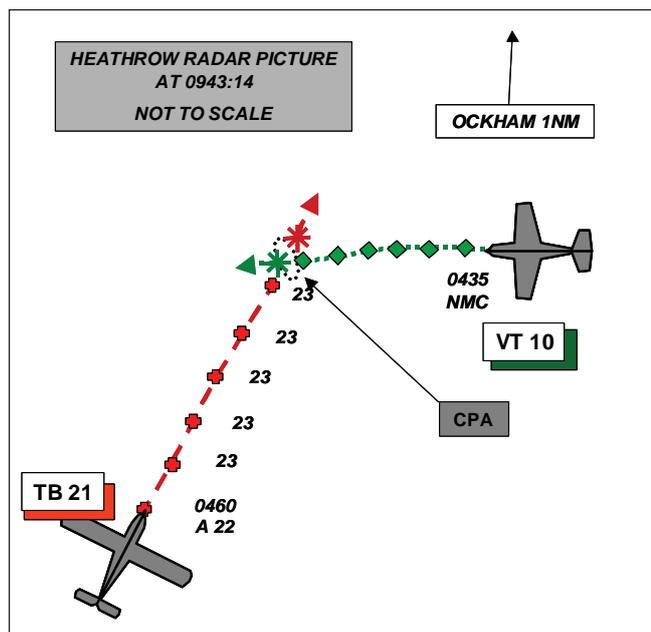
THE VICTA AIRTOURER (VT10) PILOT reports flying a red and white ac with the red beacon switched on, on a private flight from Rochester to Compton Abbas. SSR was fitted but with no Mode C. After leaving Rochester to the W he contacted Biggin Hill for a FIS and he passed Biggin Hill to the S along the M25 at 105kt and then to the N of the London Gatwick TMA at 2400ft. He continued on a heading of 270° and once S abeam Kenley he contacted Farnborough Radar who told him to squawk 0435. He was identified and given FIS, passed his route and was 'cleared' direct to OCK, remaining at 2400ft on the London QNH of 1011mb.

Cause: A non-sighting by the TB21 pilot and effectively, a non-sighting by the Victa Airtourer pilot.
