**UK AIRPROX BOARD**

**Selected extracts from UKAB Reports  
for use by General Aviation Pilots**

**Airprox in UK Airspace  
Involving General Aviation Pilots**

**Incidents reported July - December 2003**

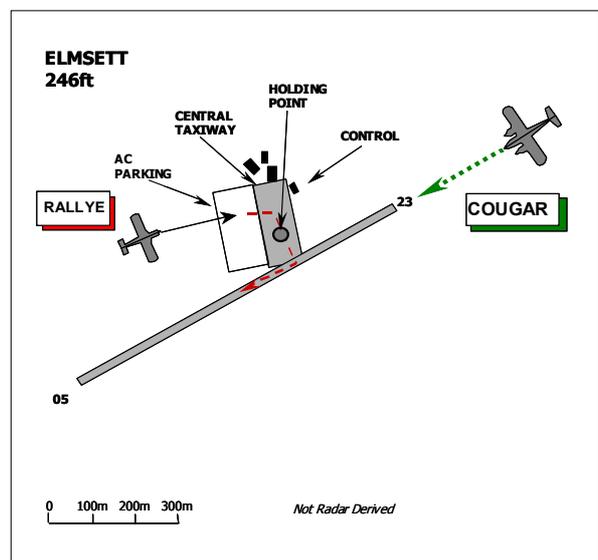
### AIRPROX REPORT NO 141/03

Although there were many secondary factors, this was in essence a very straightforward occurrence caused primarily by the Rallye pilot entering an active runway without checking that it was safe to do so. Specialist members considered that he made many mistakes in the lead-up to the incident. The video

Cause: The Rallye pilot entered the runway and took off into conflict with the Cougar which was on short finals.

The Elmsett A/G station was not manned as required by CAP452, Ch3, Para1.

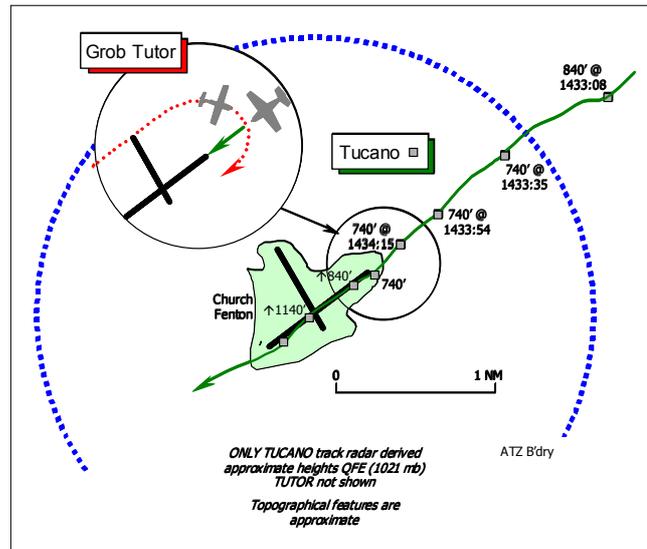
### AIRPROX REPORT NO 145/03

Cause: The Student Tutor pilot flew into conflict with the Tucano on final approach.

That DASC, in conjunction with HQ PTC, should conduct a widespread publicity campaign with particular emphasis on the interaction of instrument traffic within the visual circuit area especially at flying training units.

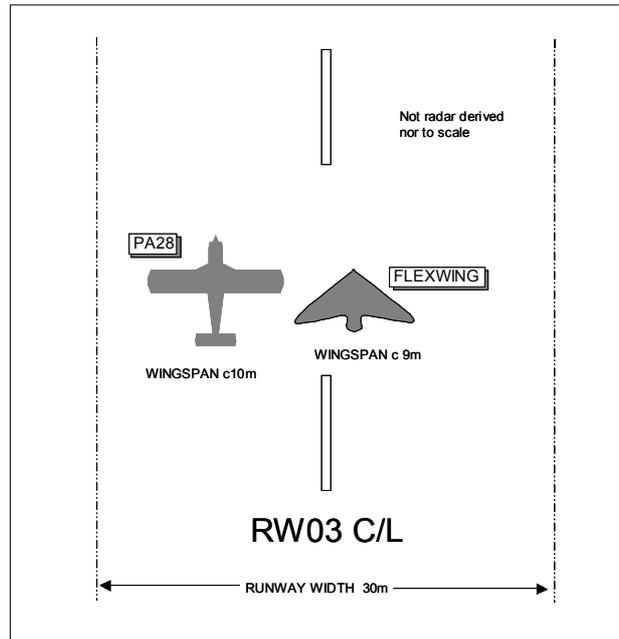
**AIRPROX REPORT NO 165/03**

Cause: The PA28 pilot continued to approach and elected to land on the RW that was already occupied by the Microlight, contrary to Rule 17 para 7 (b).

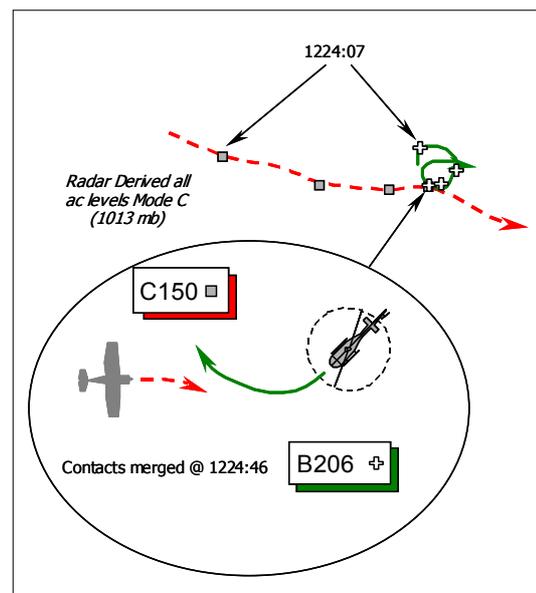
Cause: The C150 pilot flew into conflict with the JetRanger.

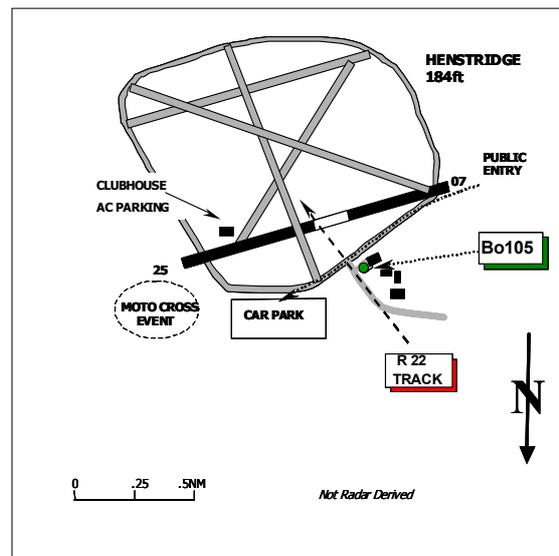
**AIRPROX REPORT NO 135/03**

Cause: The R22 pilot flew close enough to the Bo105 to cause concern.

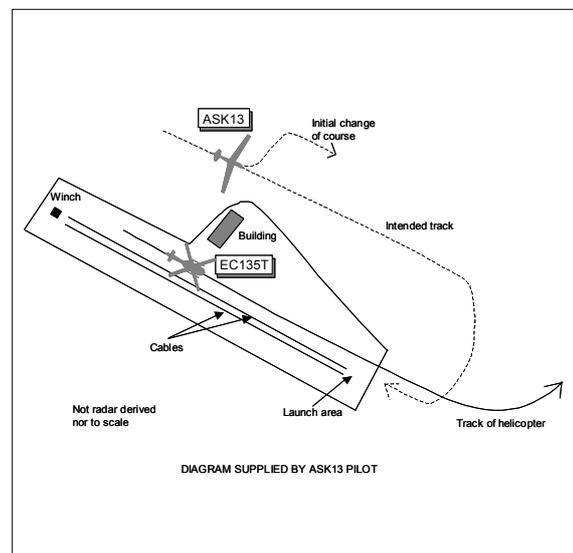
Members were dismayed that the EC135T pilot had used a GPS track without adequately monitoring his progress subsequently by use of a map. This course of action had led him to overfly an active promulgated glider site below cable launch height, which could have resulted in a potentially serious incident, but had ultimately caused the Airprox. The ASK13 pilot was concerned to see the helicopter without warning just 100m on her R, in conflict and apparently without seeing her ac.

Cause: The EC135T pilot flew overhead an active promulgated glider site below cable launch height and close enough to cause concern to the ASK13 pilot.

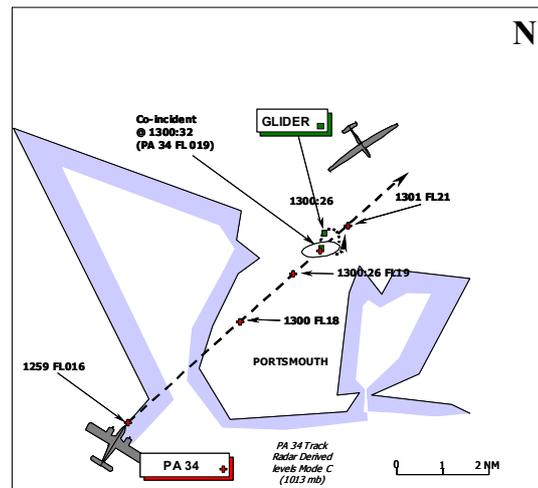
### AIRPROX REPORT NO 138/03

Cause: A non-sighting by the PA 34 pilot and a very late sighting by the SHK1 pilot.

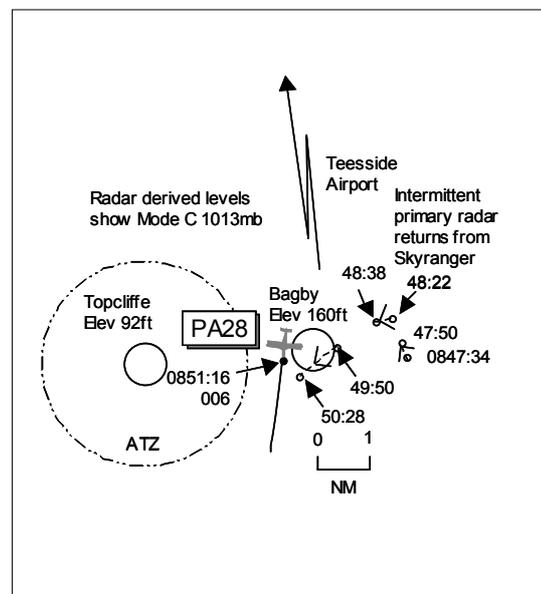
### AIRPROX REPORT NO 126/03

**Cause:** A non-sighting by the Skyranger pilot and a late sighting by the PA28 pilot in the vicinity of an unlicensed promulgated airfield.

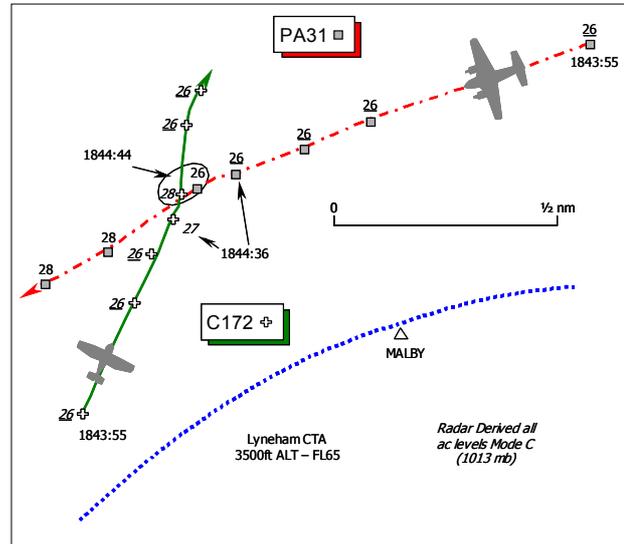
Cause: Very late sightings by both the C172 pilot and the PA31 pilot.

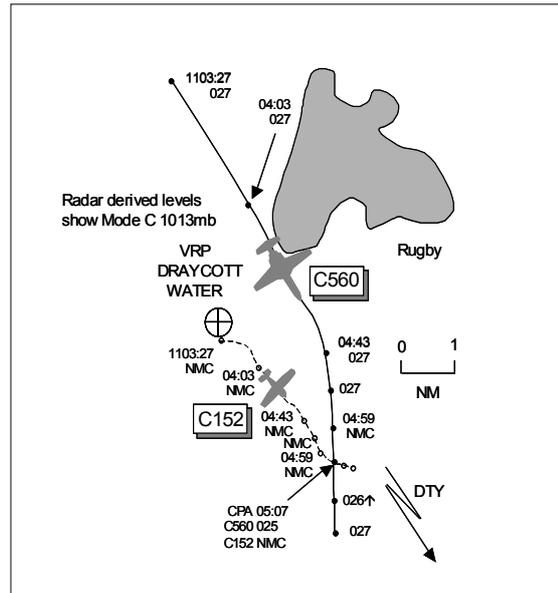
**AIRPROX REPORT NO 199/03**

Cause: Conflict resolved by the C560 crew.

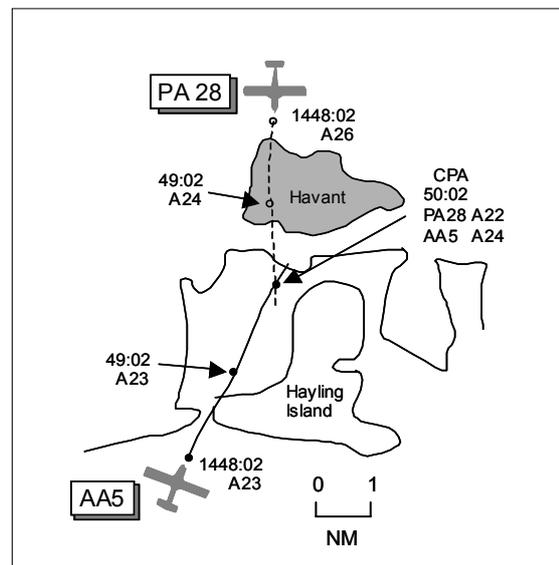
**AIRPROX REPORT NO 203/03**

Both reporting pilots agreed that their very late sightings had caused the Airprox and this was endorsed by the Board. The opportunity had been there for earlier sightings although from the PA28 cockpit, the pilot's lookout had been slightly degraded by the low sun and slight haze. He first saw the AA5 as it emerged from the sun just R of his 12 o'clock 150-200ft ahead slightly above and had reacted swiftly by pushing forward on the control column. He immediately lost sight of the AA5 as he went underneath but estimated it passed 50-100ft above. Meanwhile, the AA5, which had two pilots on board, was flying down sun but, having gone 'heads-in' whilst changing frequency, the handling pilot had only seen the PA28 on looking up; it was in his 10 o'clock range 400m crossing L to R and slightly below. He had immediately commenced a climbing R turn to avoid and had enough time to see the PA28 pitching down during its own avoiding action manoeuvre, passing <100ft below. Some members thought that, even though both parties took action, it had been effected too late to alter their respective flight paths to the extent that a collision risk existed. However, the majority of members believed otherwise and that the actions taken by both pilots had been effective in stopping the ac colliding. Nevertheless, the subject ac had passed in such close proximity that safety had been compromised to a significant extent during the encounter.

Cause: Very late sightings by both pilots.
