# ACAS II Bulletin

November 2017 | N°22

## ATC vertical rate and heading instructions

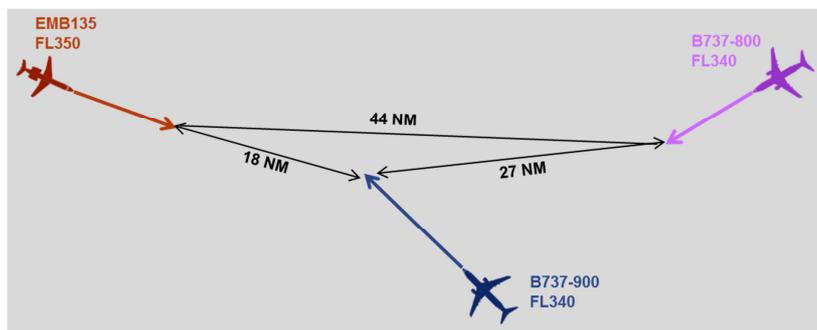
Three aircraft are involved in the event illustrated below: an Embraer 135 at FL350 heading 110° (shown in brown), a Boeing 737-900 at FL340 heading 310° (blue) and a Boeing 737-800 also at FL340 heading 240° (purple). As the EMB135 is approaching its top of descent ATC instructs it to turn right 5° and descend to FL330 “to be level in 2 minutes”. The B737-900 is instructed to continue on its present heading.

The heading instructions are meant to maintain the predicted horizontal separation of over 5 NM between the EMB135 and the Boeing 737-900, while “to be level in 2 minutes” instruction is issued to ensure that the EMB135 is below the B737-800 before the horizontal separation is lost.

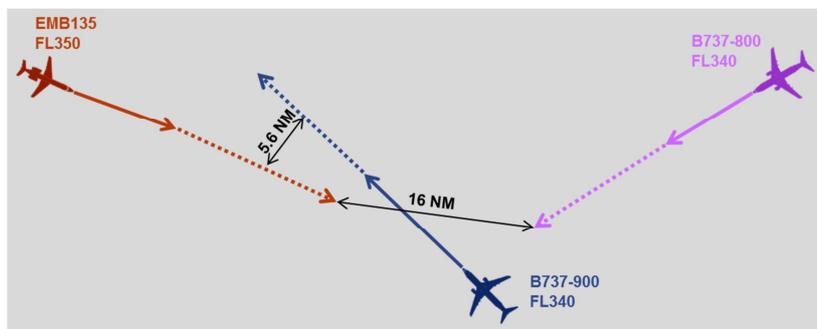
After 45 seconds, when the EMB135 is passing through FL348, both the EMB135 and B737-900 get TAs against each other. The TAs are issued because the aircraft are slightly converging and the time to Closest Point of Approach falls within the TA generation threshold.

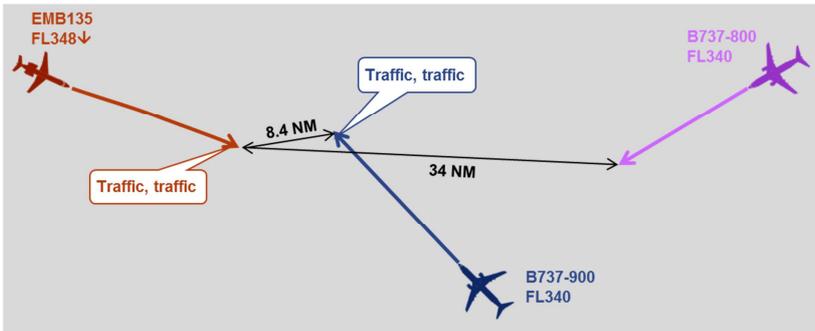
As both aircraft are “locked” on their headings there is no loss of separation. Soon after receiving the TA, the EMB135 stops its descent and reports “unable rate due to TCAS TA”.

The controller again instructs the EMB135 to descend to FL330. Additionally, the EMB135 is given a left turn onto a heading of 090° to ensure the horizontal separation with the southwest bound B737-800 is maintained while the EMB135 is descending through its level.

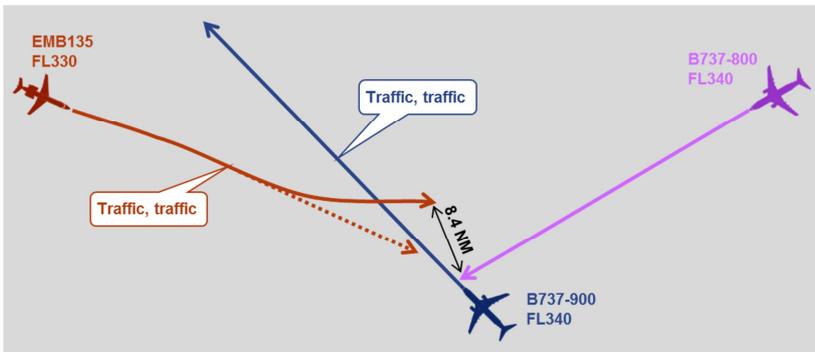
The TAs, subsequently, terminate after 20 seconds.

The EMB135 continues its descent and when it reaches FL330 (i.e. it is below the B737-800 at the distance of 8.4 NM) is cleared on own navigation.

Without the turn, as the EMB135 crew reduced the vertical rate in response to the TA, the horizontal separation would have dropped below the required 5 NM.

**Conclusions:** The EMB135 crew did not follow the ATC instructions and reduced their vertical rate because of the TA. There was no risk of loss of separation with the aircraft against which the TA was issued (the B737-900) and the closure rate was such that no RA would have been triggered. As the EMB135 stopped descending at the instructed rate, the controller had to issue an additional turn instruction to the EMB135 crew to prevent a separation loss with the B737-800.

- The objective of a TA is to aid visual acquisition of an intruder and prepare the crew for a possible RA.
- ICAO provisions are quite specific – pilots shall not manoeuvre their aircraft in response to TAs.
- Chances are that a manoeuvre prompted by a TA may actually lead to a genuine loss of separation or RA which otherwise would not have occurred.
- Unless an RA has been issued, the pilot must comply with ATC instructions, including any given vertical rate and heading.

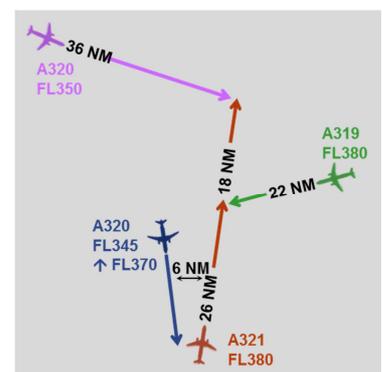
A northbound Airbus 321 (shown in brown on the adjacent figure) is maintaining FL380 while a southbound Airbus 320 (blue) is passing through FL345 climbing to FL370. Further north, an Airbus 319 (green) is heading west also at FL380 and another A320 (purple) heading east is maintaining FL350.

The controller instructs the northbound A321 (brown) and southbound A320 (blue) to continue on their headings to ensure that the predicted horizontal separation of 6 NM is maintained. Then, the controller instructs the A321 to descend to FL340 with a vertical rate of 1000 ft/min. or more. The vertical rate is given due to the two aircraft on crossing tracks further north: by following the descent rate the A321 will get below both aircraft before horizontal separation is lost.

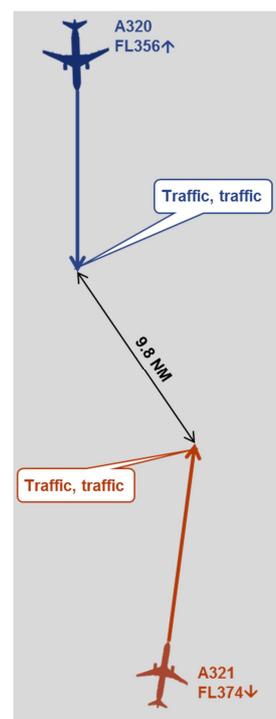
When the A321 and A320 are 9.8 NM apart and passing through FL374 and FL356 respectively, they both get TAs. Soon after, the A321 crew reports that they have reduced their rate of descent due to the TA and ask for traffic information, which the controller provides.

After 26 seconds, when the A321 passes FL369 and A320 FL362, the aircraft pass each other at a distance of 5.9 NM, and the TAs terminate. Subsequently, the A321 resumes its descent as instructed and there is no loss of separation with the two other aircraft further north on the crossing tracks.

**Conclusions:** This event illustrates the importance of following ATC instructions since they are issued taking into account all surrounding traffic, including those aircraft which may be on another frequency or still some distance away. In this case the vertical speed reduction by the A321 had no significant negative consequences as both the crossing aircraft were still some distance away and separation recovery was possible. However, there was no justification for the reduction of the ATC instructed vertical rate because of a TA. In this geometry no RA would have been triggered.

- **Pilots:** Always comply with vertical rates and headings instructed by ATC. Controllers use them to achieve separation. Controllers anticipate delays in reaching the assigned rate and a level off manoeuvre and apply some margin when calculating the required rate.
- Air traffic controllers base their actions on the complete traffic picture to provide safe and expeditious flow of aircraft.
- **Controllers:** If workload and frequency occupancy permit, provide pilots with traffic information, so the reasons for heading/vertical speed instructions are known to flight crews.

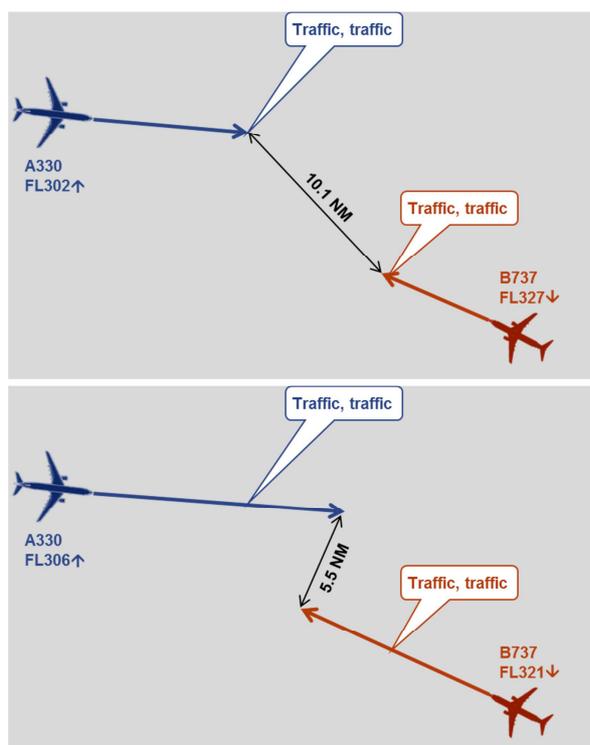
A westbound Boeing 737-800 is at FL340 at the top of descent. To facilitate its descent the controller instructs the crew to turn left 10° and clears them to FL260 with the rate of 2000 ft/min. The vertical speed instruction is meant to bring the B737 below a stream of north-south traffic several miles away in the adjacent sector while the left turn is to provide horizontal separation with an Airbus 330 which is climbing to FL370 in the opposite direction. Both aircraft are “locked” on headings and expected to pass more than 5 NM apart.

The B737 starts to descend and as the aircraft get closer the B737 crew observe the A330 on their TCAS traffic display and determine they are in conflict as the A330 appears to be on their 12 o’clock position. Soon after, they get a TA against the A330 and reduce their descent rate to 200 ft/min. At the time when the TA is issued the aircraft are separated by 10.1 NM and 2500 feet. The TA terminates after 16 seconds and after another 20 seconds the aircraft pass with the horizontal separation of 5.5 NM and vertical separation of 1500 feet.

**Conclusions:** The B737 crew reduced the vertical speed contrary to the ATC instruction as they determined (based on the TCAS traffic display) that the A330 was on a collision course. In fact, the A330 was on an almost parallel opposite direction track. Their assessment of the A330 position was incorrect as sufficient horizontal spacing with the A330 was provided by ATC.

- TCAS Traffic Display must not be used for self-separation as it can be misinterpreted. It has limited bearing accuracy ( $\pm 30^\circ$ ) and it is based upon a moving reference. As the trajectory and intentions of other aircraft are not known, avoidance manoeuvres based solely on a TA may create a problem or cause a situation to deteriorate.
- Nominally, TCAS surveillance range is to 30 NM and 10,000 feet; however, in high-density airspace the TCAS surveillance range might be reduced to as little as 5 NM to reduce undesired interference with other systems (without compromising the collision avoidance capability). Consequently, not all aircraft in the vicinity will necessarily be shown on the traffic display.

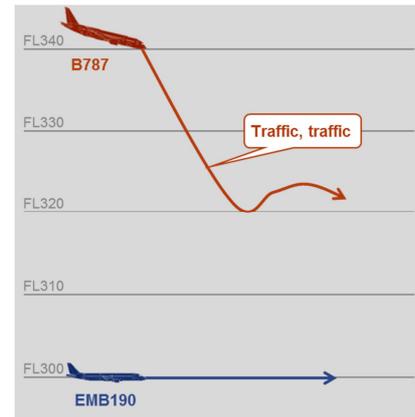
A Boeing 787 is maintaining FL360 above an Embraer 190 at FL300. Both aircraft are proceeding to the same destination. When the B787 asks for descent it is cleared to FL310.

When the B787 is approaching FL320 at the rate of 3000 ft/min., the crew asks the controller about the traffic below. The controller provides traffic information and confirms that B787 has been cleared 1000 feet above the aircraft below. The B787 crew confirms the clearance to FL310 but at the same time they stop the descent and start to climb until the aircraft levels off at FL324.

Subsequently, the B787 crew reports that the reason for their climb was “*information about traffic below*”. After brief level off, the B787 continues its descent to FL310.

**Conclusions:** A post incident analysis showed that the crew started to climb soon after receiving a TA against the EMB190 below. As no RA has been issued there was no justification for a manoeuvre contrary to ATC instruction.
