AIRPROX REPORT No 2011044

Date/Time: 20 May 2011 0952Z			
Position:	5159N 00103W of Croughton)	(5nm E	lieton aney-
<u>Airspace:</u>	London FIR	(<u><i>Class</i></u> : G)	HINT
	Reporting Ac	Reported Ac	THERE
<u>Type</u> :	Magic Laser	MD902 Explorer	N Kings
	Flexwing ML		
<u>Operator:</u>	Civ Pte	Civ Comm	
<u>Alt/FL</u> :	2000ft amsl	<1000ft amsl	
<u>Weather:</u> Visibilit <u>y</u> :	VMC CLBC 50nm	VMC CLBC >10km	THEYE
Reported Separation:			INTEN
	300ft V/nil H	500ft V/100ft H	PARACH
Recorded Separation:

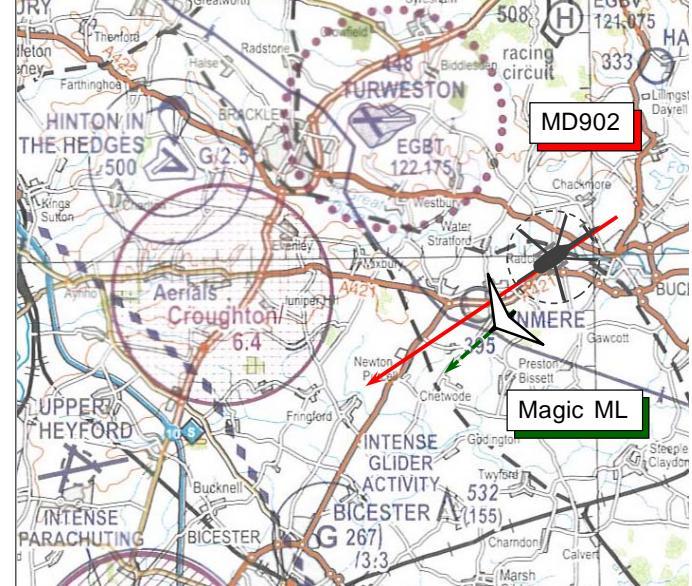
UKAB Note (2): Analysis of the LATCC (Mil) Clee Hill Radar recording shows the MD902 as an SSR contact only, identified by its discrete squawk, transiting the Airprox location near Finmere (elev: 395ft amsl), however, the Magic ML is not evident at all. The MD902 maintains a transit altitude of 900-1000ft throughout and is shown at 0952:56, at a position 5nm E of Croughton tracking 235° level at an altitude of 1000ft London QNH (1019mb) – equating to a height of broadly 600ft agl.

The ML pilot reports he was flying at an altitude of 2000ft whereas the MD902 pilot was maintaining a level cruise at an altitude not above 1000ft – as indicated on Mode C from the recorded radar data. The ML pilot estimated the vertical separation at 300ft before he was affected by turbulence and the MD902 pilot estimated 500ft. A Member suggested that the helicopter pilot might have been better placed to judge the separation from below and helicopter Members agreed that the MD902 pilot would not have thought that 500ft separation could have posed a hazard to the ML; furthermore the MD902 pilot reports a slight lateral offset as he overtook the ML. By the time the ML pilot had recovered to level flight he had lost 200ft putting him between 100ft and 300ft above and behind the helicopter and in a position where he was more likely to be affected by its wake. Whilst the recorded radar data suggested that the vertical separation might have been somewhat more than either of the

The ML was seen by the helicopter pilot late he reports, 15sec before he flew under it – a sighting range of about 0-33nm away at a closing speed of 80kt. However, the ML would have remained on a constant bearing with no crossing motion to draw attention to it as the MD902 approached from astern. With the yellow wing under-surface of the ML possibly quite difficult to see against a background cloudscape, the MD902 pilot probably saw the ML as soon as was feasible in these circumstances.
