AIRPROX REPORT No 2019045

Date: 26 Mar 2019 Time: 0815Z Position: 5258N 00154W Location: 3nm ESE Cheadle

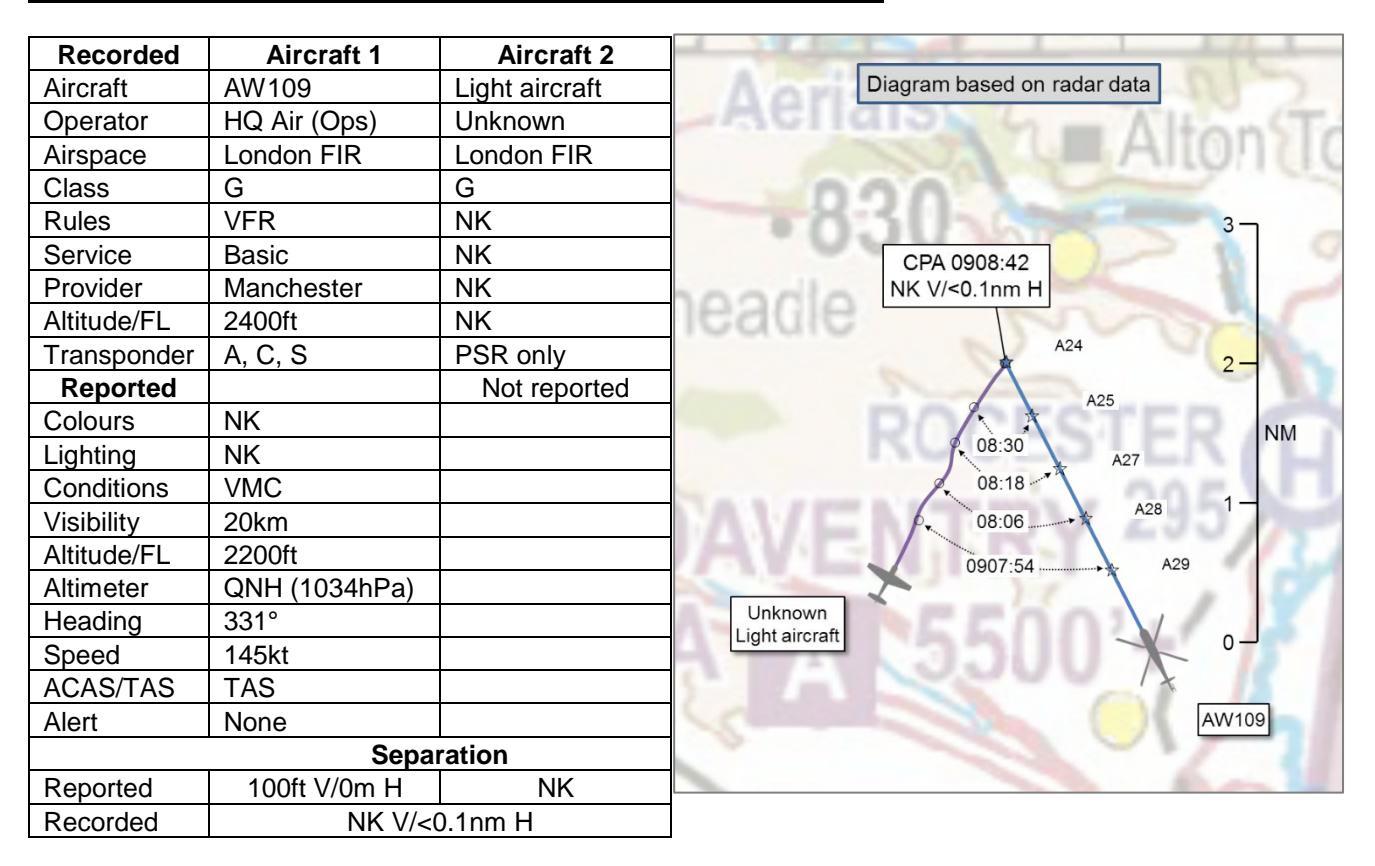
THE AW109 PILOT reports that he was in transit and had established radio communication with Manchester Radar. He had requested a Traffic Service but they were unable to provide one so he was under a Basic Service. Manchester Radar cleared him to enter controlled airspace at VRP Macclesfield South not above 1500ft QNH. He had started a cruise descent from 2900ft when he saw a low-wing single engine 'Extra 300 type' light aircraft converging in the left 10 o'clock position at a range of about 300m that passed close underneath. He became visual with it again on the right-hand side, now climbing above his level. There was no time to conduct an evasive manoeuvre. The light-aircraft did not appear on the TAS at any point, indicating that it probably wasn't using a transponder. The combination of flying single-pilot in the RHS with a descent profile versus the climb profile of the light-aircraft had, in his opinion, made it very difficult to see the potential confliction until very late.

At the time of writing, it is unfortunate that the details of the conflicting traffic are not available. The evidence would suggest that this aircraft was not communicating with ATC and not using a transponder. Furthermore, from the track displayed on the radar replay it would appear that no avoiding action was taken by this traffic. This Airprox serves as another stark reminder that seeand-avoid can be the only available barrier to avoiding MAC in Class G airspace and illustrates the importance of lookout.

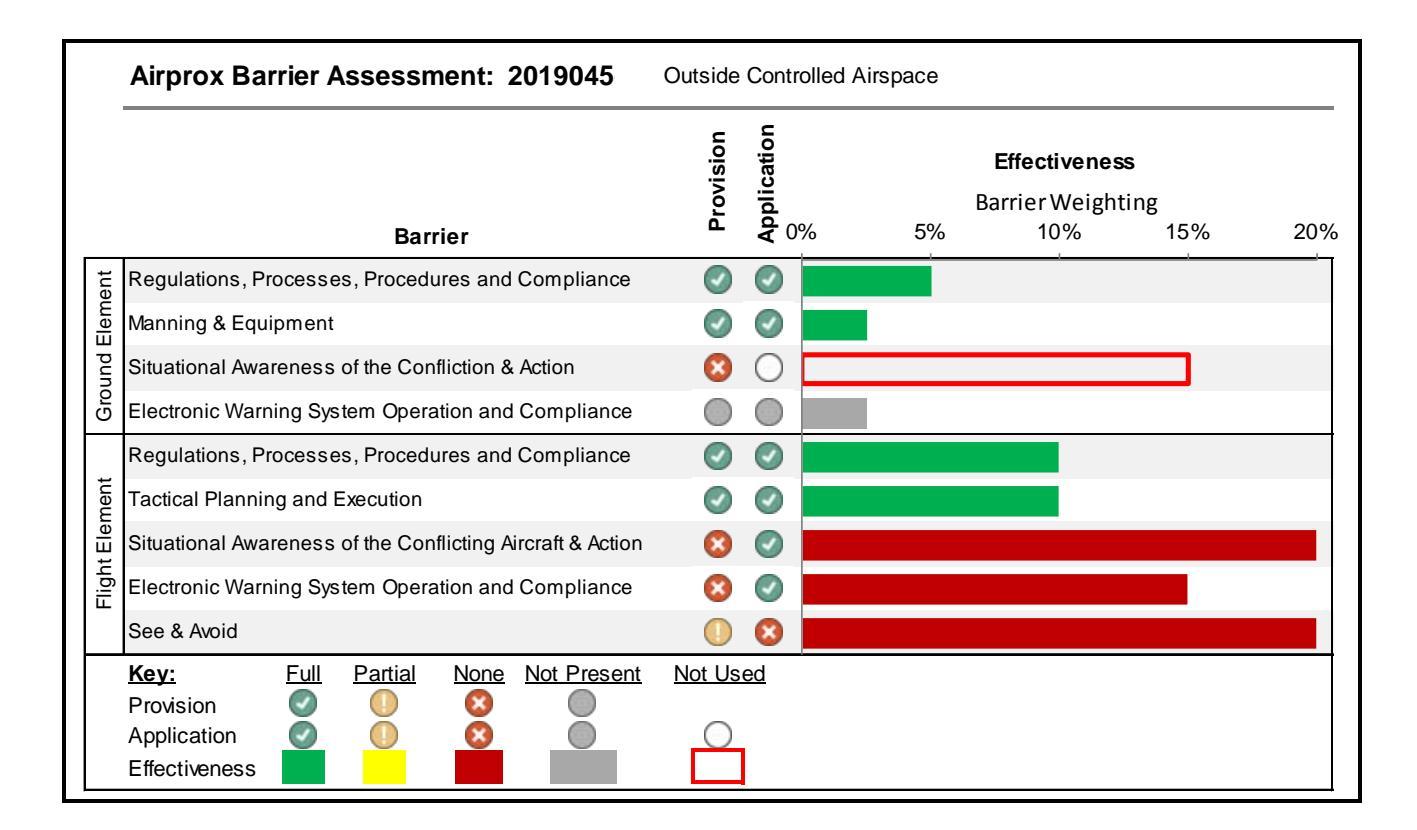
In assessing the effectiveness of the safety barriers associated with this incident, the Board concluded that the key factors had been that:

Situational Awareness of the Confliction and Action were assessed as ineffective because neither pilot was in receipt of a ATS that would provide SA.

Situational Awareness of the Conflicting Aircraft and Action were assessed as ineffective because the AW109 pilot did not have SA on the converging light-aircraft and, considering the radar tracks and reported separation at CPA, neither did the unknown light-aircraft pilot.

Electronic Warning System Operation and Compliance were assessed as **ineffective** because the light-aircraft did not display SSR and was therefore not detectable by the AW109 TAS.

See and Avoid were assessed as **ineffective** because the AW109 pilot did not see the other aircraft in time to increase separation at CPA, and the unknown aircraft pilot had either not seen the AW109 or, if he had, did not sufficiently give way.
