AIRPROX REPORT No 2019074

Date: 23 Apr 2019 Time: 1135Z Position: 5155N 00054W Location: 4nm NE Westcott

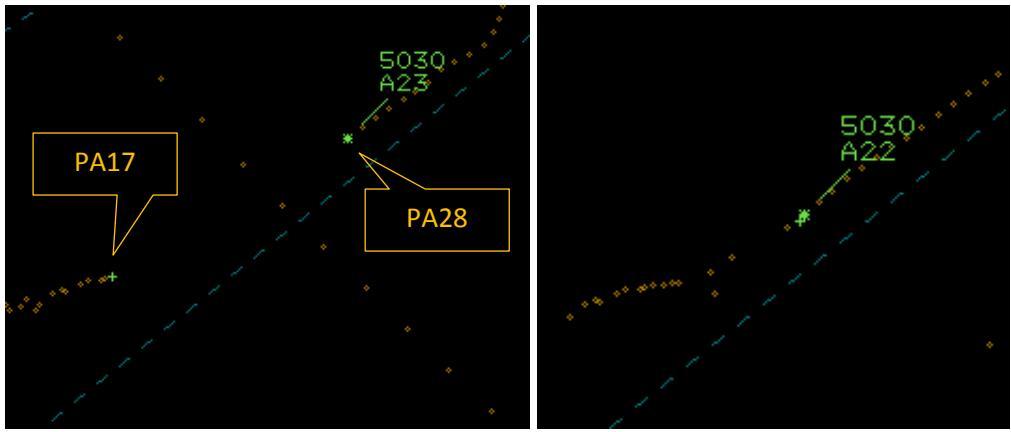
Figure 1 1135:00

At Figure 1 is a radar screenshot taken from the NATS area radar showing the geometry just before the incident. The PA17 was not squawking but was identified by following the flight profile from its departure airfield. The PA28 can be seen squawking 5030 at 2300ft. CPA occurs at 1135:27 (Figure 2) with the two aircraft head-on, separated by <0.1nm; the height separation is not known.

Figure 2 CPA 1135:27
