AIRPROX REPORT No 2018026

Date: 25 Jan 2018 Time: 1122Z Position: 5216N 00053E Location: Mildenhall

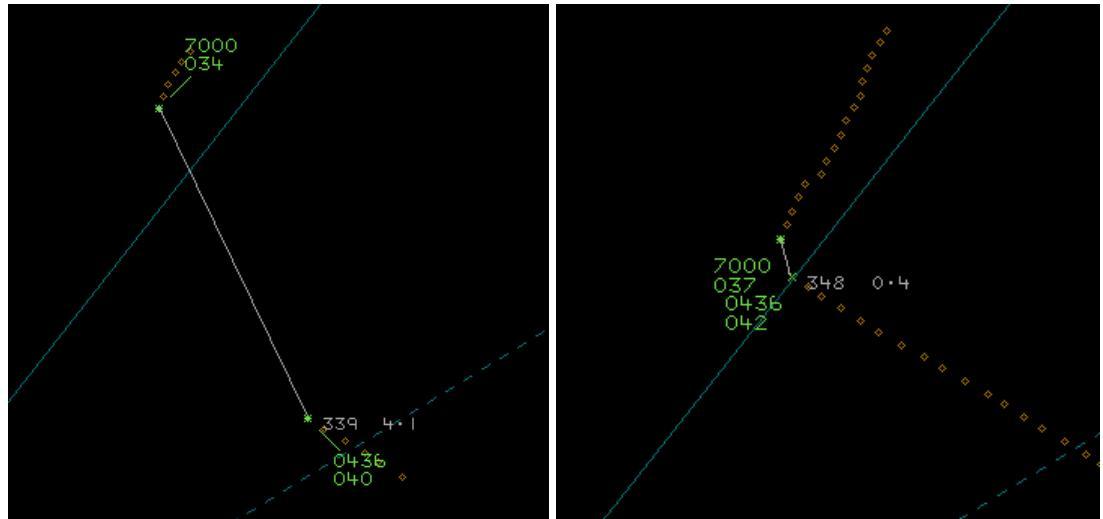
Figure 1: 1121:34

Radar screen shots are taken from the NATS radars and are not representative of the radar available to the Lakenheath controller. At Figure 1 (1121:34), the C21, squawking 0436, can be seen on a northeasterly heading and the controller has already given Traffic Information on the RV6 (squawking 7000) by this stage; the C21 pilot has replied with 'searching'. The C21 pilot calls visual after the controller calls the traffic a second time at 1121:56. At 1122:31 (Figure 2) the C21 pilot reports climbing due to a TCAS RA, at this stage the vertical separation is 300ft. CPA takes place at 1122:35; lateral separation is 0.1nm but due to the C21's climb, vertical separation is now 600ft.
