AIRPROX REPORT No 2018093

Date: 17 May 2018 Time: 1352Z Position: 5231N 00217W Location: Halfpenny Green

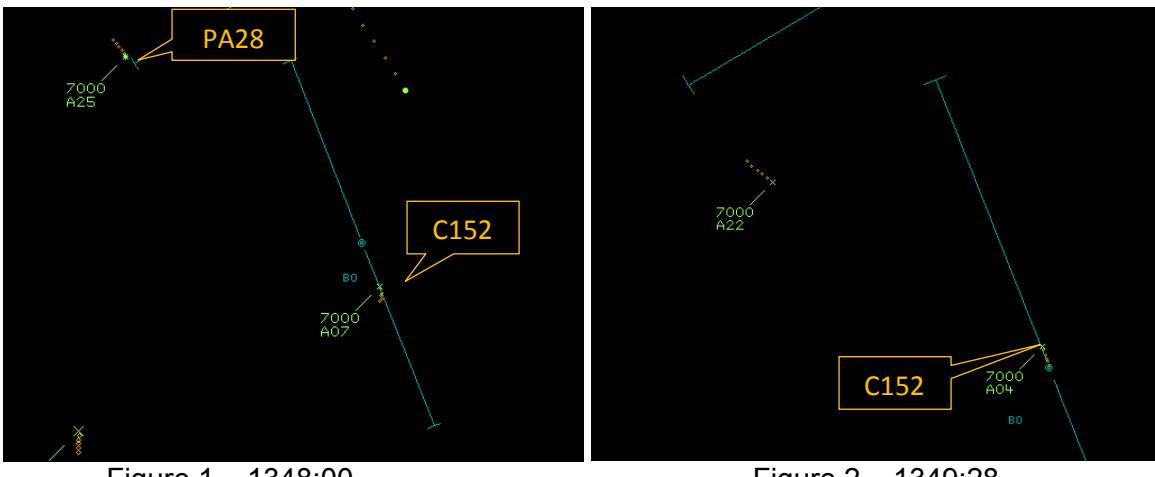
Figure 2 – 1349:28

The C152 had been observed on the radar replay on two previous circuits to drift towards the right of the climb-out before turning crosswind left-hand. On this particular circuit, the drift was more pronounced, (Figures 2-6).
