## AIRPROX REPORT No 2018233

Date: 23 Aug 2018 Time: 1105Z Position: 5213N 00139W Location: NW Wellesbourne

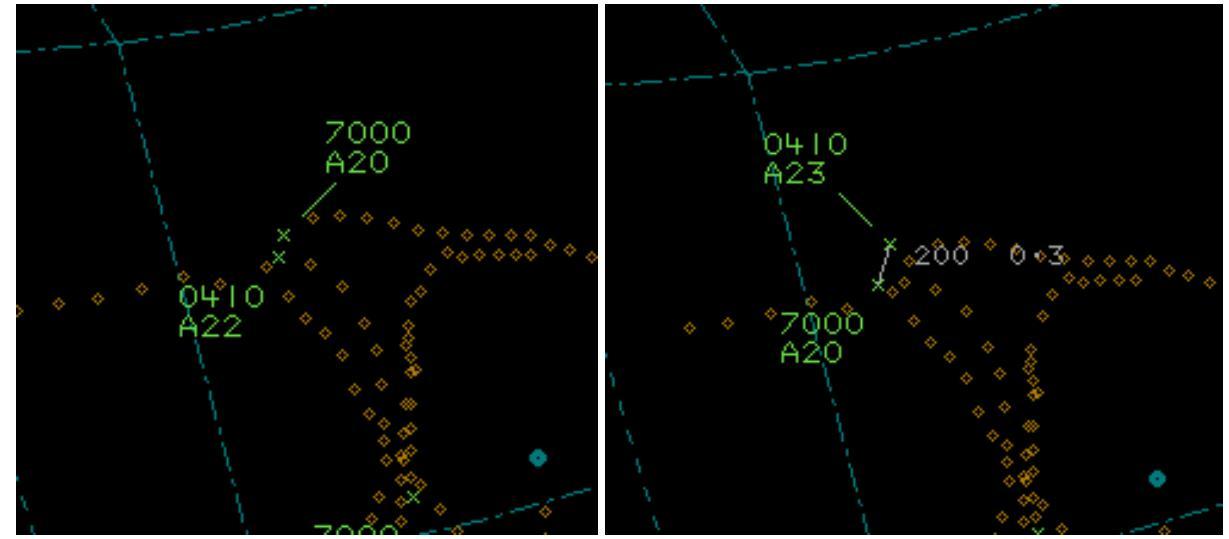
The Figures 2 and 3 were taken from the NATS radar at 1105:18 when the two aircraft are 0.2nm apart, and just afterwards at 1105:26 by which time the aircraft have past each other and are 0.3nm apart. Therefore, the actual CPA occurs between radar sweeps and cannot be measured, although the C172 photographic image indicates that there was no horizontal separation at CPA.

Figure 1 1105:18 – 0.2nm Figure 2 1105:25 – 0.3nm C172 Squawking 0410, TB9 squawking 7000
