AIRPROX REPORT No 2017057

Date: 09 Apr 2017 Time: 1305Z Position: 5357N 00245W Location: 2nm east of Cockerham

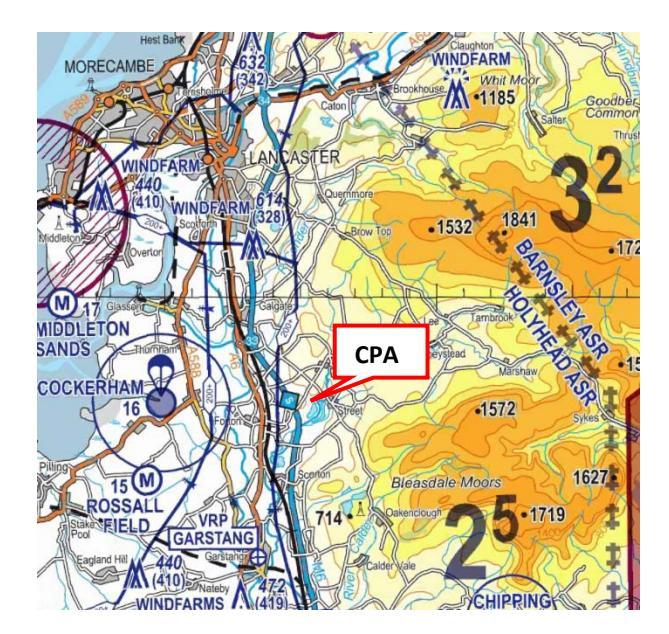
Figure 1

The pilot of the EC135 (a HEMS aircraft) reported being en-route with a casualty from a site to the north-east of Lancaster to a hospital in Preston. The C208 was conducting parachute drops from FL150 into the Cockerham parachuting site (Figure 1).

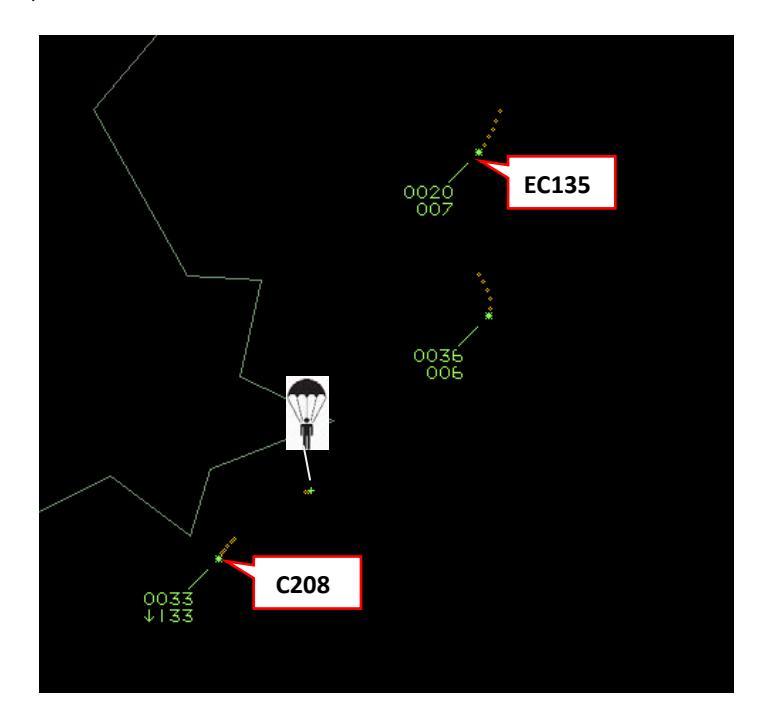
$Figure \ 2-1304{:}40$ (note levels indicated are Flight Levels – 108ft to be added for altitudes)

At 1304:40, the C208 was observed in the descent from FL150, with strong primary contacts appearing behind, believed to be the parachutists, near the designated Cockerham parachute jumping site (Figure 2).

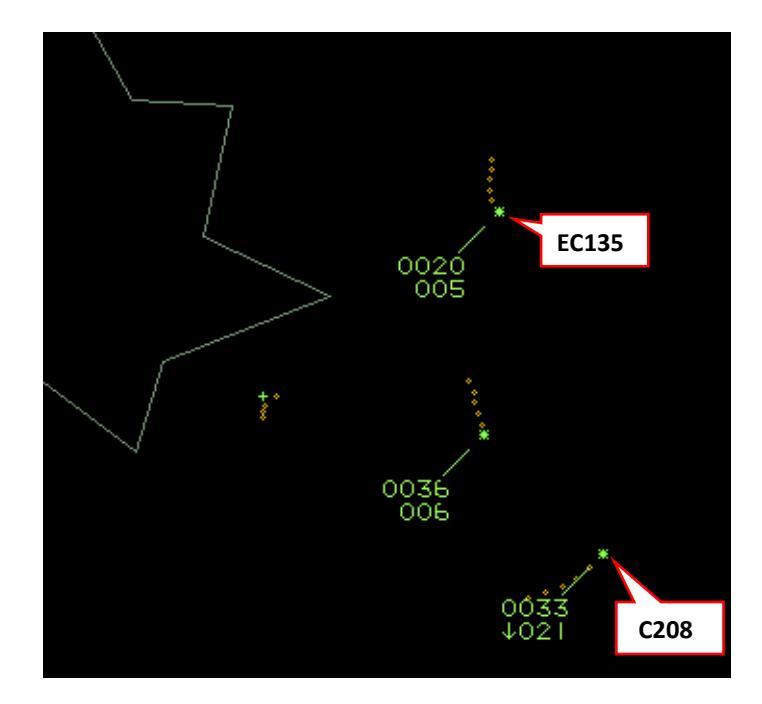
Figure 3 – 1306:27

At 1306:27 the C208 was below 2500ft, continuing in the descent, clear and to the south-east of the parachuting site (Figure 3).

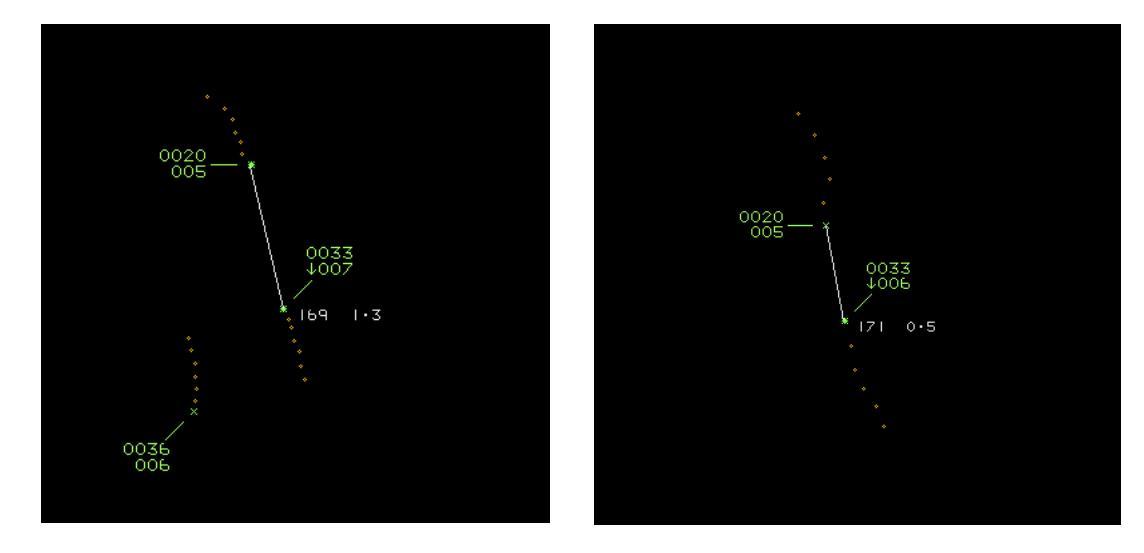
Figures 4 & 5 illustrate the situation at 1307:03 and 1307:20 respectively.

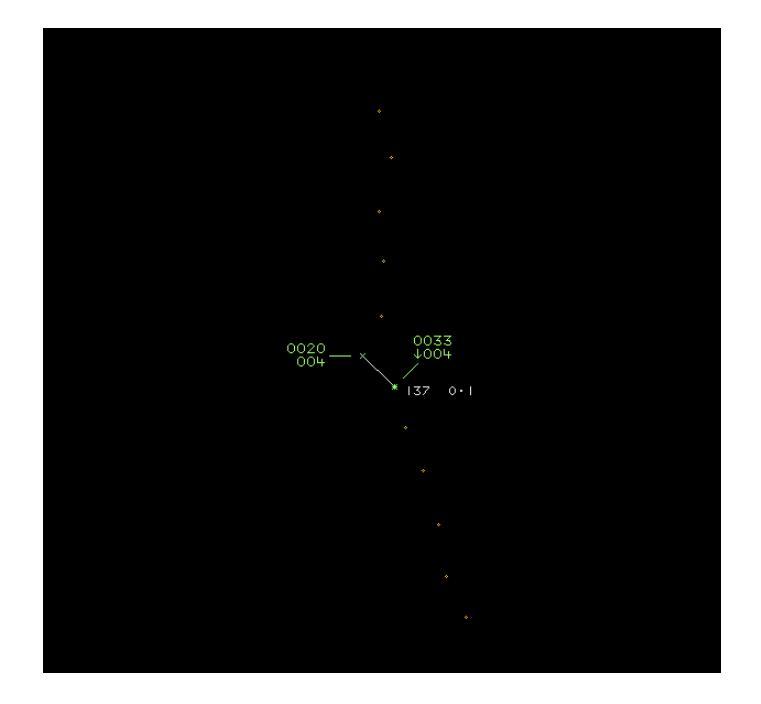
Figure 5 - 1307:27 - CPA

CPA took place at 1307:27 with the aircraft indicating at the same level and separated by less than 0.1nm laterally (Figure 5).

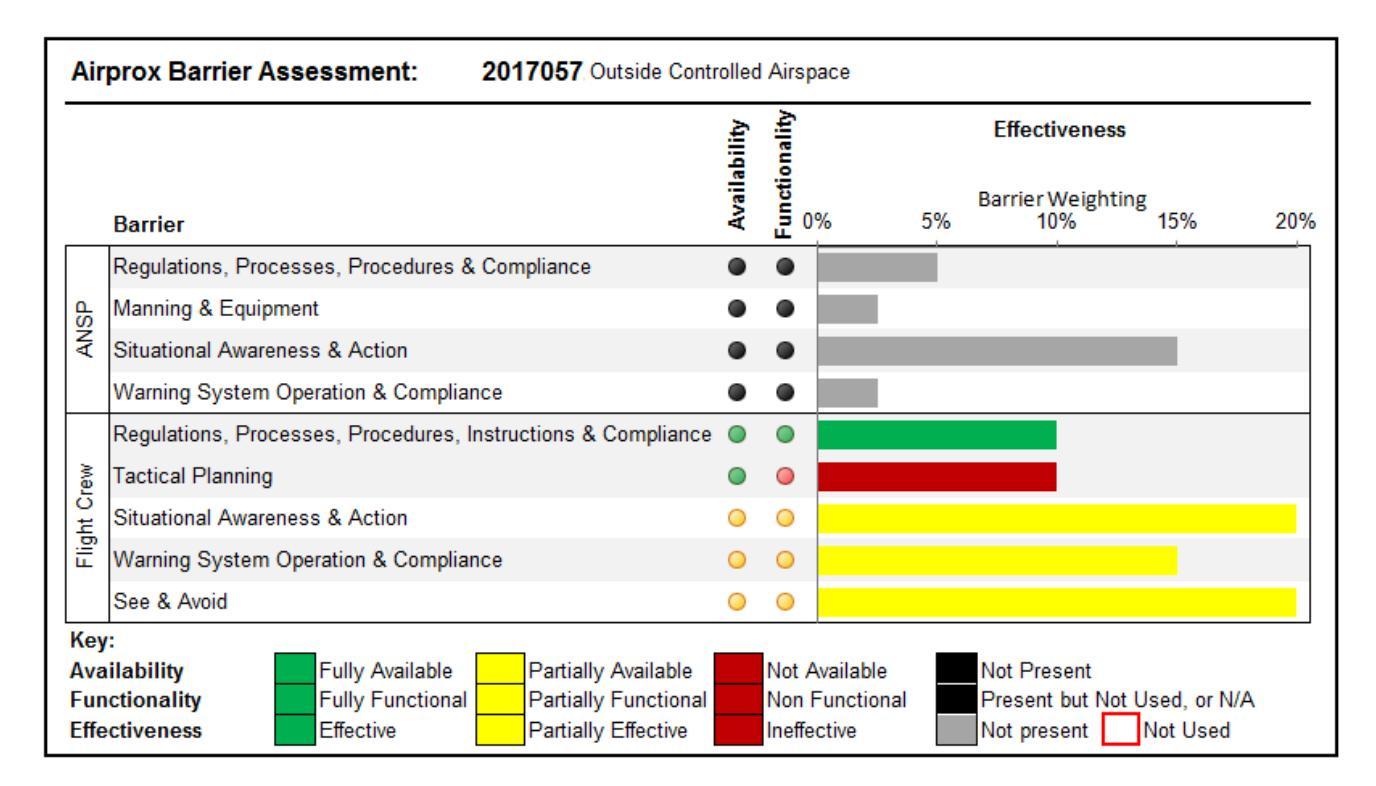
Tactical Planning was assessed as **ineffective** because the C208 pilot had descended IMC through cloud.

Situational Awareness & Action was assessed as **partially effective** because, although the EC135 pilot was generally aware of the other aircraft through his TCAS indications, the C208 was not aware of the EC135 at all.

Warning System Operation and Compliance was also assessed as **partially effective** because, although the EC135 pilot was able to make some assessment of the C208's proximity and adjust accordingly, the EC135's TCAS TA alert appeared too late for him to take effective associated action.

See and Avoid was assessed as **partially effective** because the EC135 and C208 pilots could only see each other as the C208 popped out of cloud, too close to take effective avoiding action.
