### AIRPROX REPORT No 2017180

Date: 31 Jul 2017 Time: 1328Z Position: 5113N 00031W Location: 3nm E Guildford

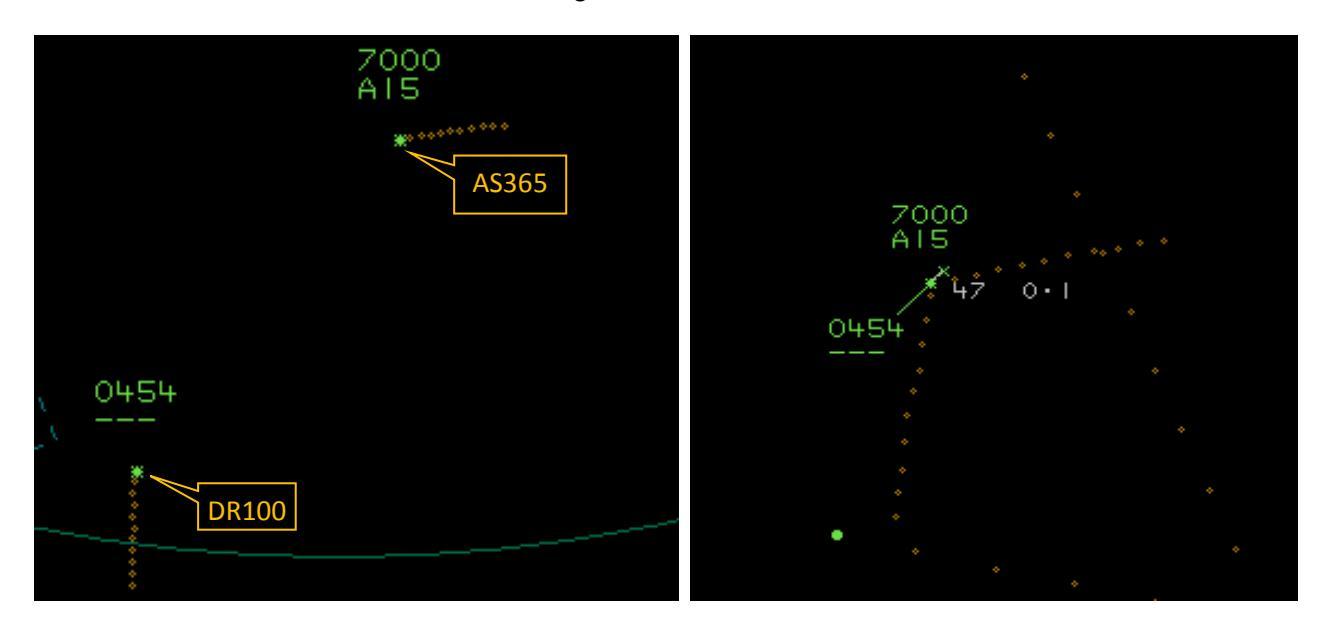
Figure 1 – 1327:01

The AS365 was not in receipt of a service from Farnborough and was not known traffic to the Farnborough controller. The identity of the AS365 has been established from the area radar replay. The aircraft were first observed on the radar replay at 1327:01 (Figure 1). The AS365 was 5.4nm NNE of the DR100 and was tracking west.

CPA took place at 1328:39 (Figure 2), with the aircraft separated by <0.1nm. The vertical separation could not be determined because the DR100 was not displaying Mode C.
