AIRPROX REPORT No 2016048

Date: 10 Apr 2016 Time: 1323Z Position: 5236N 00102W Location: Leicester Airport

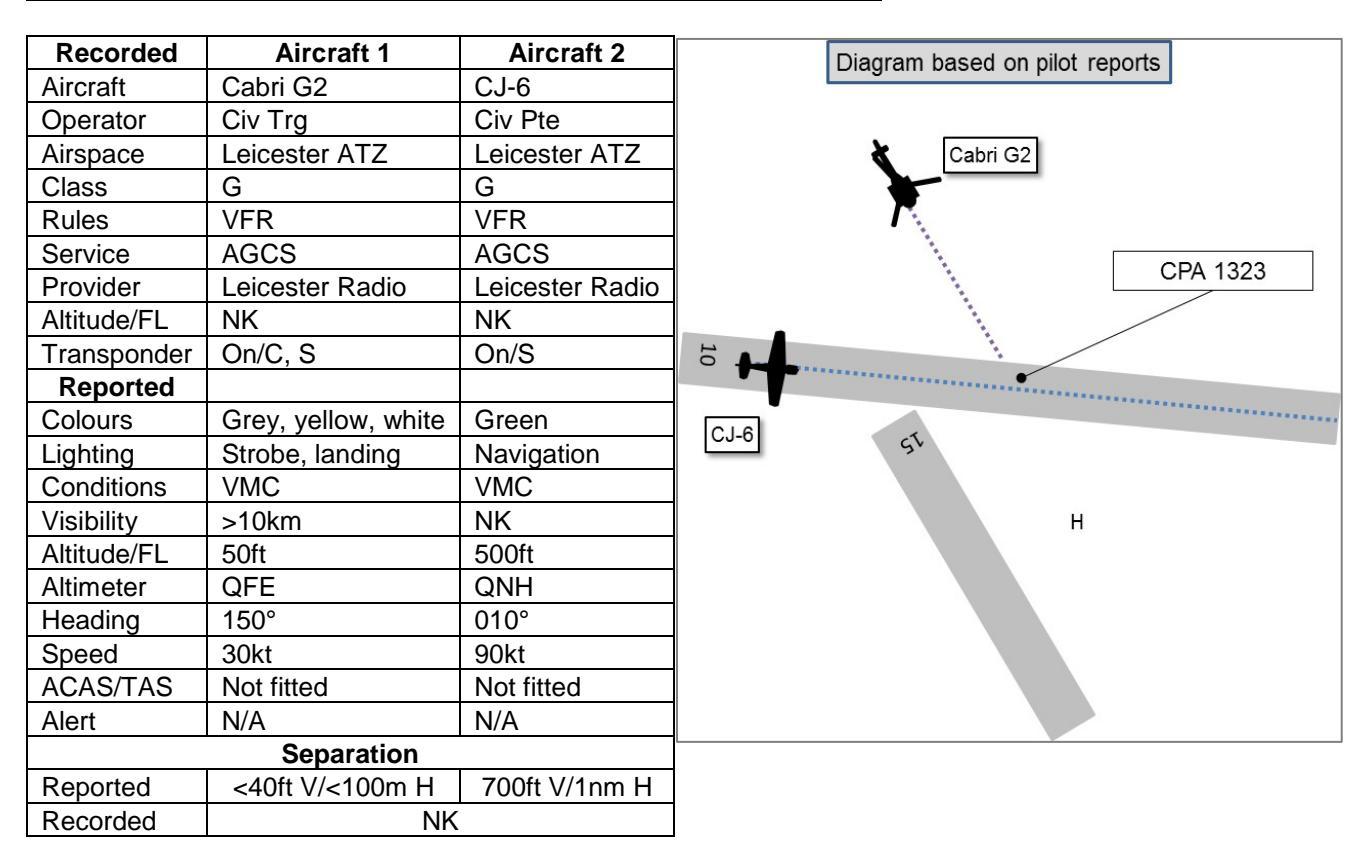
THE CABRI G2 PILOT reports that he and his student had joined the circuit downwind after a training sortie in the local area; he was using the duty runway RWY15L for rotary traffic (RWY15R for fixed wing). His student made all the radio calls as required and they turned onto the final leg. One helicopter had just landed and one fixed-wing aircraft was ahead of them and had called final for RWY15. His student called final for the H (in the centre of the airfield between the runways). A CJ-6 was lined up at the threshold of RWY10 and called ready for departure. The CJ-6 held his position until the fixed-wing aircraft on final had crossed RWY10 to land on RWY15. The CJ-6 then called for takeoff. The Cabri G2 pilot immediately called that he was on a short final for the H on circuit 15L. The CJ-6 pilot 'ignored' his radio call and started the take-off run. The Cabri G2 pilot slowed to a high hover as the CJ-6 passed less than 100m in front of him and approximately 40-50ft below.
